NDCRS ARCHITECTURAL SITE FORM

Field Code Plumer Township School

SITS# 32 DV 324

Project & Principal Investigator:
Country Schoolhouse Project

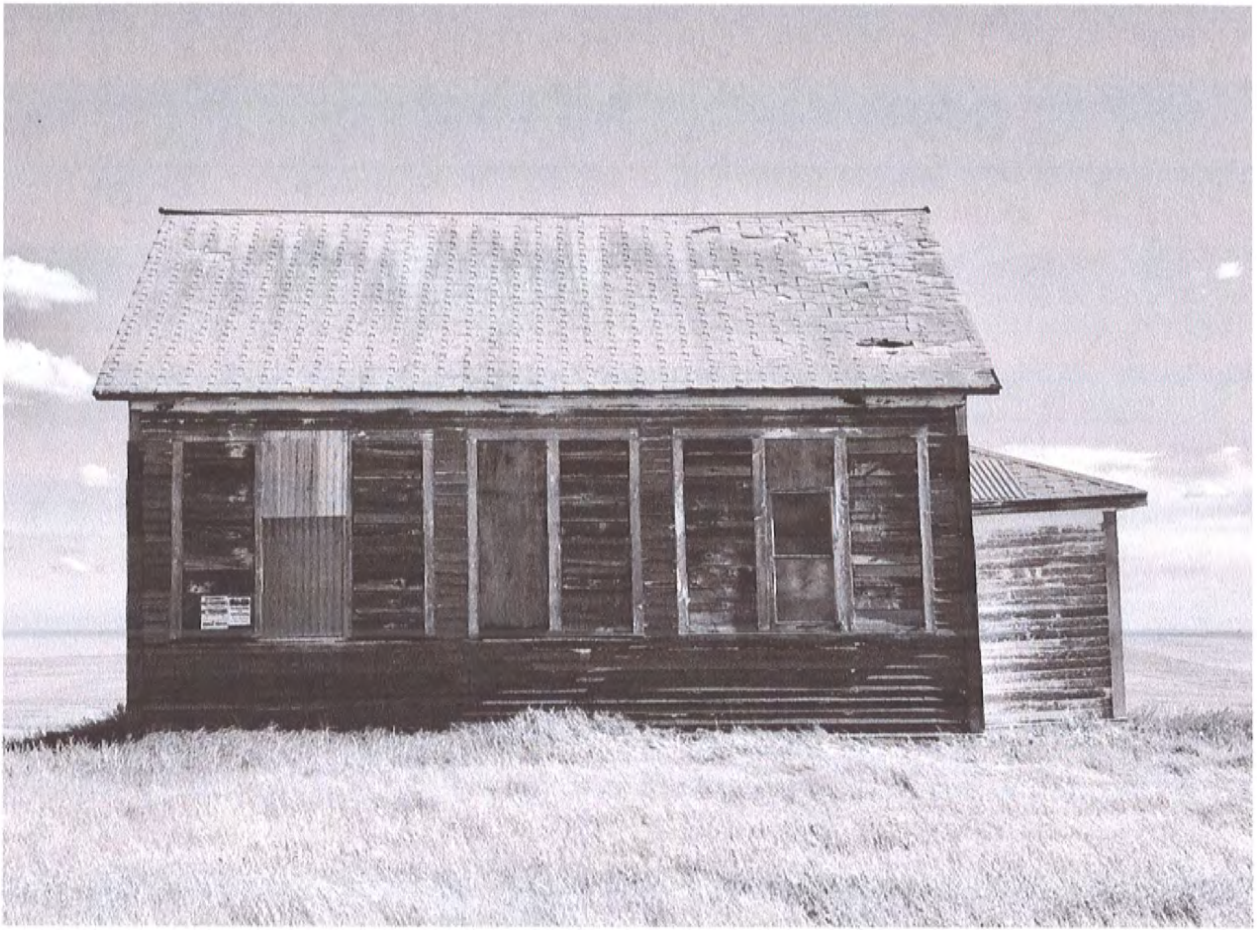
North Side
Plumer Township School

The feature is a one room prairie school on a foundation of poured concrete. The roof of the school, entry and bathroom addition are covered with asphalt shingles. The chimney is gone. The building measures 28 feet north and south and 20 feet east to west with a 12 by 6 foot addition for the toilets on the north side and a 14 by 8 foot entry on the west. The soffits are closed.

Wide trim boards run under the eaves at the peak ends of the school and entry as well as under the eaves of the bathroom addition. The siding is 6 inch wood lap with 6 inch corner trim. At the bottom edge of the siding there is a skirting board with watertable. There are 8 double hung windows on the north wall, all shuttered. Two windows in the bathroom addition as well as a window in the entry on the south are also covered. This school is similar to others in the area in the interior configuration. We were not able to go into the school but a small opening in one of the window coverings allowed a peek inside. The walls are finished with lathe and plaster on the upper 2/3 and wainscot on the bottom 1/3. The door that comes in from the entry is a 5 panel wood door. In the southwest corner of the school there is a coal or wood burning stove with a beautiful stove surround. The ceiling is wallboard panels with wood trim strips. The floor is hardwood. Did not see blackboards. No evidence of electricity.
