**NDCRS ARCHITECTURAL SITE FORM  
PAGE 1**

**SITE IDENTIFICATION** Rocky Mountain School #2

Country Schoolhouse Project

ESCA-Tech. North Dakota  
Historic Site Survey (1980)

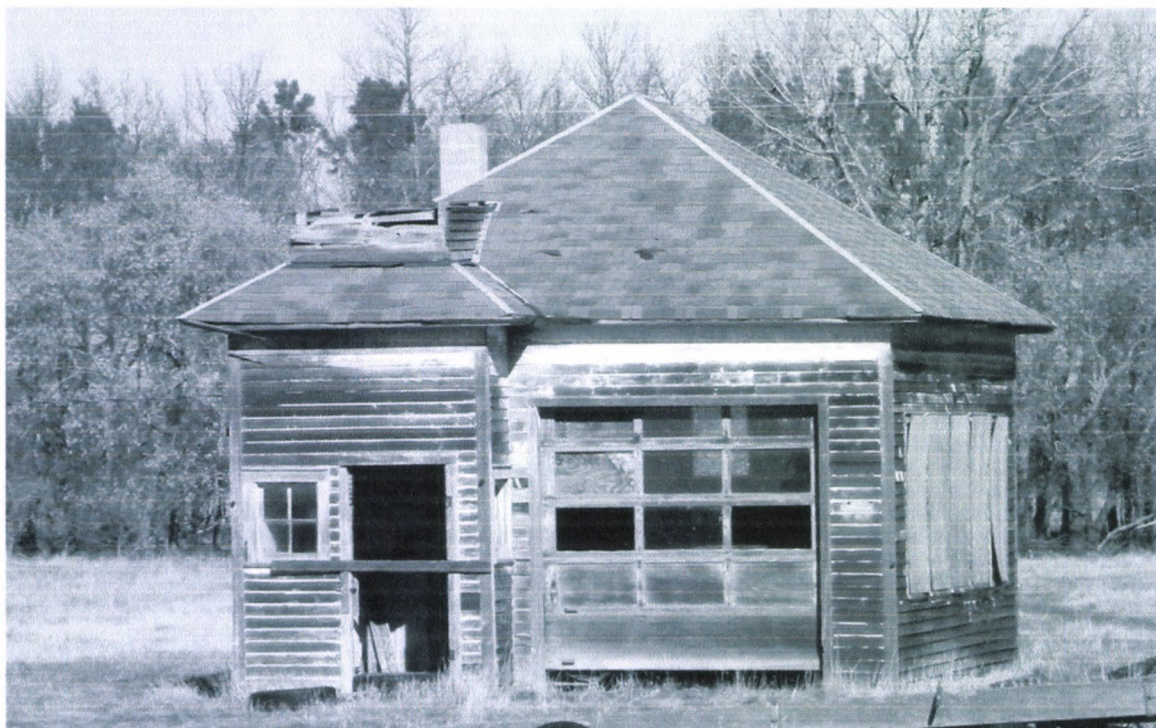
Rocky Mountain School #2 10/22/2010 South Side Kathy Wilner ED

This tired school measures 20 feet east to west and 24 feet north to south with a bump out entry on the southwest corner. It bumps out to the south 3 feet. This school has been moved to this location to be used for storage/garage. It is in pretty good shape considering that it was moved. The horizontal wood siding is almost bare of paint. Typical corner trim boards are 4 inches wide. An opening was cut in the south side of the building to install a garage door. The north side of the building has three high windows and the east side has 5 larger windows.

The entry has a door and small window on the south side with another small window on the east side. There is an angled wall with a door that leads into the rest of the building. Hooks for a coatroom were hung on a 4 inch board that runs along the wall in that entry.

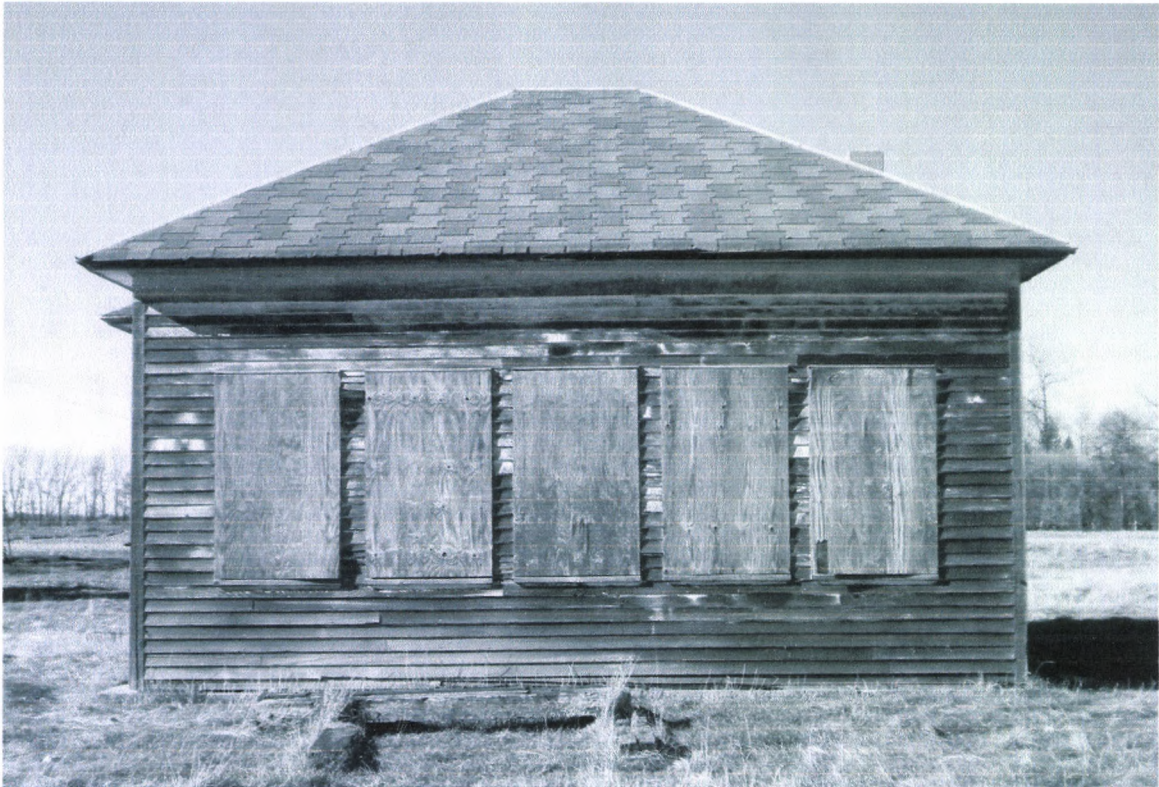
Rocky Mountain School #2 10/22/2010 East Side Kathy Wilner ED

Inside the building you can see the three high windows on the north wall and the space beneath them used to have a blackboard. The walls and ceiling is lath and plaster with much of the plaster falling from the ceiling. There is a chimney in the northwest corner with a stovepipe sticking out about half way up. The double hung windows on the east side are covered with plywood, some of the glass is still intact.

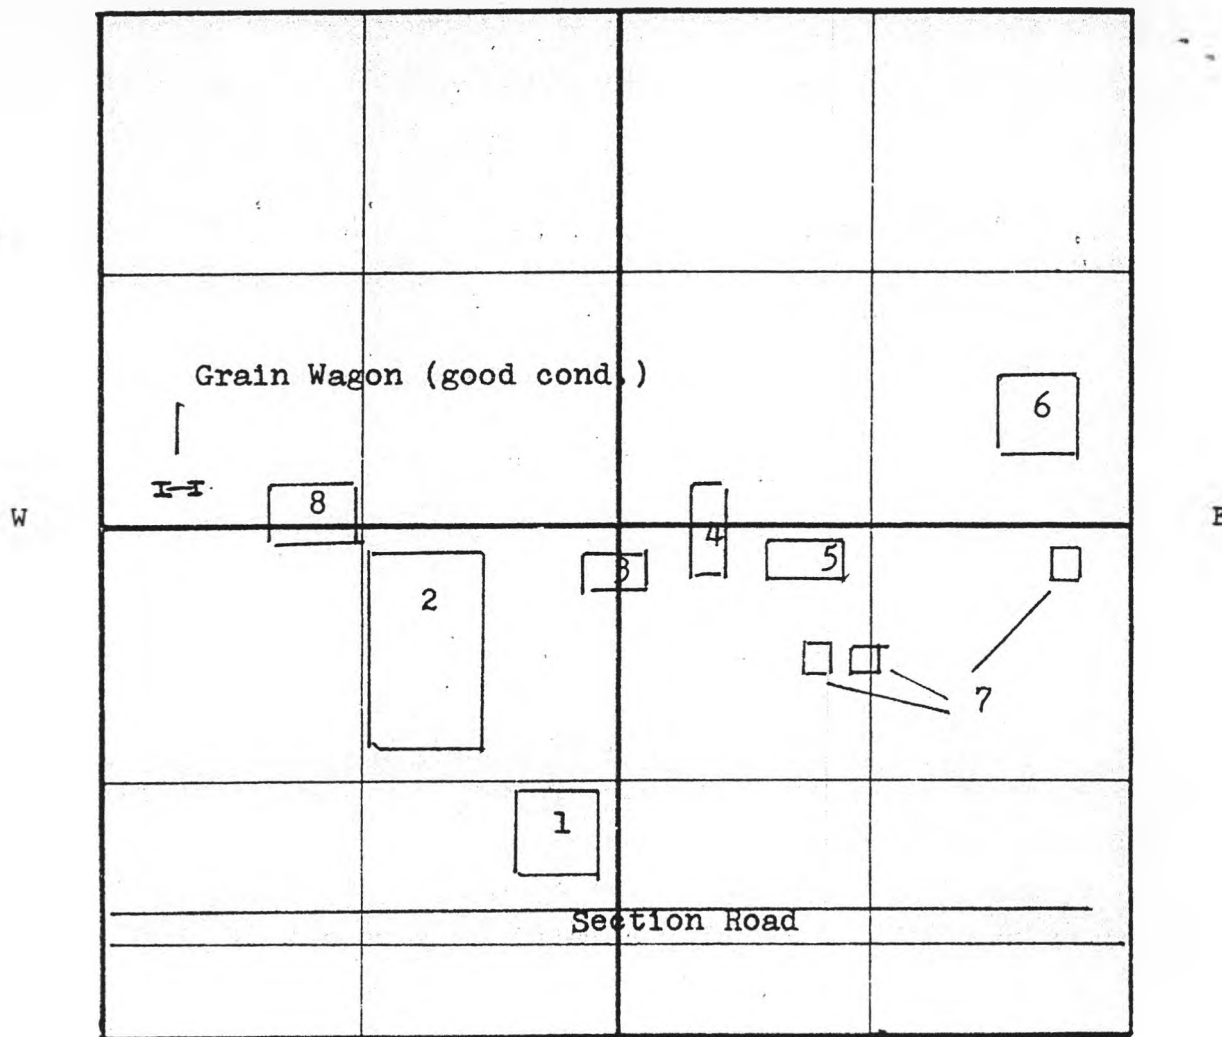
20. Sketch Map of Site: Scale: 1 cm = 20 m

KEY TO SITE SKETCH MAP ON PAGE 2

| 1. rebuilt main house | 16. _____ |
| 2. barn | 17. _____ |
| 3. pig shed (in use) | 18. _____ |
| 4. storage | 19. _____ |
| 5. chicken coop | 20. _____ |
| 6. school house (moved here 10 yrs ago from 10 miles away) | 21. _____ |
| 7. 3 outhouses used as storage | 22. _____ |
| 8. garage | 23. _____ |
