| NDCR | S ARCHITECTURAL FORM PAGE 1 | |
| Field Code Emmonsburg Township School | SITS# 32 ^{EM} | UPDATE 877 |

NDCRS ARCHITECTURAL FORM

1. Feature Description, Integrity, Eligibility:

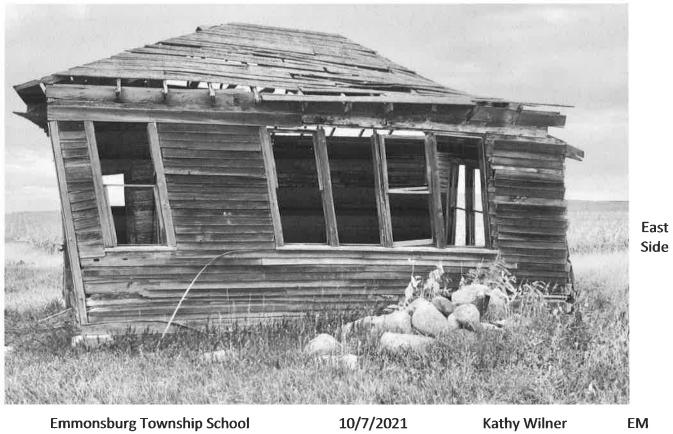
Emmonsburg Township School

The feature is a one room prairie school on a poured concrete foundation. The roof has only slat board left and there are holes, No chimney. Soffits are open. The building measures 24 feet north to south and 16 feet east to west.
