NDCRS ARCHITECTURAL FORM

Field Code Joe Bush Creek Township School

Site Name Joe Bush Creek Township School

Field Code Joe Bush Creek Township SchoolSITS# 32 EM 982Complete one Page 3 for *each* architectural feature at the site.

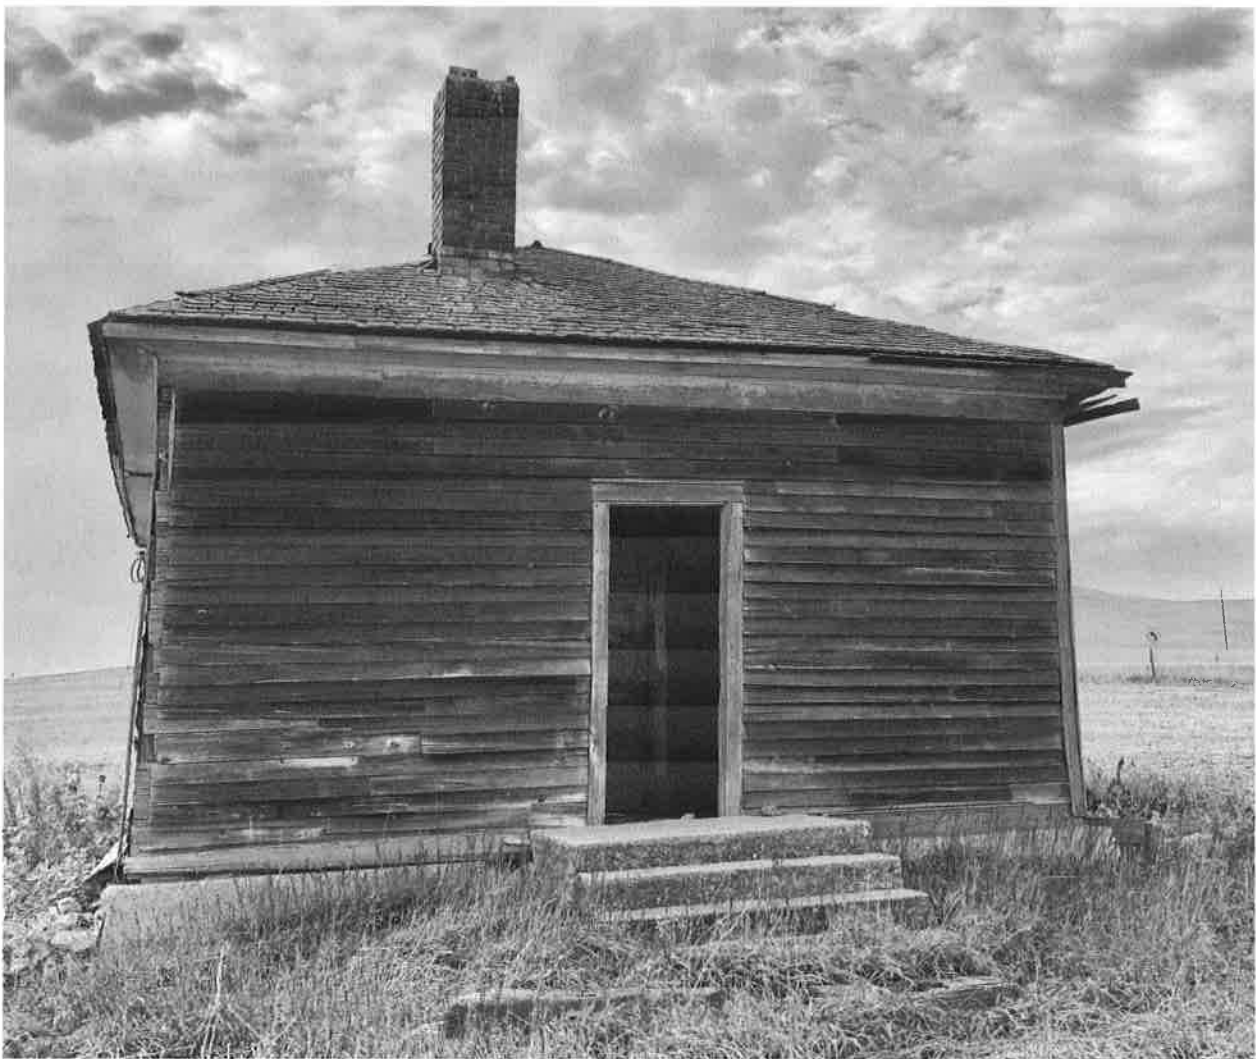
South Side

The feature is a one room prairie school on a poured concrete foundation. The hip roof is partially covered with wood shakes. There is a red brick chimney on the south slope and some of the top bricks have fallen off. The soffits are closed.

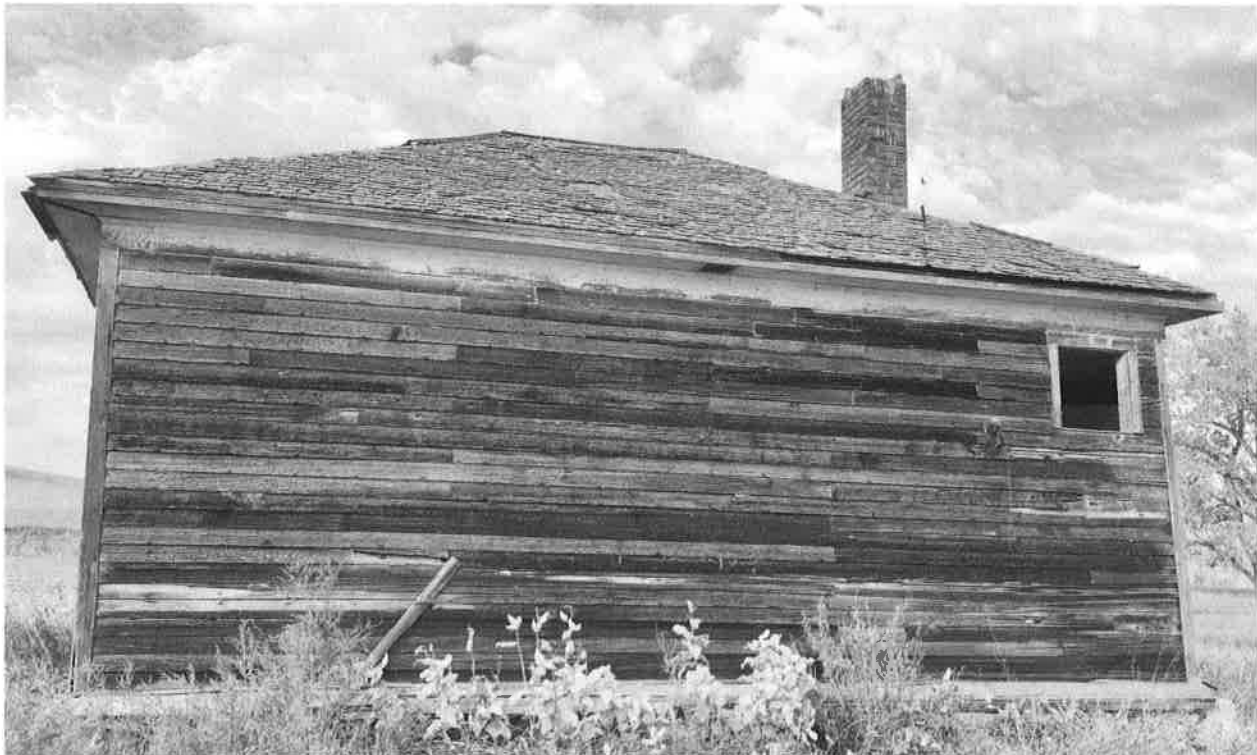
West Side

A rake board begins the siding under the eaves on all four sides of the school. The remaining siding is 6 inch wood lap and 4 inch corner trim with waterboard at the bottom. Three concrete steps lead to a concrete platform which takes you through the entry door opening. The floor is tongue and groove hardwood and it is falling away in the entry. The interior school room floor has old grain covering it. The interior walls and angled ceiling were finished with beadboard. Most of the ceiling beadboard has fallen in. Three double hung window openings are located on the north side, with four more on the east side. The windows have a bit of framing and no glass. One more window opening is located on the east wall near the south end in the coatroom. A small opening near the south side on the west wall was likely a fuel door.

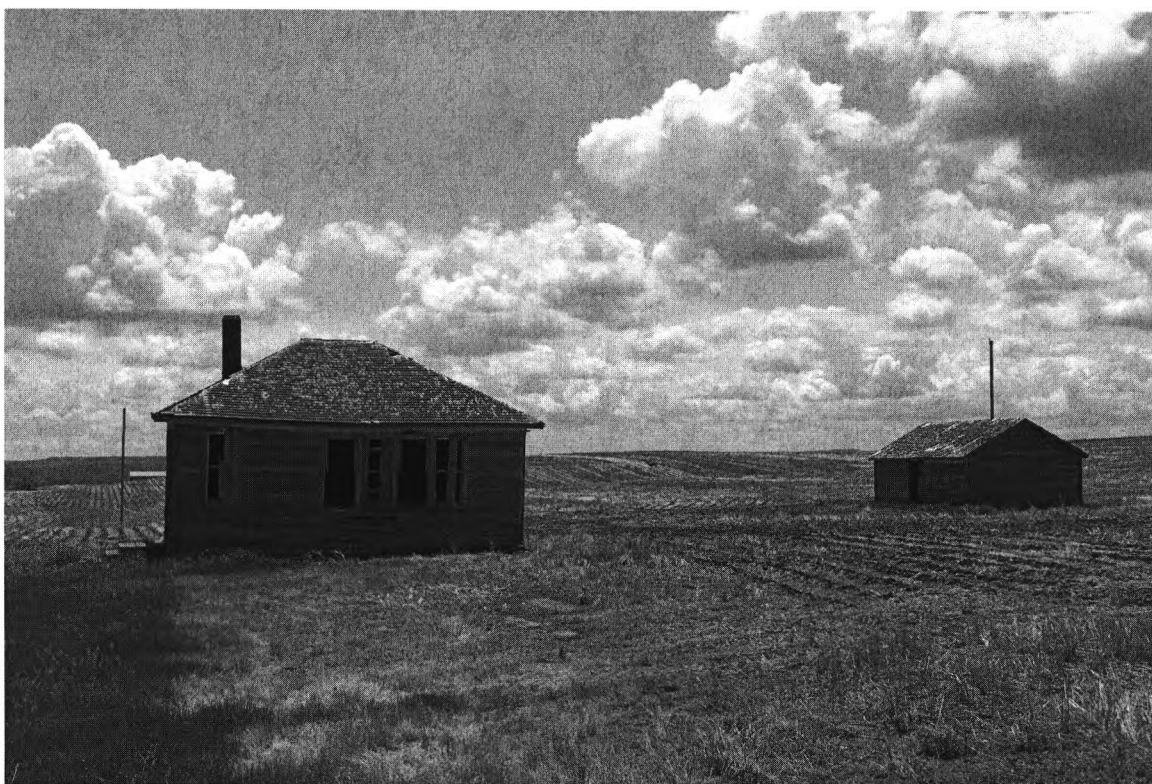
view to SW context

A barn sits to the southwest of the school. I did not document this barn.
