NDCRS ARCHITECTURAL FORM

Field Code Dekker Creek Township School #1

SITS# 32EM 1032

Site Name Dekker Creek Township School #1
Site Name

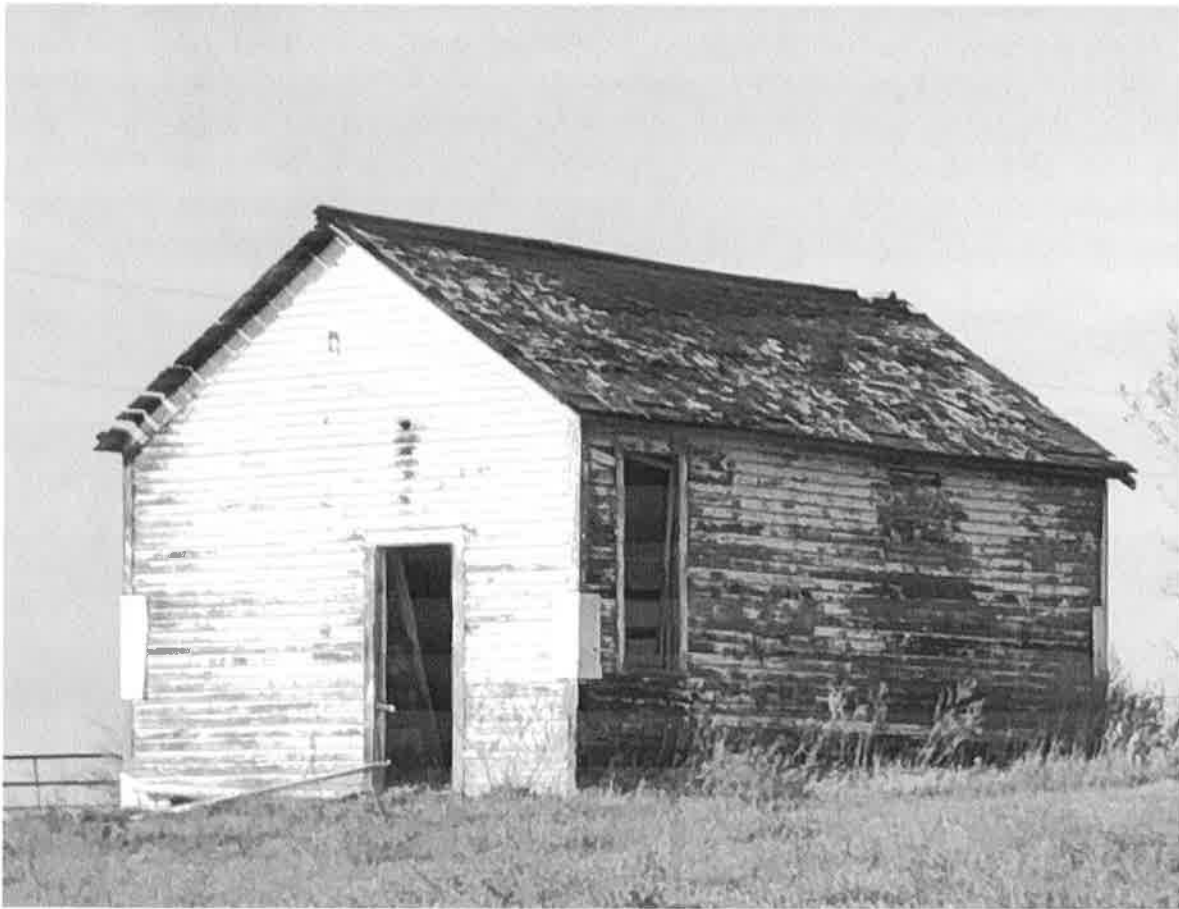
East Side

Rake boards begin the siding under the eaves at the peak ends of the school. The rest of the siding is 6 inch wood lap with 6 inch corner trim. Some of the trim at the corners is gone. On the west side some of the siding boards are missing and you can see the flax straw that was used for insulation. On the east side there is one covered window opening near the south end. A fuel door is at the south end of the west wall and all the other windows are covered. A door opening is located on the south wall. No information about the interior.

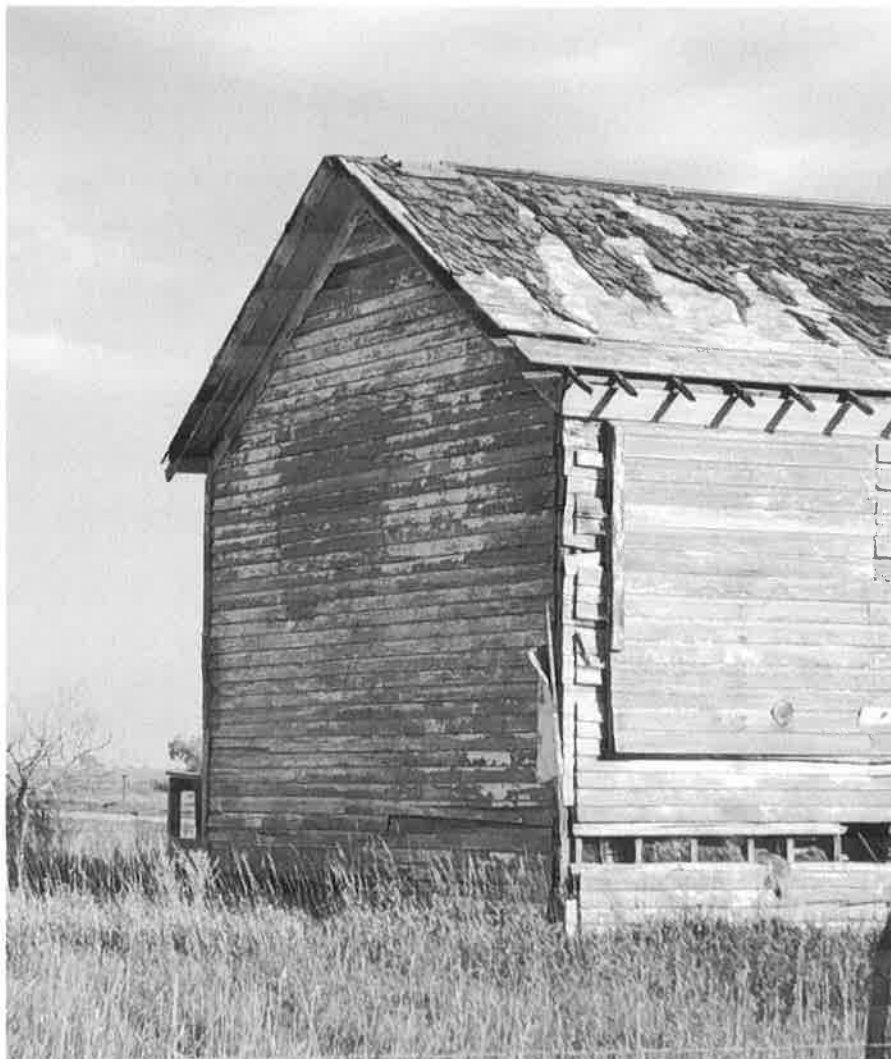
North Side

The feature is a one room prairie school on a poured concrete foundation. The gable roof has little in the way of shingles with only scraps of asphalt left. The chimney is gone. The soffits are open.
