NDCRS ARCHITECTURAL FORM

Field Code Wood Township School

SITS# 32EM 1134

A Class II Architecture Survey - Emmons-Logan Wind Energy Center in Emmons and Logan Counties, North Dakota; Melinda McCarthy, Thomas Eiceman, & Marcia Bender

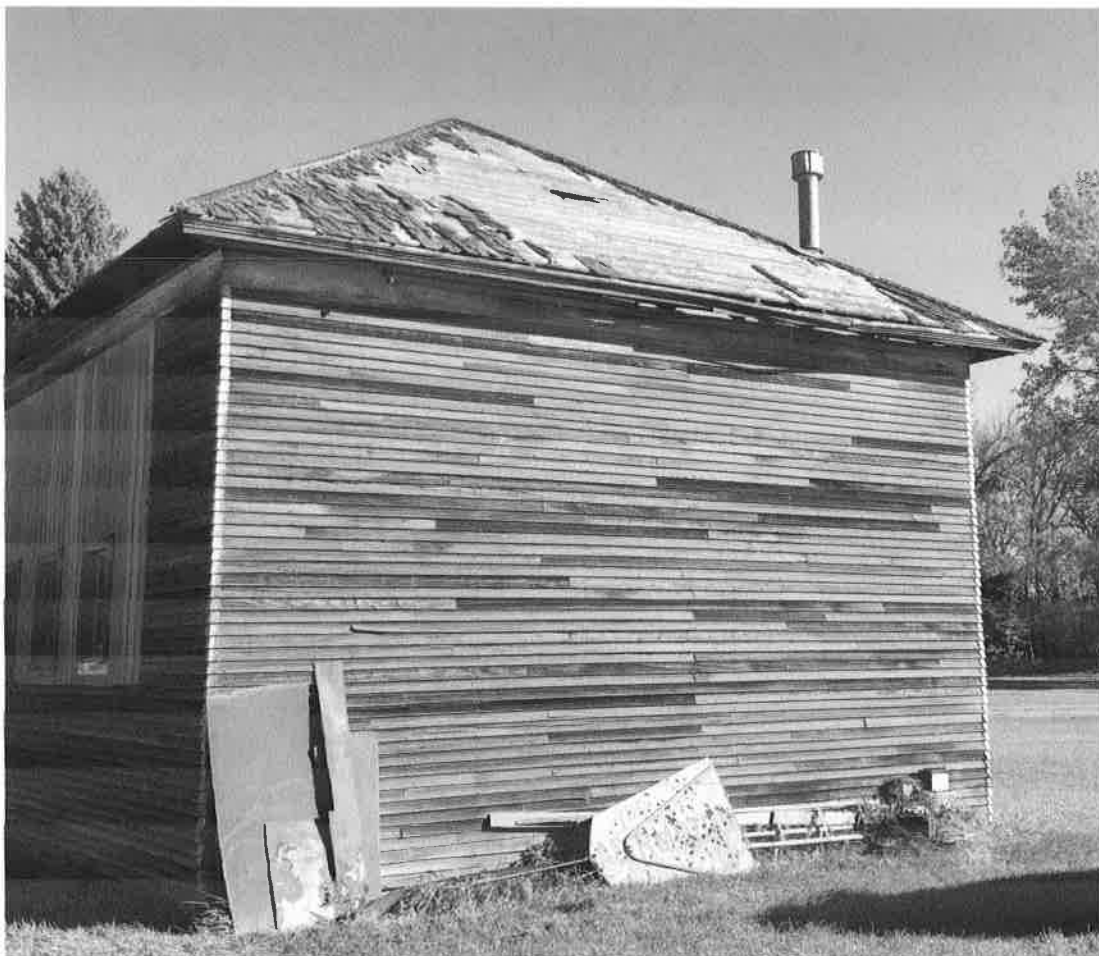
South Side

The feature is a one room prairie school on a poured concrete foundation. It was moved to this location for use as a shop. The hip roof has few a shakes remaining. The soffits are open today because of deterioration of the school. There is a metal pipe chimney near the south side of the east slope. The building measures 28 feet north to south and 16 feet east to west.

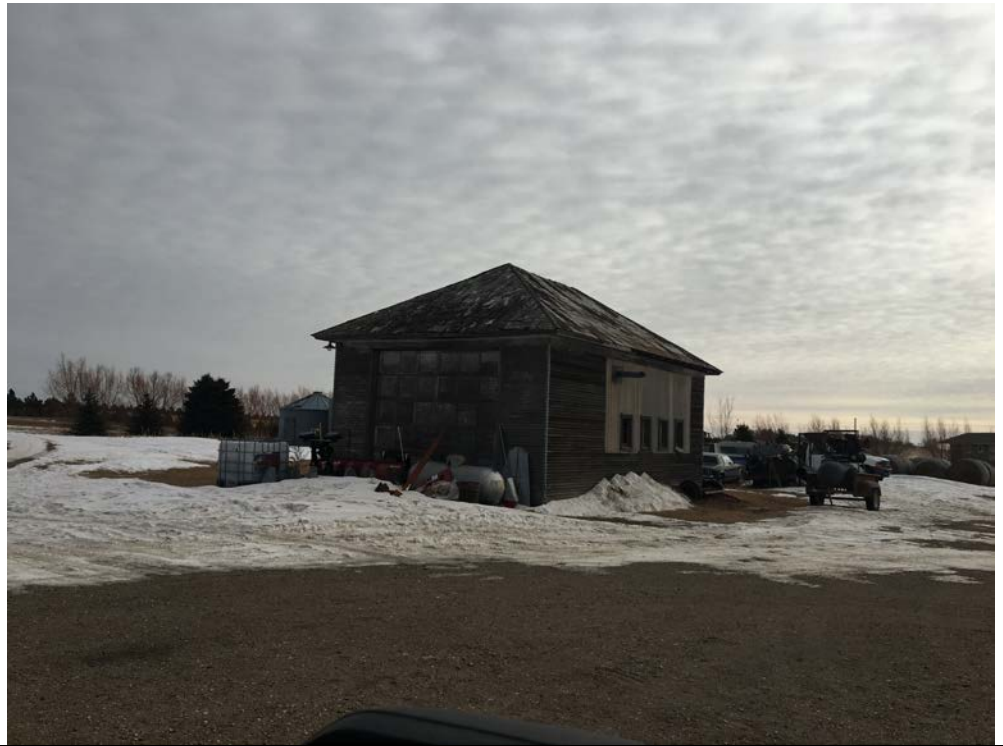
Photo No.:
IMG_8230

F.9 is a hipped roofed garage featuring a steeply pitched roof, wide eaves, and wooden shake roof cladding. The roof is in poor condition, with large sections of the shake missing and sections of the roof beginning to bow. Portions on the eaves are missing as well. The building is clad in wooden clapboard siding with metal bracing at the corners. The building rests on a concrete slab foundation.

The front (northern) façade contains a centrally-placed, single-car garage door. A large amount of farm equipment and materials are currently resting in front of the door, and it is impossible to tell if the door is completely intact. The western elevation contains four evenly spaced four-lite wooden windows set in simple wooden frames. The wall surface surrounding the windows has been replaced with vertical wooden siding. A large ventilation pipe projects off of the wall surface to the north of the windows. There is no fenestration present on the southern elevation. On the eastern elevation, a single entranceway, covered by a plywood door, is the only opening present.

The garage is considered to be in fair condition, due to deterioration and weathering visible across the structure. Changes have been made to the structure, including replacement of the building's doorway and replacement of portions of the siding. The individual integrity of the garage's materials and style are impacted due to these changes.

Description:
The front (northern) façade and western elevation of F.9, a garage. View to the southeast. Note the northern and western sides of F.7 in the background.

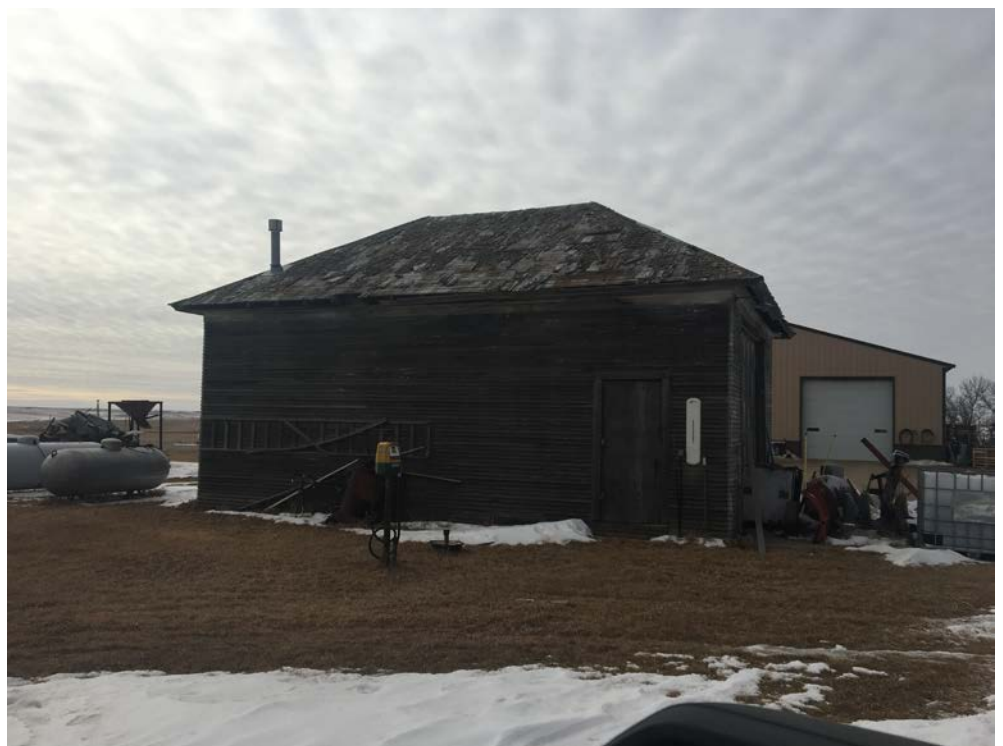
Photo No.:
IMG_8241

Description:
The front (northern) façade and eastern elevation of F.9, view to the west southwest. Note the front façade of F.4 in the background.
