NDCRS ARCHITECTURAL SITE FORM

Project: IEA- KEM Emmons County; PI: Elizabeth France

Report Title: Innovative Energy Alliance's KEM Emmons County: A Class III Cultural Resource Inventory in Emmons County, North Dakota; Author: Matthew Radermacher

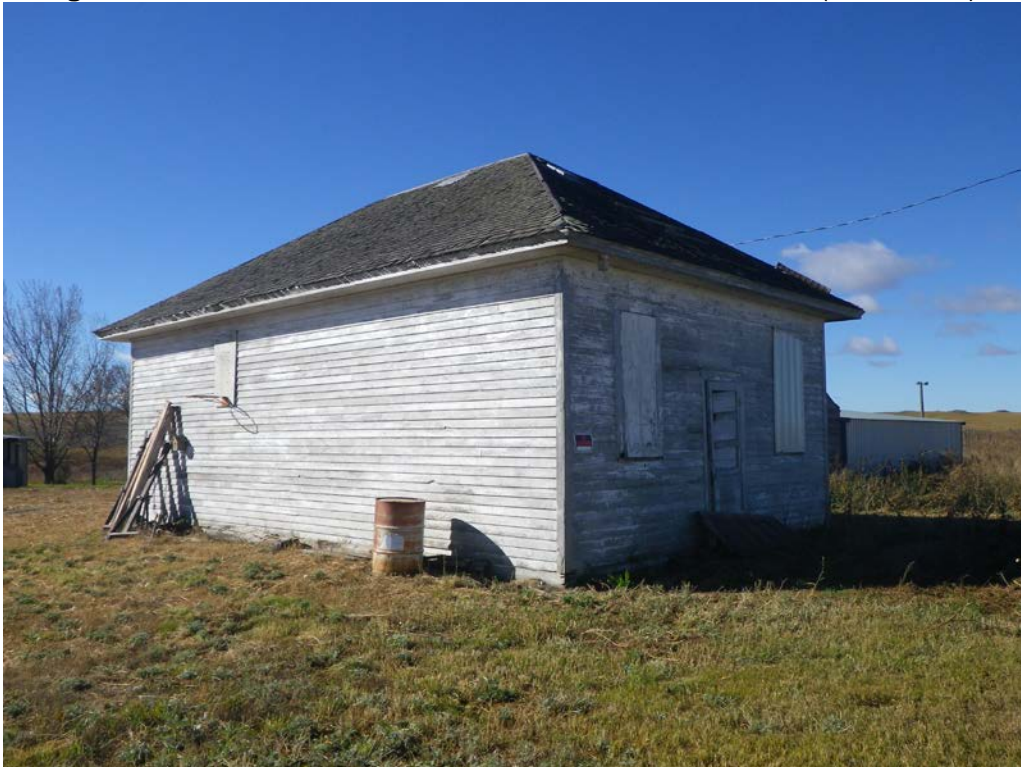
DESCRIPTION: Feature 1 is a single-story, wood-framed school that has been adapted for use as a granary. The feature has a rectangular plan and sits on a bed of gravel. The roof is hipped and covered in wood shingles and the exterior walls are clad in horizontal lap siding. The primary entry is a paneled wood door centered on the north facade. To both sides of this entry is a tall, rectangular window opening, boarded up with scrap siding. A series of 2x2-inch boards have been nailed to the roof above the north facade, serving as rungs leading to a capped fill hole. It is likely this feature has been used as grain storage. A secondary entry is located on the south facade of the feature and consists of an overhead roller door. Two banks of four one-over-one-lite double-hung windows are present on the west facade. All the window openings have been boarded over from the inside with horizontal wood siding, another indication of the feature's likely conversion for grain storage. No fenestration is present on the east facade, though a basketball hoop has been fixed to the wall.

INTEGRITY: Feature 1 is in poor condition but retains integrity of feeling and workmanship. Condition of the siding and window sash have compromised integrity of materials. Alterations including covering over the fenestrations and the installation of an overhead garage door have compromised integrity of design. It appears this structure was moved to its current location for use as grain storage. Integrity of setting and location are lost.

Figure 3: Site lead MAC-KEM-x01, Feature 1, view southwest (IMPG0578).

ELIGIBILITY: This feature appears to lack sufficient integrity to convey historic character. However, it has not been evaluated for inclusion in the National Register of Historic Places. Current survey data are not sufficient to determine significant associations. Until a deed search can be performed, avoidance is recommended.

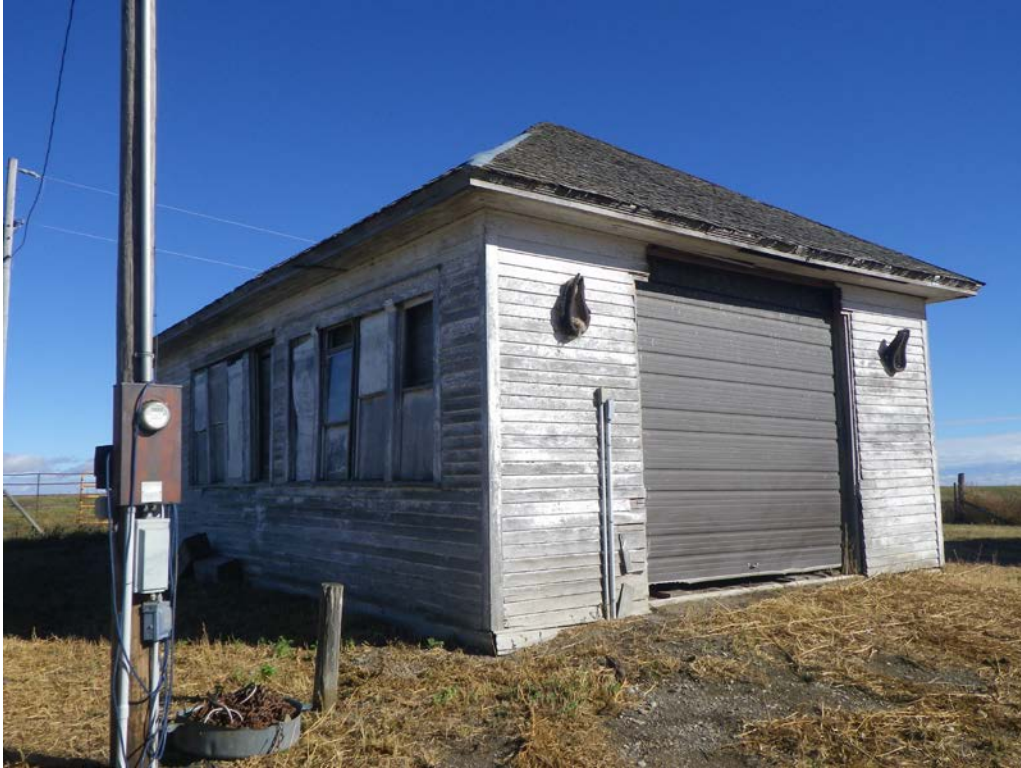
Figure 4: Site lead MAC-KEM-x01, Feature 1, view northeast (IMPG0582).

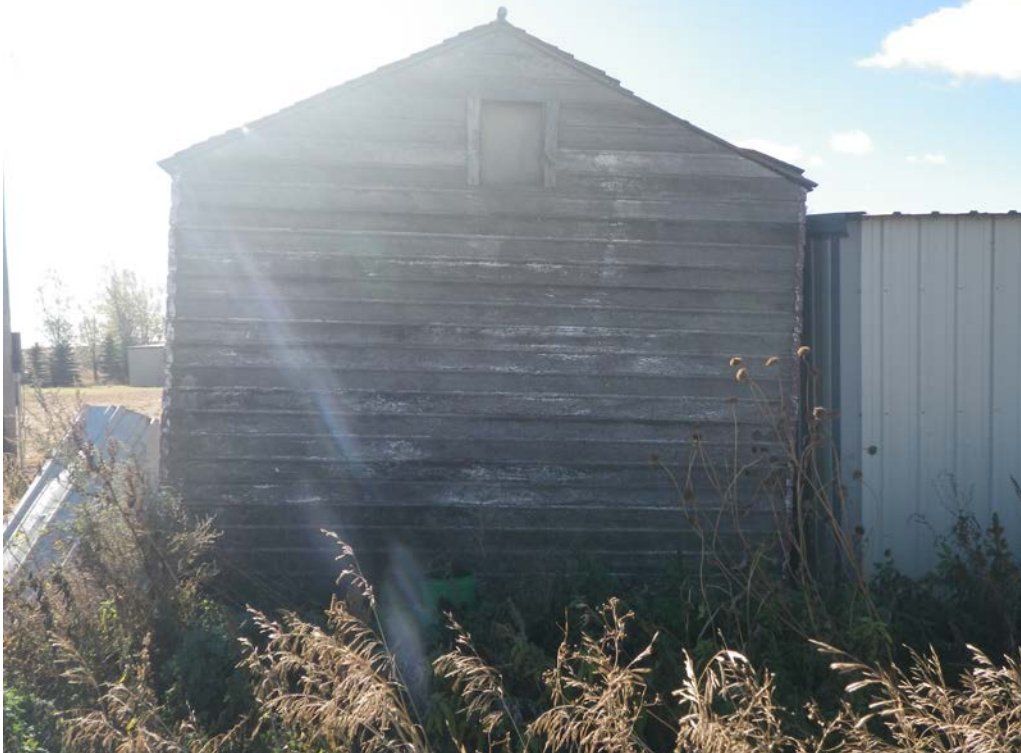
DESCRIPTION: Feature 2 is a wood-framed, gable-roofed granary. It has a rectangular plan with no foundation. The roof is covered in wood shingles and the exterior walls are clad in horizontal drop siding. The primary entry is located on the south facade and consists of a braced wooden door, mounted on an overhead track. A rectangular opening is located in the peak of the gable and was open at the time of inventory. An identical opening is located in the peak of the north gable end as well, though it has been boarded up from the inside and remnants of a shutter closure are visible on the exterior frame. No other fenestration or ornament is present.

INTEGRITY: Feature 2 is in fair condition and retains integrity of materials, design, feeling, location, workmanship, and setting.

Figure 5: Site lead MAC-KEM-x01, Feature 2, view south (IMPG0584).

ELIGIBILITY: Feature 2 has not been evaluated for inclusion in the NRHP. Current survey data are insufficient to determine significance of this site lead. Until further research and documentation, including a deeds search, can be performed, the feature remains unevaluated and avoidance is recommended.

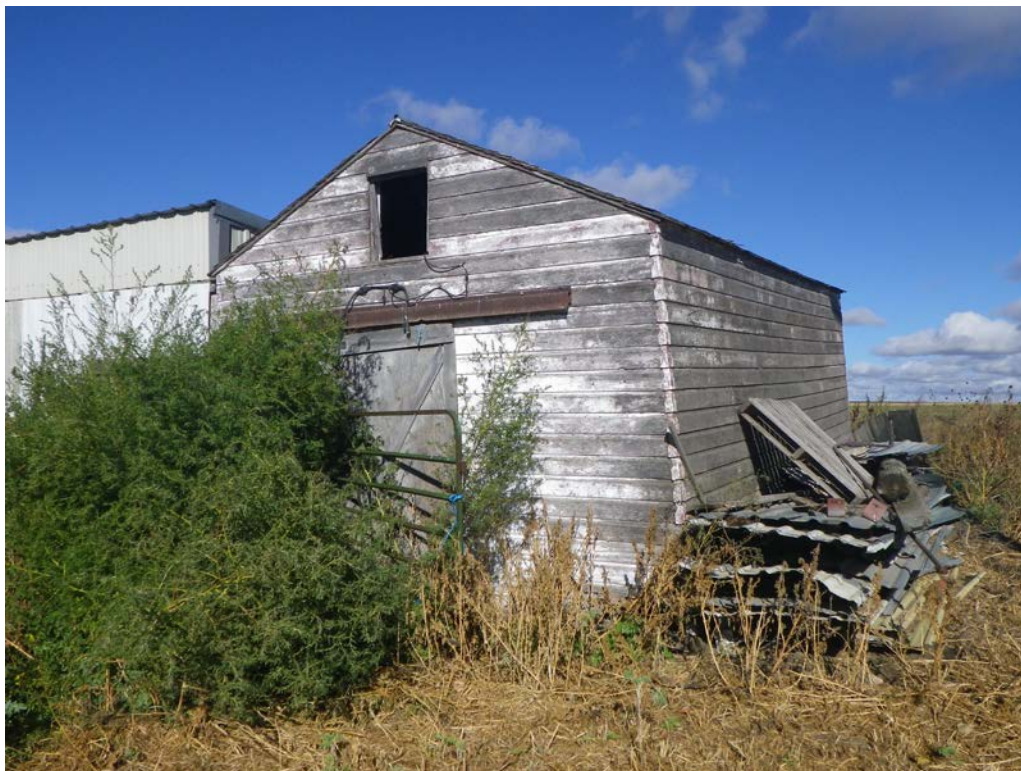
Figure 6: Site lead MAC-KEM-x01, Feature 2, view northwest (IMPG0586).
