NDCRS ARCHITECTURAL FORM
PAGE 1

Field Code Longview Twp School #3

Site Name Longview Township School #3
Site Name

Country School House Project
Kathy Wilner
366 43rd Ave SE, Bowdon, ND 58418

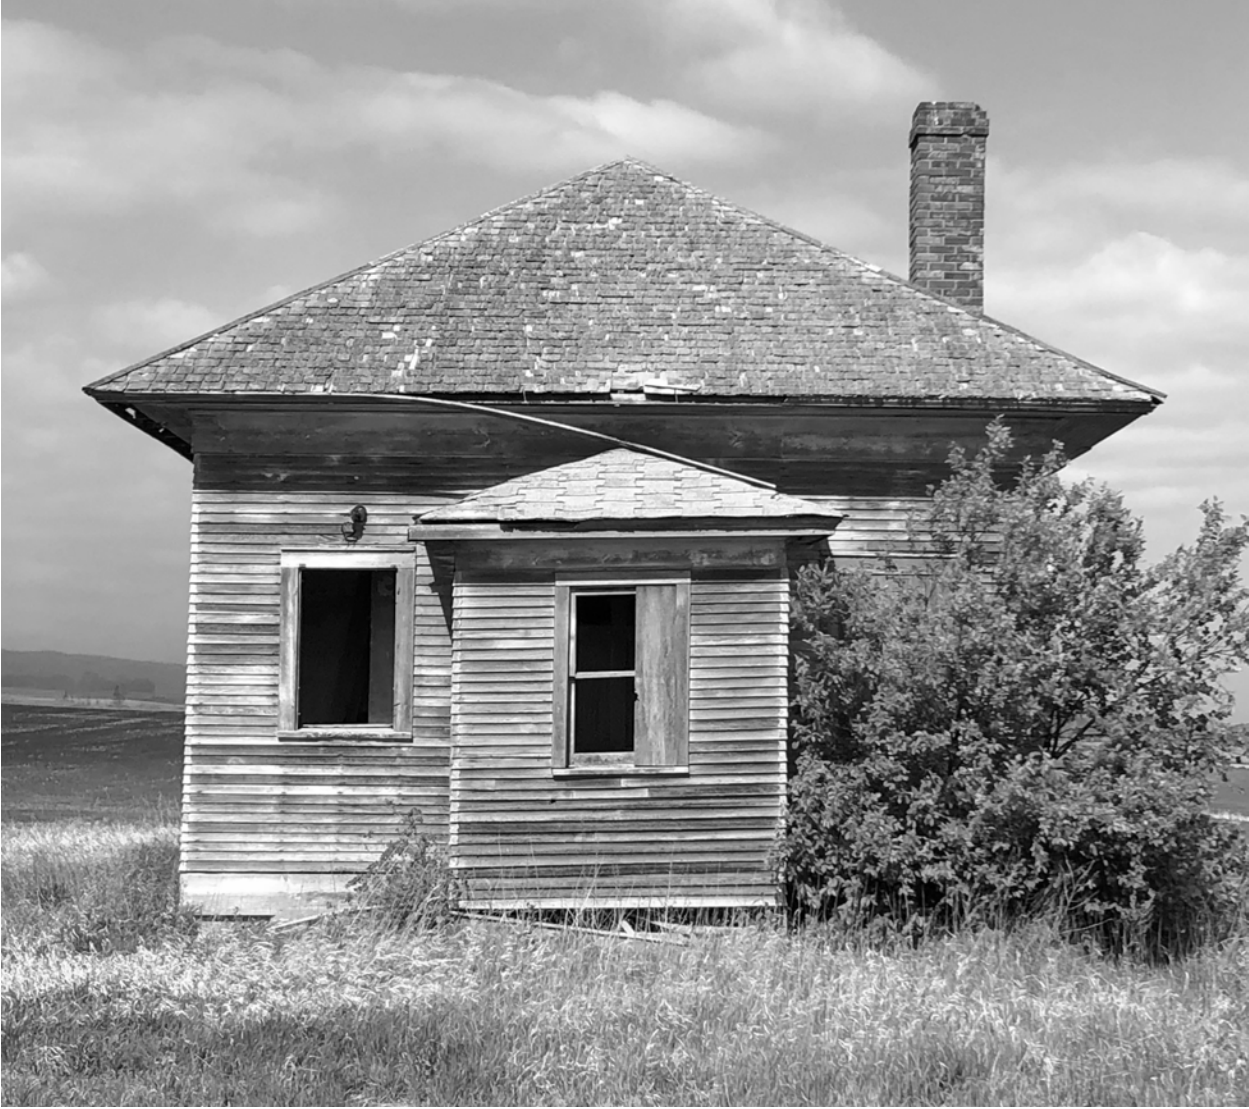
East Side

The siding begins with a rake board under the eaves on all side of the school. The remainder of the siding is 6 inch wood lap siding with metal corner trim. A water board finishes the bottom of the siding. There is an entry on the east side of the school. A concrete step leads into the entry. The exterior door is missing. A 4 panel wood door with two small windows near the top gives entry into a short hallway. There is a coat room to the left and fuel storage right. The walls and ceiling are lathe and plaster, much of the ceiling has fallen in. The floor is tongue and groove hard wood and it is buckling from weather. A bank of 5 double hung window openings run along the south wall. Two more double hung windows on the west wall are covered. All the windows were mostly covered as the building was used for grain storage. There is a blackboard on the north wall and indications that more blackboards were either side of the windows on the west wall. This school has a picture rail running along the walls about a foot from the ceiling. A wide trim board can be seen at the floor level. The school was wired for electricity.

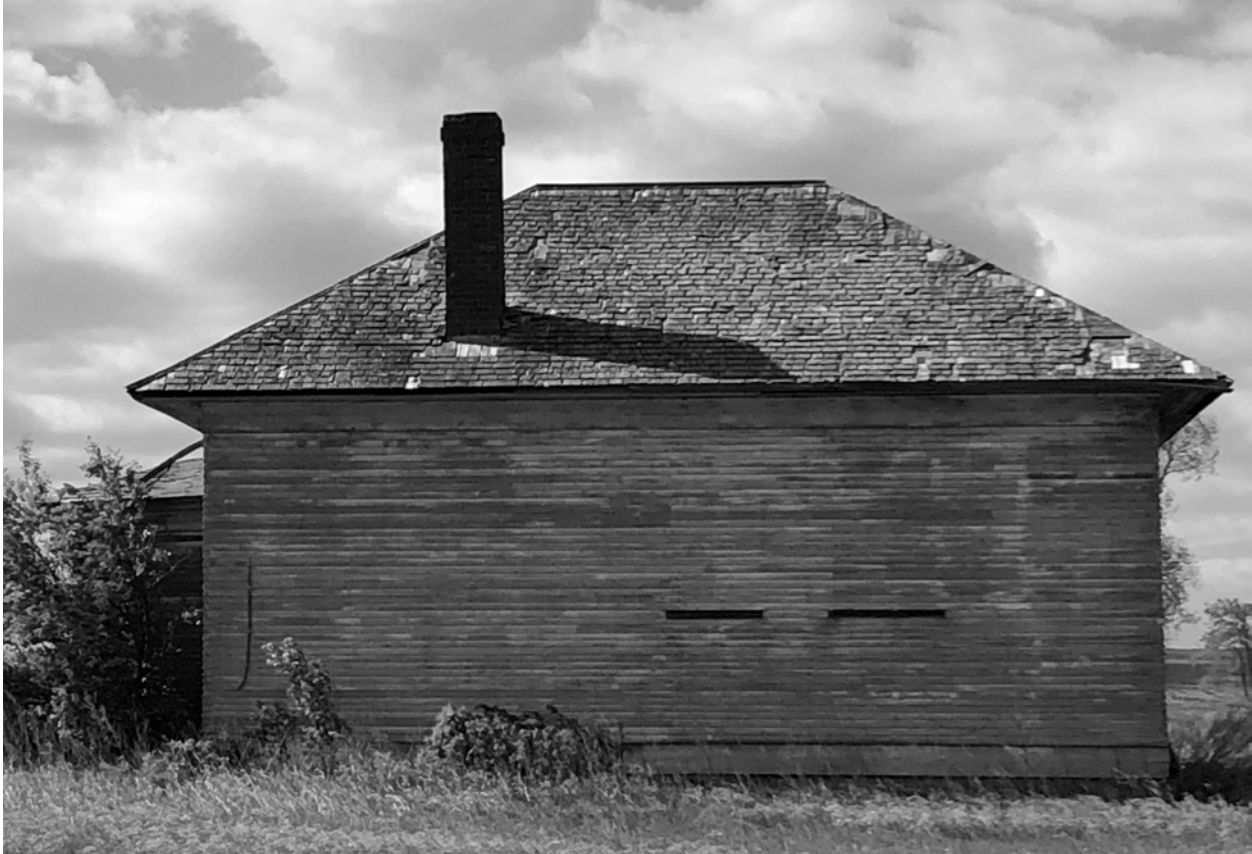
North Side

This feature is a one room prairie school sitting on a poured concrete foundation. The hip roof is covered with failing wood shakes with some metal capping. There is a red brick chimney on the north slope of the roof. The school measured 16 feet north to south by 28 feet east to west. The soffits were closed.
