NDCRS ARCHITECTURAL SITE FORM

Field Code Larimore Twsp. School #15

Map Quad Larimore West Site Name Larimore Township School #15
Map Quad _____ Site Name _____

Larimore Township #15 School

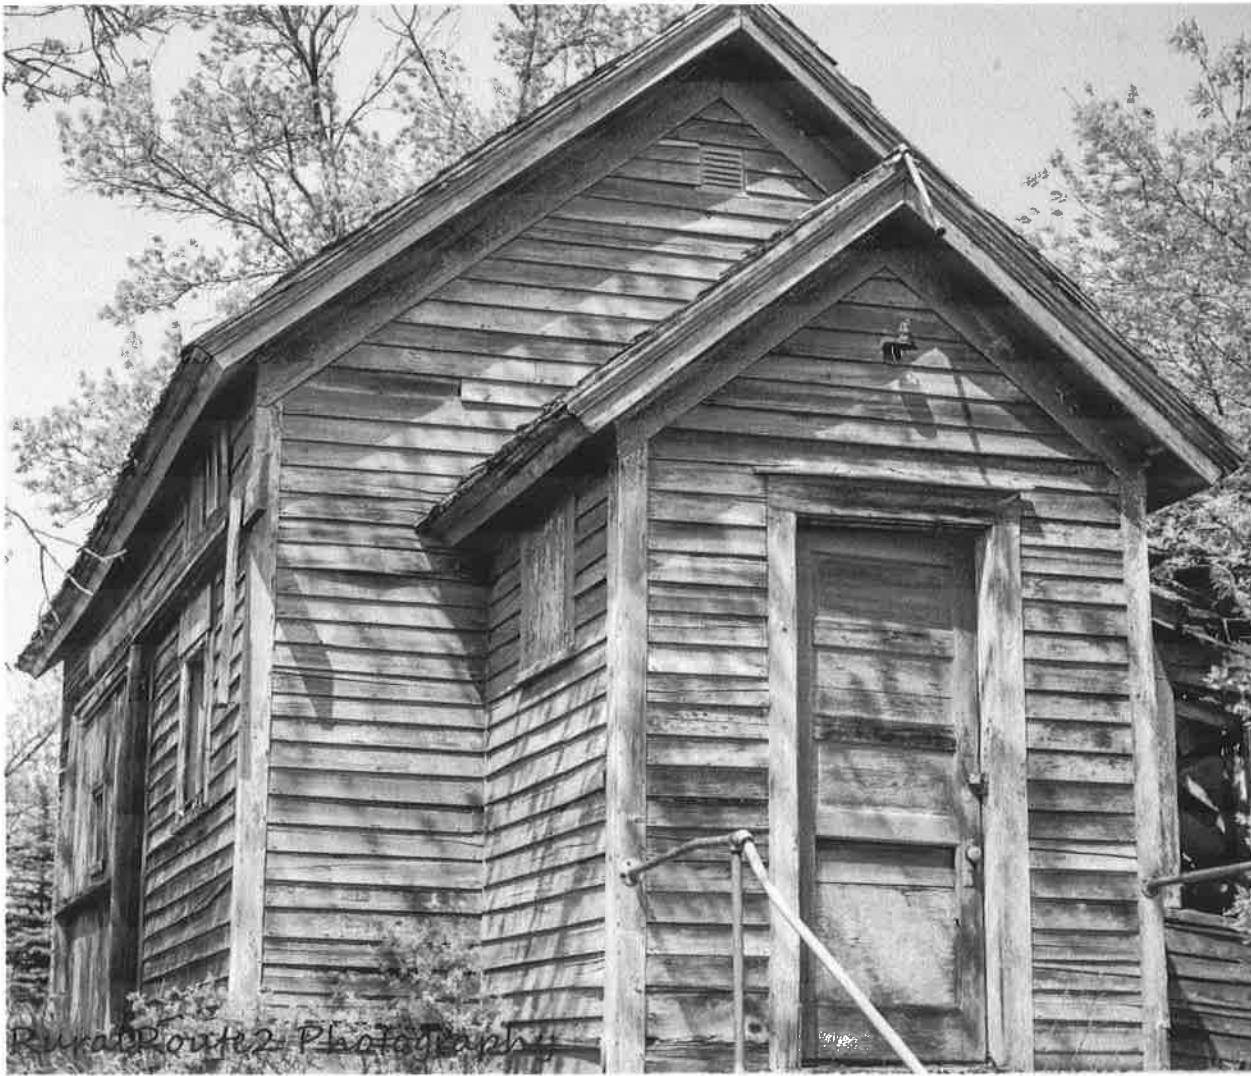
East Side

A rake board runs under the peaks of the school sections as well as the entry. 6 inch wood lap siding and 4 inch corner trim complete the siding. An entry, with a broken 5 panel wood door, is located at the east end of the school, reached by concrete steps and a porch. Either side of the concrete porch are metal hand rails. There is one small, covered opening on the south wall of the entry. The main body of the school has lathe and plaster on the walls with a mix of lathe and plaster and wallboard finishing the ceiling. Much of the ceiling is falling in. A sliding door was installed along the south wall of the school, giving access to the interior for vehicles. Also on the south wall is one double hung windows with some glass. Four more double hung windows are located on the west wall with some glass as well as framing. There are also remnants of middle pull windows shades on these windows. There are two small windows at the east edge of the north wall in what looks like a shed addition. Speculation is that this shed addition was a room for the teacher. There is yet one more windows opening on the east wall of the shed addition. Inside the school room there is a door to the right leading into the shed addition and this is a 5 panel wood door. The floor is tongue and groove hardwood. There were blackboards on the north and east walls of the, one blackboard remains on the east wall. Wainscot, painted teal blue, is located along most of the walls. A light fixture above the entry door and hanging lights inside the school indicate electricity.

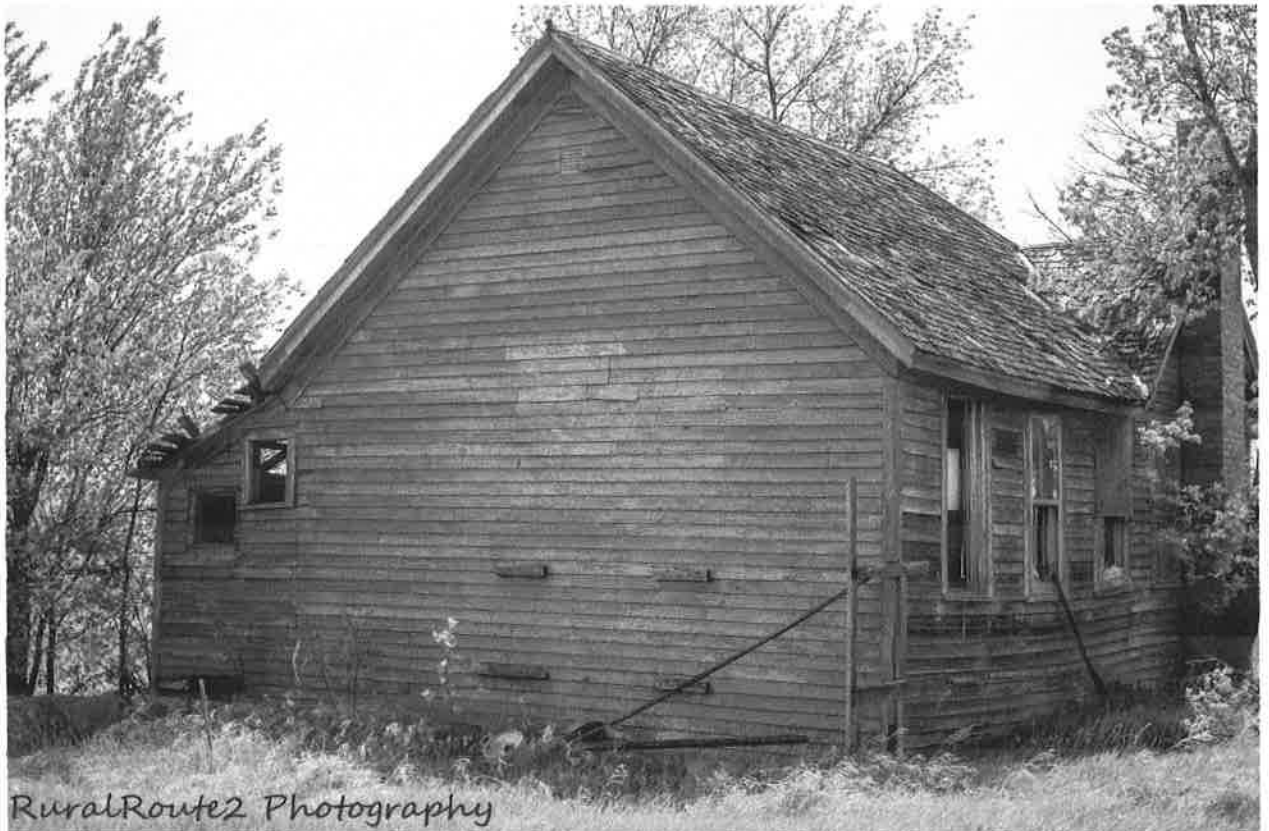
North Side

The feature is a one room prairie school on concrete block foundation in its original location. The roof line of this school features two intersecting gables, the north/south part of the school is near the west end of the building. The roof is covered with wood shakes with metal capping at the peaks and finials at the ends. There is a large, red and yellow brick chimney located on the outside wall of the west side. The soffit is closed. This building was later used as a shop/garage.
