NDCRS ARCHITECTURAL SITE FORM PAGE 1

Field Code Clearfield Township School Site Name Clearfield Township School

Project Title & Supervisor:
Country Schoolhouse Project

NDCRS ARCHITECTURAL SITE FORM
PAGE 3—Feature DataField Code Clearfield Township SchoolSITS# 32 GG**Complete a Page 3 for each feature.****1. Feature Description, Integrity, Eligibility:**

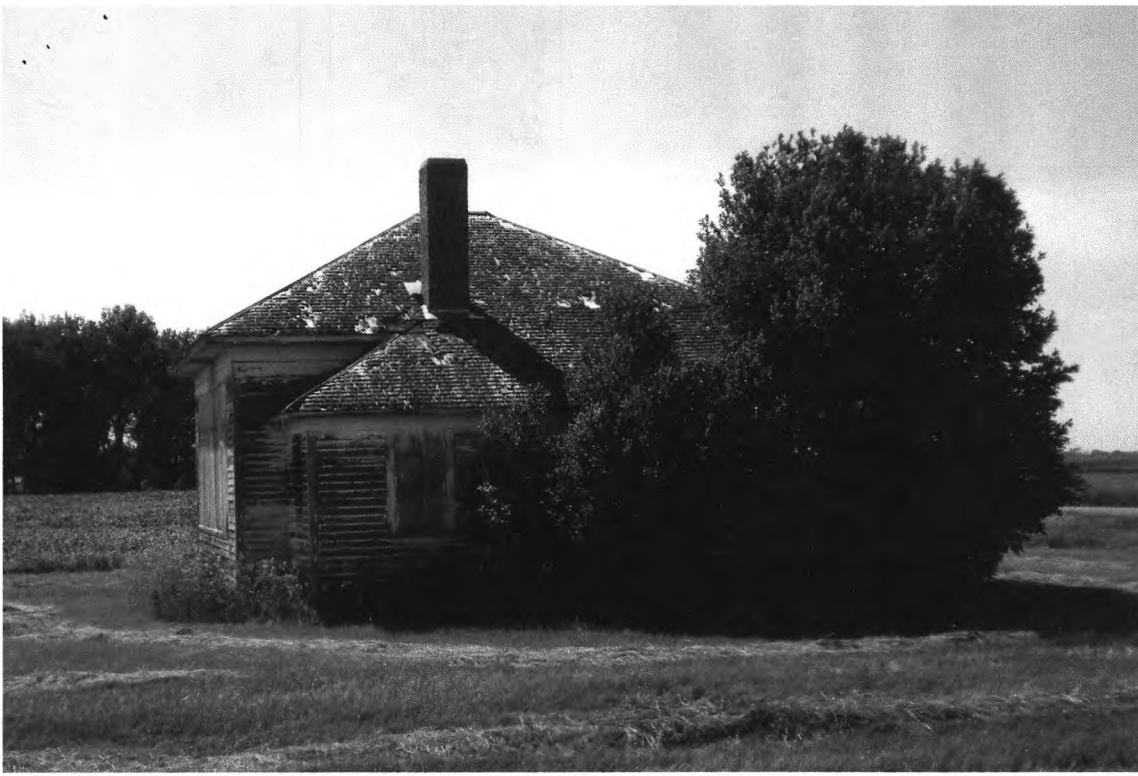
East Side (only sort of view of the South Side)

The feature is a one room wood framed prairie school sitting on a poured concrete foundation. The roof is pretty tired, mostly covered with wood shake. Some are missing and more are curling. There is metal capping at the top of the hip roof as well as all four slope seams. The east slope continues beyond the top of the main body wall to cover the east porch. It is one continuous slope with one small slope to the south. There is a red brick chimney, with metal flashing on two sides, located on the east slope of the roof. The building measures 27 feet north to south and 23 feet 4 inches east and west with a porch measuring 7 feet east to west and 22 feet north to south.

There is an entry/porch/coatroom on the east side. The door is missing. There is a wide trim board running under the eaves on three sides of the school as well as the entry. The siding is 6 inch wood lap with 4 inch wood corner trim. The school remains mostly watertight with all windows covered. The windows are double hung with some glass remaining. The south side has a bank of 5 windows. There are two more covered windows on the west side with small windows in the entry. The entry has one window facing south and two windows facing to east. There is some buckling of the tongue and groove hard wood floor. The walls and ceiling are lathe and plaster. The blackboard is located on the north wall. There is electricity to the school and they had an oil burner for heat. This school closed about 1960.
