NDCRS HISTORICAL ARCHEOLOGICAL SITE FORM

Field Code: UW#2019-3

1. **Access:** From the town of Carson, go east on ND Highway 21 for 0.7 miles. Turn south and follow the county road for 25.4 miles.
2. **Description of Site:** The site consists of an abandoned rural school in Grant County. Eight features were recorded at the site. The first, a single room schoolhouse (F1), is described on the attached Architectural Sites Form page. A north-south county road is located directly to the east of the site, and a dirt section line road is located to the south. The west and north edges of the site are bounded by rows of trees and brush.

13. Snow Cover (% visible): 100%.
 14. Man-hours Spent on Site: Two.
 15. Project Title: Grant County Survey.
 16. Report Title: Road Improvement Project in Grant County, North Dakota.
Author: Greg L. Wermers.

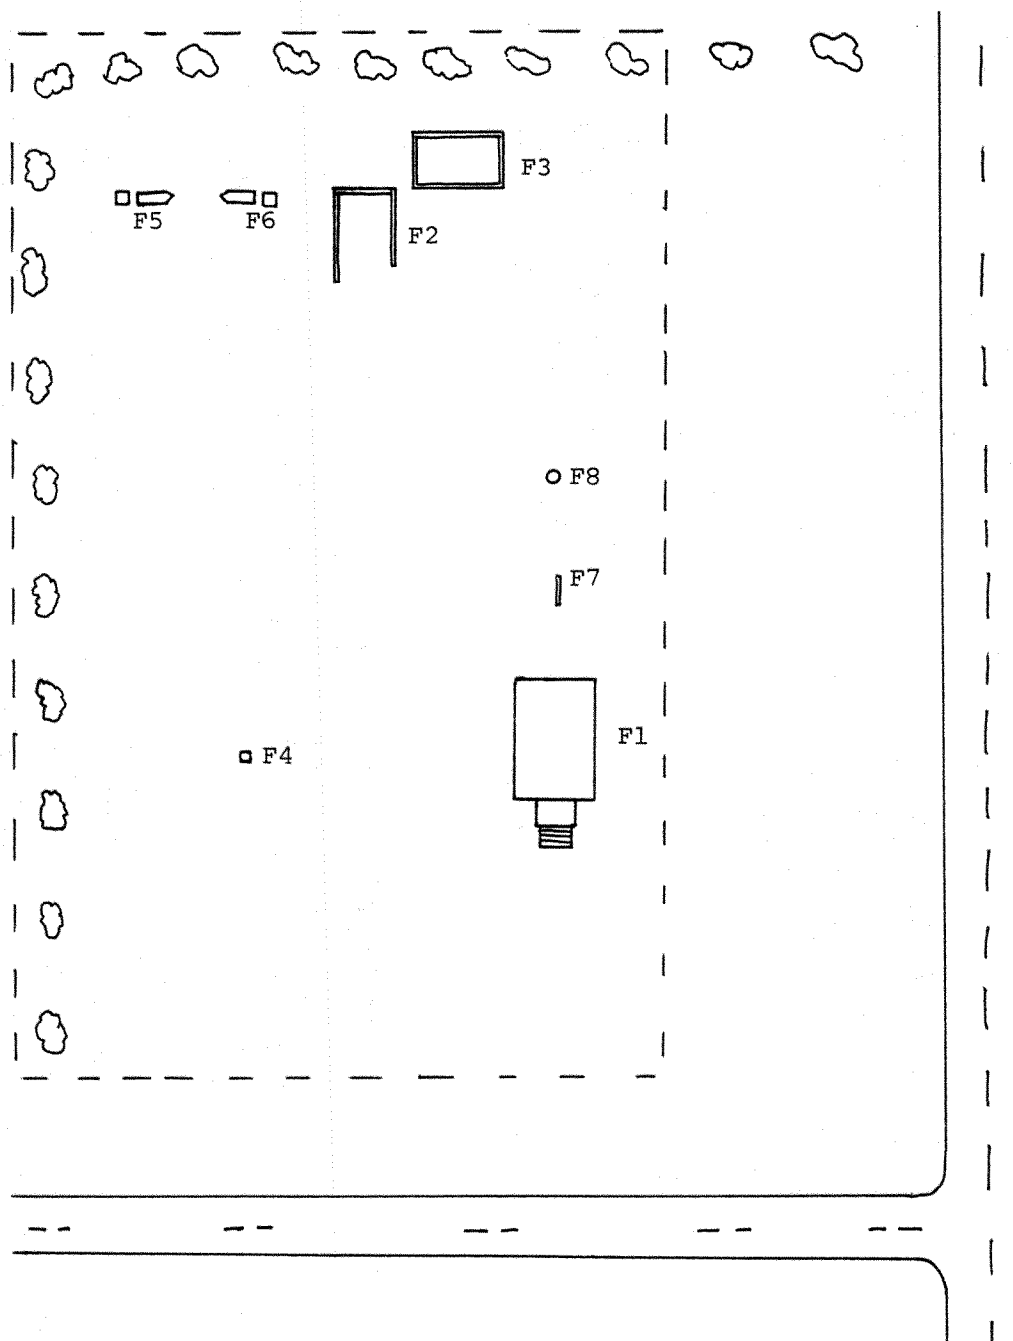
Include a north arrow, site boundaries, road or street names, location of artifacts, features, buildings, structures, objects, and depressions with each item individually numbered and keyed to the Map Key, and road or street name(s).

- Map Key: --- Site Boundaries
= Maintained County Road
= Unmaintained Section Line Road
F1 Schoolhouse
F2 Foundation (Garage Location?)
F3 Foundation (Dwelling Location?)
F4 Capped Well/Water Pump Location
F5/F6 Outhouse
F7/F8 Playground Equipment
☁ Trees

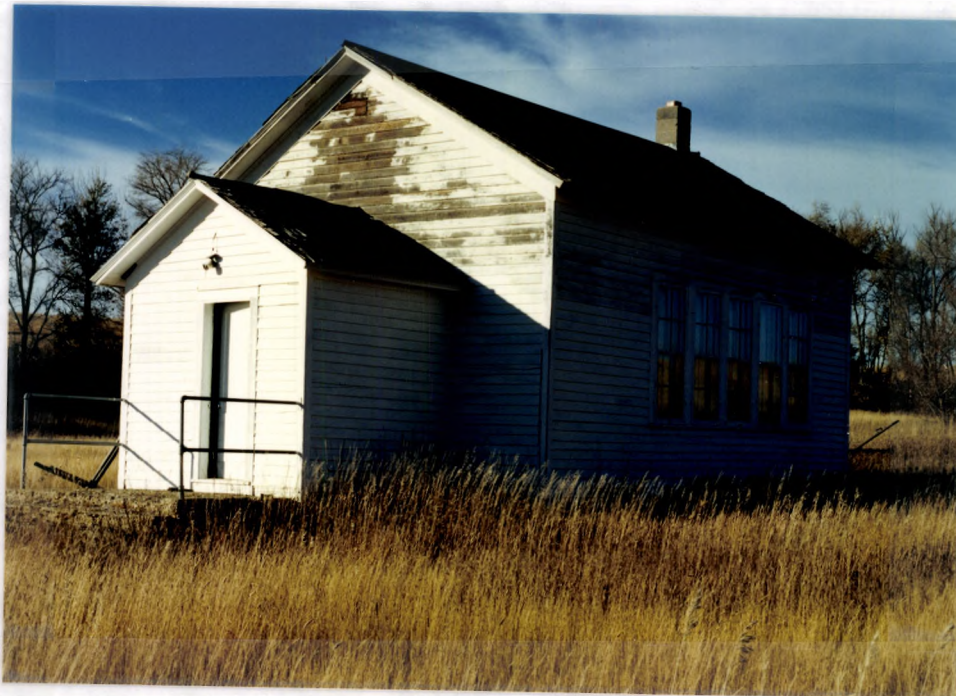
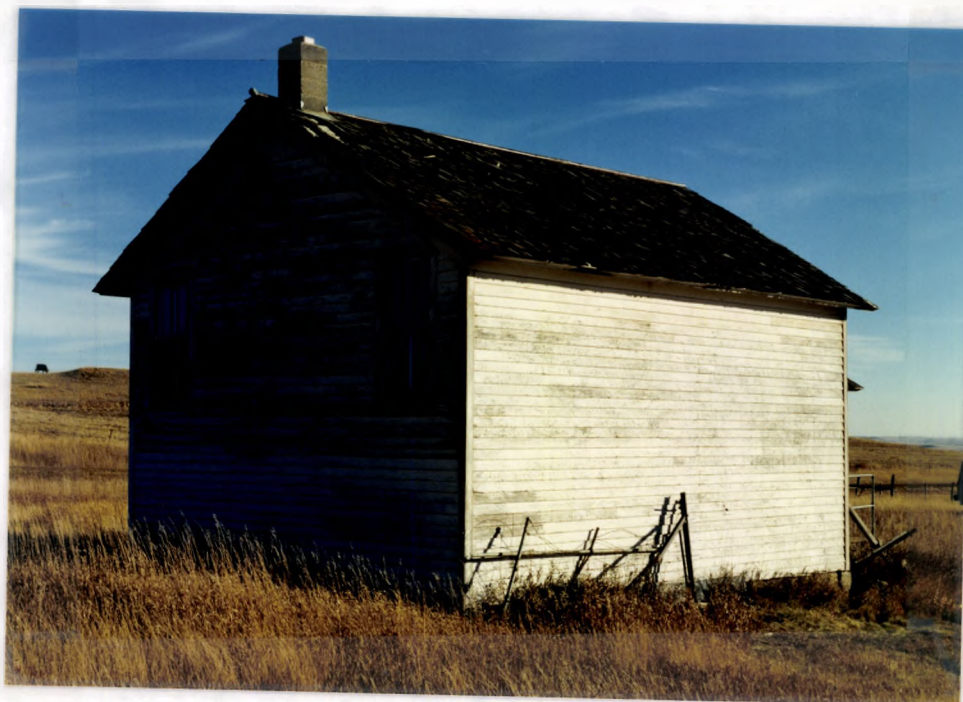
DESCRIPTION/INTEGRITY/ELIGIBILITY: The feature consists of a single room rural schoolhouse. Structurally, the exterior of the building appears to be in excellent condition and the interior appears to be in good to excellent condition. The main building measures about 30 feet north-south by 16 feet east-west. A small (6 feet by 8 feet) entryway is attached to the south side of the building. This may have been added after the school came into use. A concrete stairs runs out from the entryway. The window openings all appear to be original and, although it is uncertain if the glass is original, all openings have glass in them. Four windows are located on the eastern side of the building. These include three which have eight panes each and one which has four panes. Two windows are located in the north wall. Each of these have four panes.

Integrity of the schoolhouse appears to be excellent, although other structures and buildings related to it (two outhouses, a well or water pump location, a garage, and a dwelling), have been removed or tipped over. There is no evidence that the exterior or interior structural system has been extensively modified since the school was built.

Appendix 2. Photographic coverage of the schoolhouse (Feature 1) at site UW#2019-3. Top photo taken facing northwest. Bottom photo taken facing southeast. UW#2019. Field Date: November 6, 1997.

It is our evaluation that the schoolhouse, and possibly the site as a whole, may be an excellent example of a small school in rural south-central North Dakota and may be eligible to the National Register of Historic Places under National Register Criteria A and D. Full evaluation, however, would most likely require examination and research by a qualified historian and/or architect.

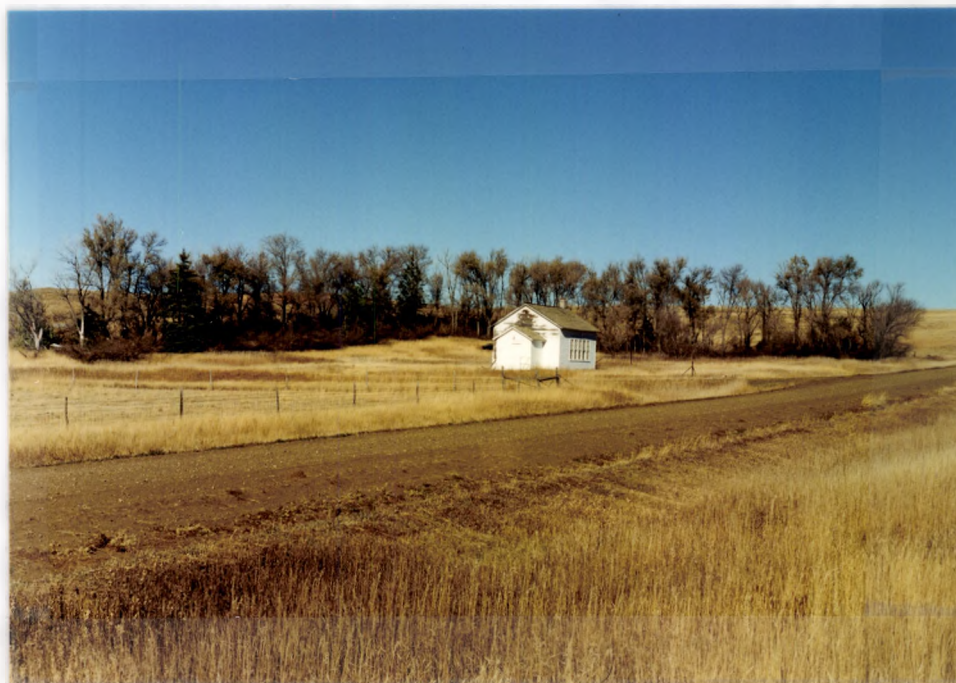
Appendix 2a. Photographic coverage of site UW#2019-3. Photo taken facing northwest. UW#2019.
Field Date: November 6, 1997.
