NDCRS SITE FORM  
 ARCHITECTURAL SITES  
 Page 1

Coder K. Schweigert Date Coded 8/21/90  
 Reconnaissance Survey \_\_\_\_\_ Intensive Survey X  
 Manuscript/Report Title: Golva East Road Cultural Resource Survey  
 Author(s): Kurt Schweigert

PROJECT TITLE: Golva East Road Cultural Resource Survey

15. Project Title: Southwest Pipeline Medora-Beach Phase II, Class III Cultural Resources  
Inventory in Western North Dakota

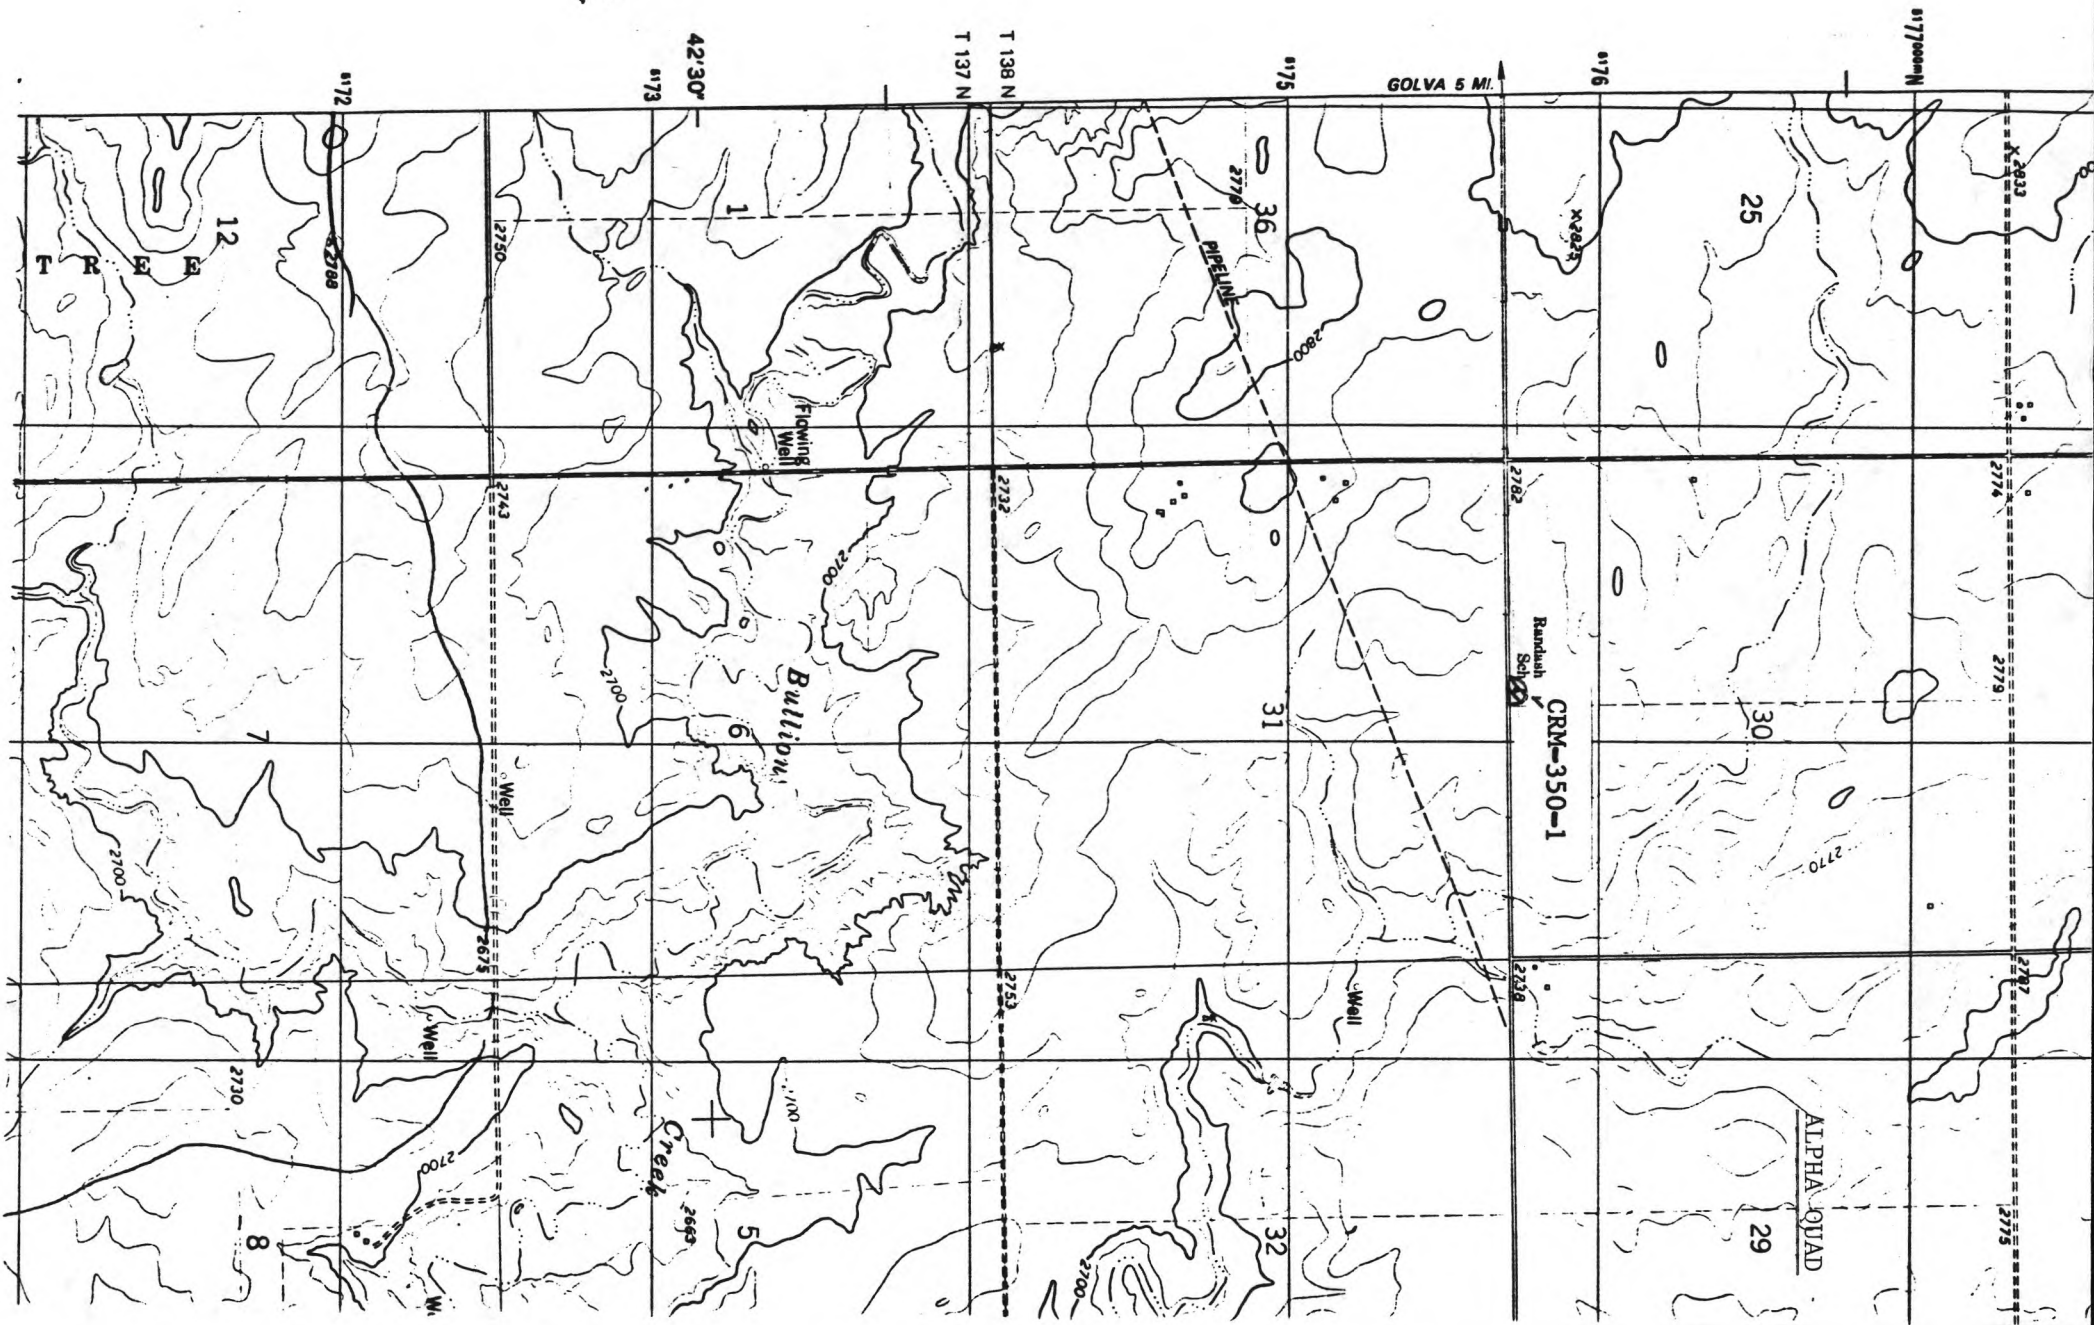
T138N-R104W, Sec. 30  
Alpha Quadrangle

CULTIVATED FIELD

SITE  
BOUNDARY

SCHOOL  
YARD

F-1

COUNTY ROAD

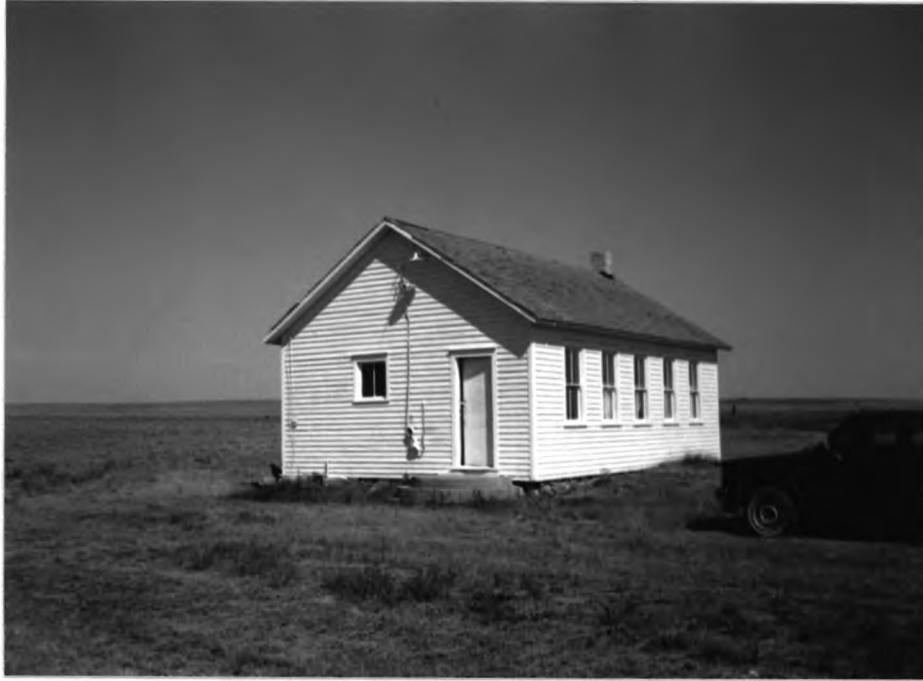
05: CRM350-1 - rural school house - view northwest

This rural one-room school has wood frame construction, a gabled roof covered with wood shingles, exterior walls covered with horizontal wood lap siding, and a foundation of poured concrete. Basement/cellar was not observed. Five 2-over-2 double hung windows are on the east side of the structure, two blinded windows are on the north end, a single 1-over-1 double hung window is near the south end of the west side, and a 2-pane fixed window and a non-original wood panel door are on the south end of the building. A brick chimney exits the roof peak near the north end.

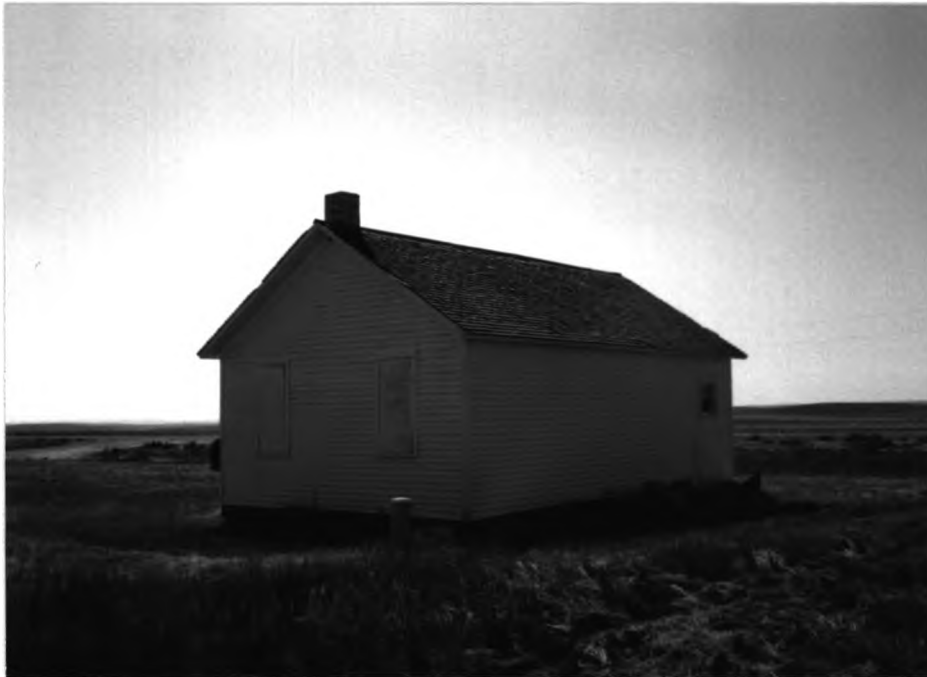
06: CRM350-1 - rural school house - view southeast

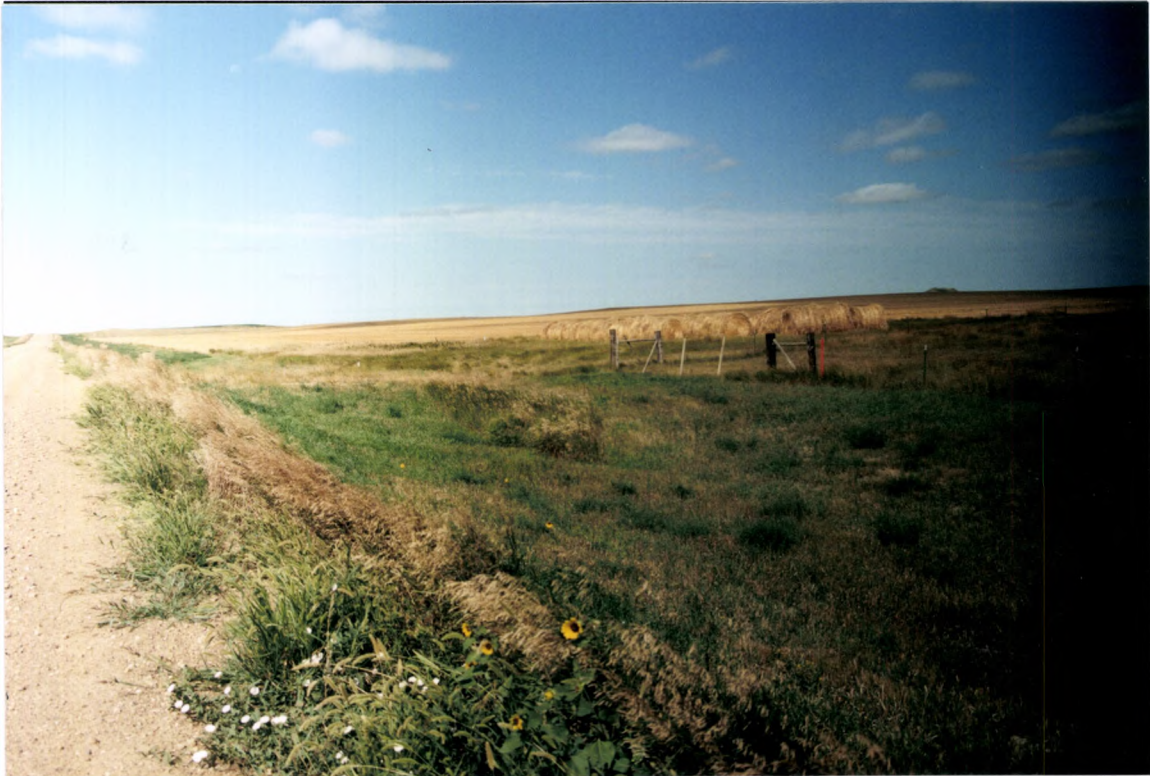
Site area overview, view west northwest (SWPL05-CP179).

The site is the location of a former school building. A concrete foundation remains. Some concrete steps have been dislocated from the foundation. The site area currently is an uncultivated corner of a grain field that is used for hay storage. Glass, wire, metal, and wood items were observed in the area.

The building is gone. The site consists of a concrete foundation and sparse scatter of lumber, metal and glass. The area is used for hay storage, and the feature is largely ignored.
