NDCRS ARCHITECTURAL SITE FORM PAGE 1

Site Name Plainview School

Project Title & Supervisor:
Country Schoolhouse Project

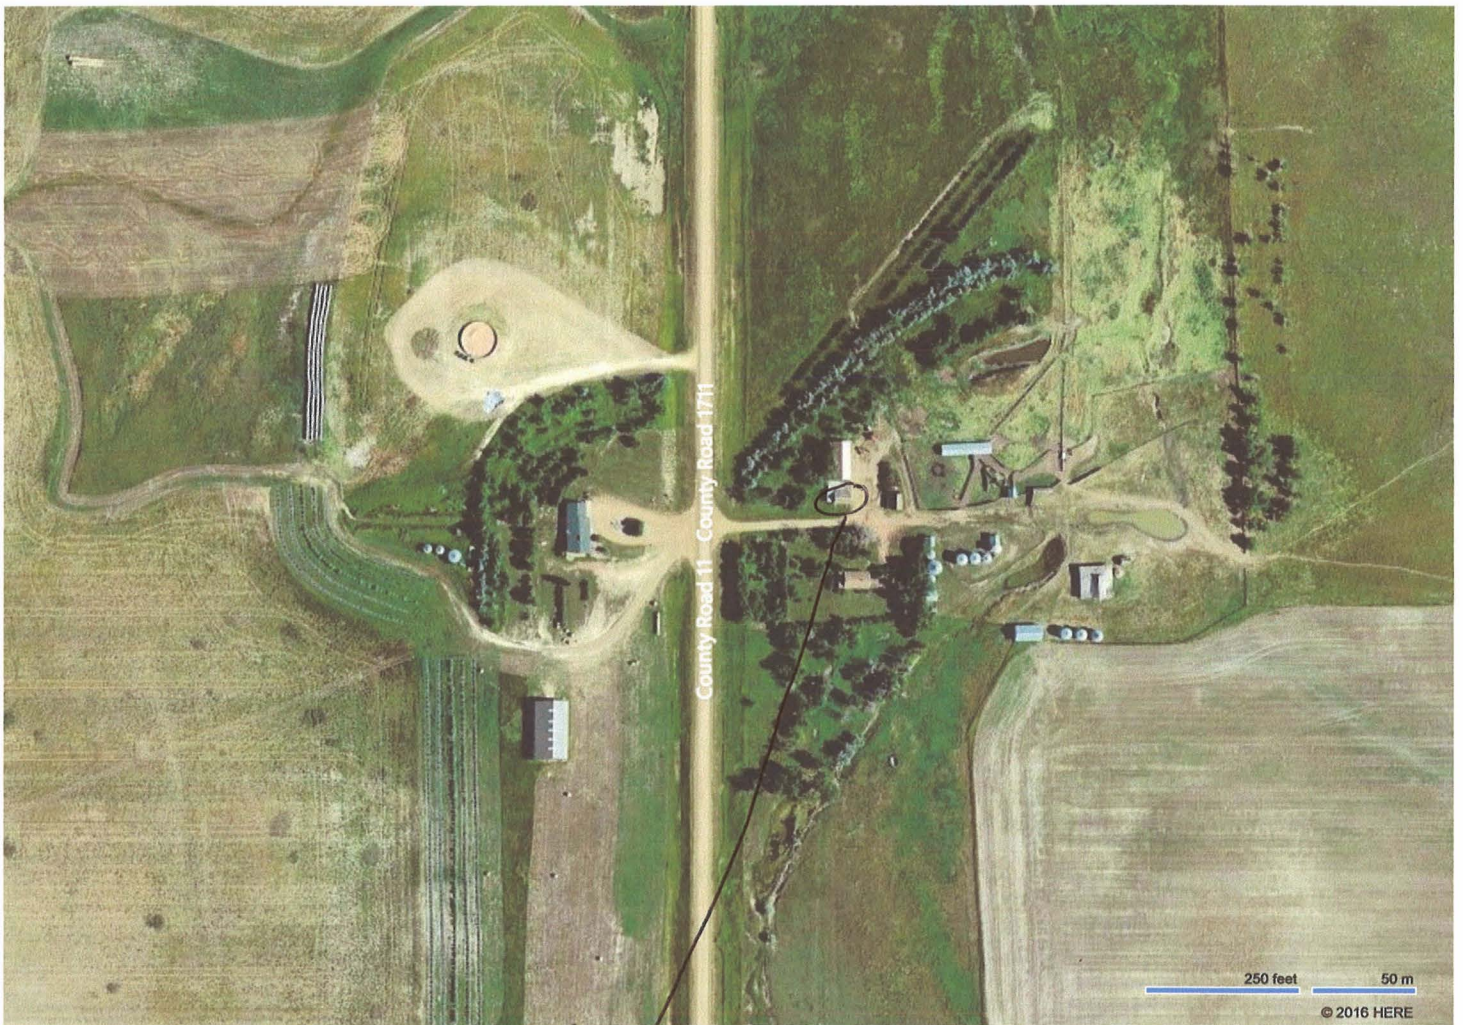
Feature

The feature is a one room prairie school on a concrete foundation. Moved to this location to be used as a shop and/or a bunkhouse. The gable roof of the main body and the shed roof of the entry are covered with ribbed metal sheeting. A red brick chimney sits near the west end on the south slope of the roof. The soffits are closed. The building measures 40 feet east to west and 20 feet east to west.

There is a wide trim board on the exterior wall under the soffits on the peak ends of the roof. The remaining siding is 6 inch wood lap with 6 inch wood corner trim. There are two small 6 pane fixed windows and one single pane fixed window on the west wall of the entry. A 3 panel wood door with a window on the top gives entry to the building. On the west wall of the school building there is one double hung, four over four, with intact glass. On the south wall there is a replacement picture window at the location of the most west older window, with two four over four windows as well. All glass intact. On the north wall are three more four over four, double hung windows, two of these windows also have storms. The entire east wall was opened and side sliding doors were installed to give access to the interior for storage and shop work. The interior walls and ceiling are covered with a mix of wallboard and planking. The floor is concrete. Electricity is present.
