# NDCRS ARCHITECTURAL SITE FORM

Map Quad White Butte West Site Name Cherry Butte School  
Map Quad \_\_\_\_\_ Site Name \_\_\_\_\_

Country Schoolhouse Project, Lorna Meidinger

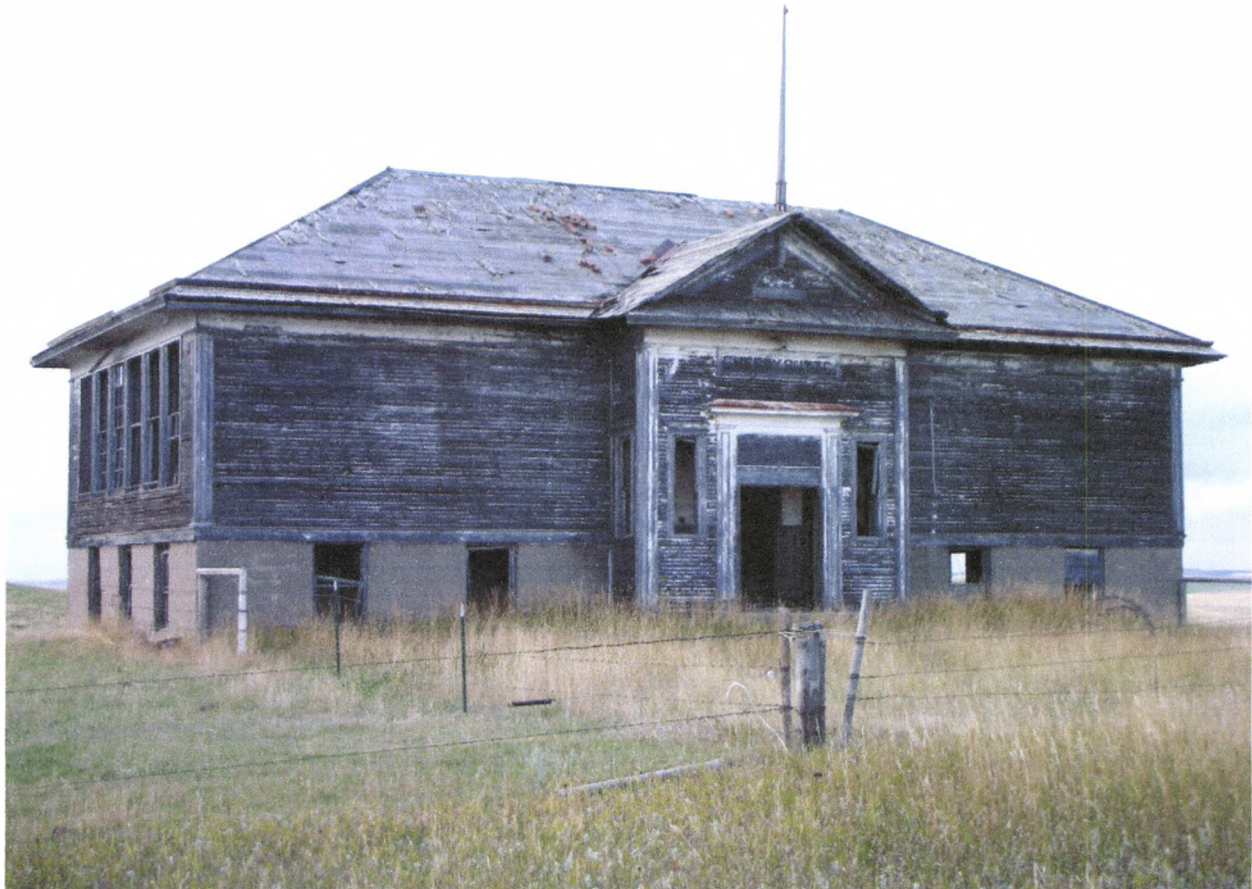
**West elevation**

Based on the photograph of Cherry Butte School, the school had two classrooms and a full basement. There are three openings at ground level on the south and two openings on either side of the main entrance on the west that are the same size. The south end also has a row of six tall windows. Centered on the west wall is a projected entrance under a gable roof with a flagpole. The gable has a skirt that extends across the front at the same level as the main eave. The triangle created by this has a fan shape detail. The rectangular entrance has four narrow windows on each side of the corner trim. The single walk door is centered on the projected entrance with pilasters on either side with a small skirt roof directly above the doorway. Above the doorway skirt roof is a sign that reads Cherry Butte. No chimney is visible from the right or way and the majority of the wood shingles are missing, leaving an exposed wood deck.

While Cherry Butte is in poor condition, it does have design integrity and some material integrity, based on what can be seen in the photograph. More investigation is required to make a determination of eligibility for this property.
