# NDCRS ARCHITECTURAL SITE FORM

Map Quad Tappen North Site Name Crystal Springs #2  
Map Quad \_\_\_\_\_ Site Name \_\_\_\_\_

Country Schoolhouse Project

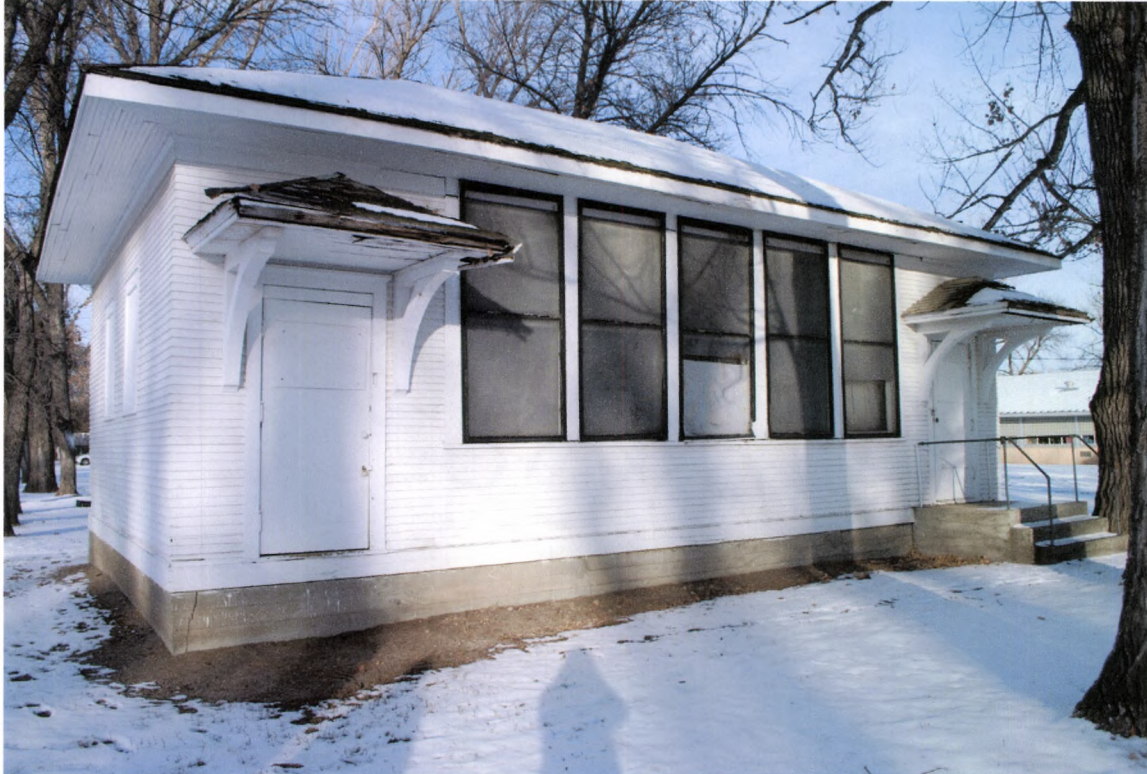
Feature 1 south southwest ↑

There is an entrance on either end of the south side of Crystal Springs #2 with five large 3 over 6 double hung windows between them. The western entrance no longer has steps and the cantilevers hood is deteriorating. The eastern entrance has concrete steps with metal poles as handrails. On the east and west ends, there are two breaks in the concrete foundation. Haadem and Iszler thought those were from when the building was moved and then they were filled in with concrete block. The building never had a basement. The east and west ends also have two windows, smaller than the front windows. Chimney block extends up from near the hip on the east end. The north side would not photograph but was a solid wall broken only by one window near the west end that appeared to be the same size as the windows on the ends.
