## NDCRS ARCHITECTURAL SITE FORM PAGE 1

Field Code White School Site Name White School  
 Site Name \_\_\_\_\_

Total # *Architectural* Features: 1  
 Fieldwork Date: 10/31/2013  
 Reconnaissance Survey  Intensive Survey \_\_\_\_\_  
 Project Title & Supervisor:  
Country Schoolhouse Project  
 Report Title & Author(s):

Architectural Feature # 1

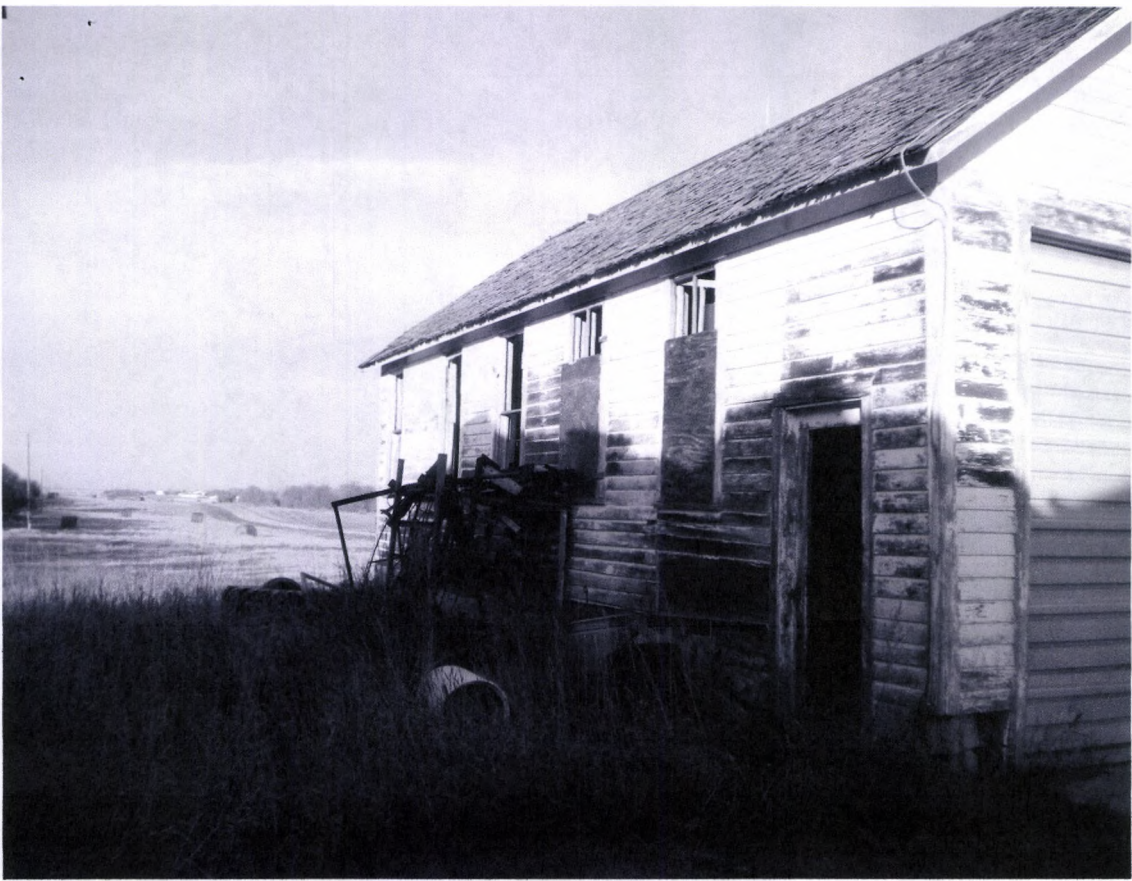
South Side

This building is an early, wood framed one room school moved to the present site to be used as a shop. The original location was about a mile south. The building integrity looks to be close to the original but a straight line of boards on the siding to the north shows that perhaps an addition was put on at some point in the life of the building. The south side of the building also shows that straight line of boards. It looks like they added about 5 feet to the east end of the building. The roof is mostly covered with shakes. There is a metal cap running the length of the building and there are three lightening rods along that metal cap. One at each end and a third in the middle. There is a hole where the chimney used to be. The siding is 6 inch wood lap siding with an 8 inch trim board running at either end of the building just under the roof. Corners are trimmed with 6 inch wood. On the north side there is an electrical box indicating electricity and I suspect this is a newer addition as the box is of a more modern design. The east side of the building has a garage door for easy access to the building. At the west end is an entry door with one window to the north. It appears to be the original entry door. Inside the school, at that west end, there are two doors leading into what was most likely the coatroom. The interior doors could be original to the school. There is a bank of windows on the south side of the building, 4 into the classroom and another at the west end. The windows are double hung with most of the glass missing. Two of the windows are partially covered on the outside with plywood. Also on the south side of the building is an entry door, a later addition.
