NDCRS SITE FORM
ARCHITECTURAL SITES

SITS # 32 ME 1408

Field Code ES 40 Site Name _____
Field Code _____ Site Name _____

Coteau: A Cultural Resource Inventory of the North Mine Area Extension.

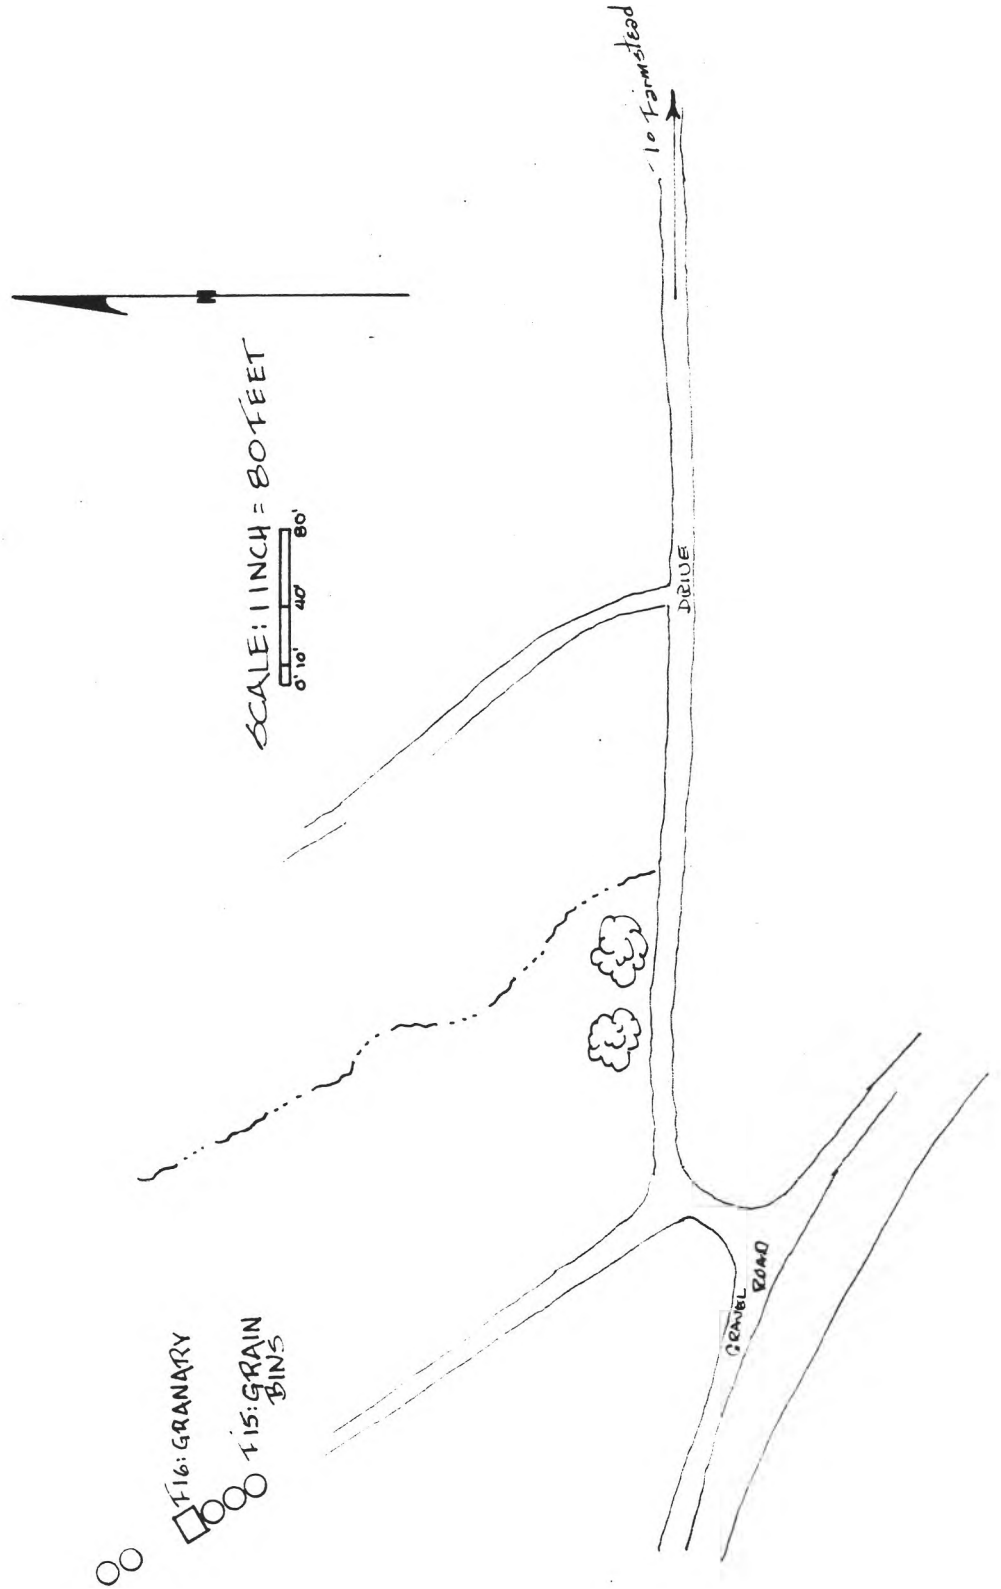
Field # : ES-40
SKETCH MAP

This farmsite consists of 14 buildings spread over a west sloping hillside with a grain storage complex situated to the west of the farmstead proper. Two scoria pits are situated within the site area. Most of the buildings have been constructed or moved onto the site since the 1950s. The site is bounded to the east and north by the continuation of the sloping hillside, by a wire fence to the south and by a wind row to the west beyond the grain storage complex. Farm machinery is scattered across the north slope.

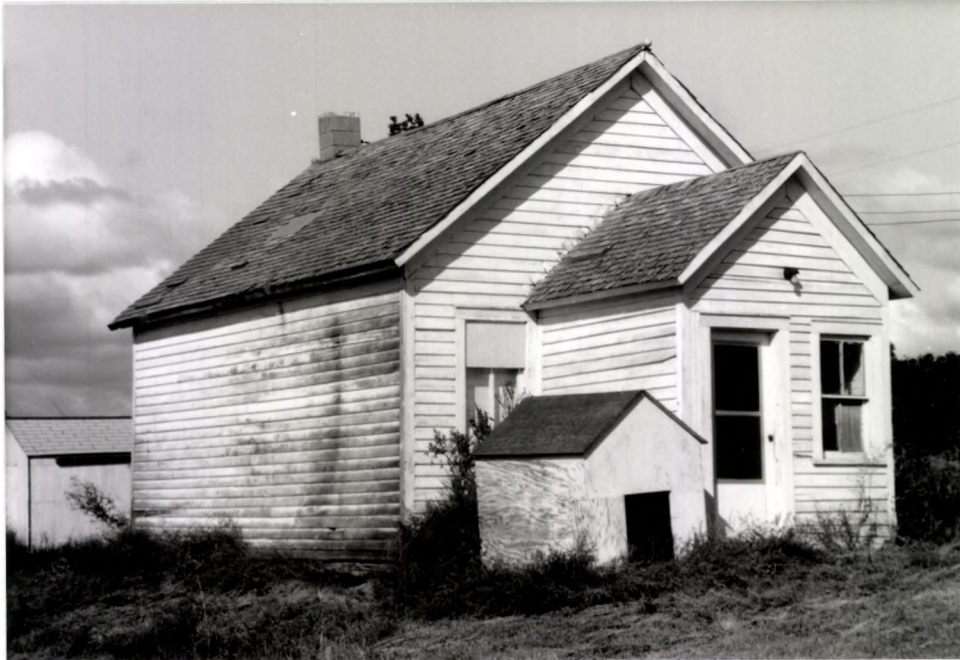
FEATURE 2: Schoolhouse, south and east elevations, view to west

Feature 2 is a former schoolhouse, moved to this location in the early 1960s. This wood frame building is set on concrete blocks and is clad with weatherboard framed by cornerboards. It has a gable roof covered with wood shingles. Roof details include a metal ridgecap with end finials, enclosed eaves and a concrete block chimney protruding from the west end of the roof ridge. The south wall has no openings, a typical characteristic of rural schoolhouses. The west end wall is symmetrical with two openings, one filled in with a replacement window in the second. The north wall holds two 2/2 double-hung window with a center opening filled-in. A steep gabled roof vestibule is centered on the east wall and flanked to either side by a 2/2 double-hung window. A screen door and a 2/2 double-hung window fill the entry (east) wall of the vestibule. The vestibule interior has beadboard walls and ceiling, tongue and groove flooring and a replacement interior wood door.

This school house has retained integrity of materials and design and is easily recognizable as a rural schoolhouse. However, the building has lost integrity of location, setting, association and feeling with its removal from its original location.

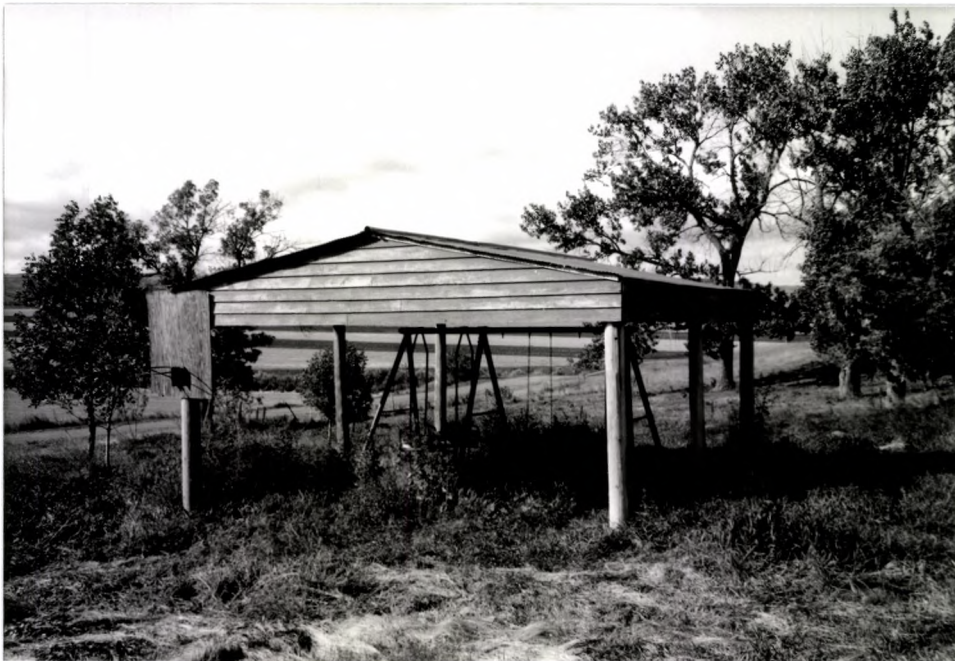
FEATURE 3: Shelter, view to southwest
