NDCRS SITE FORM
ARCHITECTURAL SITES
Page 1

Field Code IS-1.6 Site Name Saylor Farmstead
Field Code _____ Site Name _____

Manuscript/Report Title: Falkirk: A Cultural Resource Inventory of 29,600 Acres in McLean County, North Dakota

NDCRS ARCHITECTURAL SITE FORM

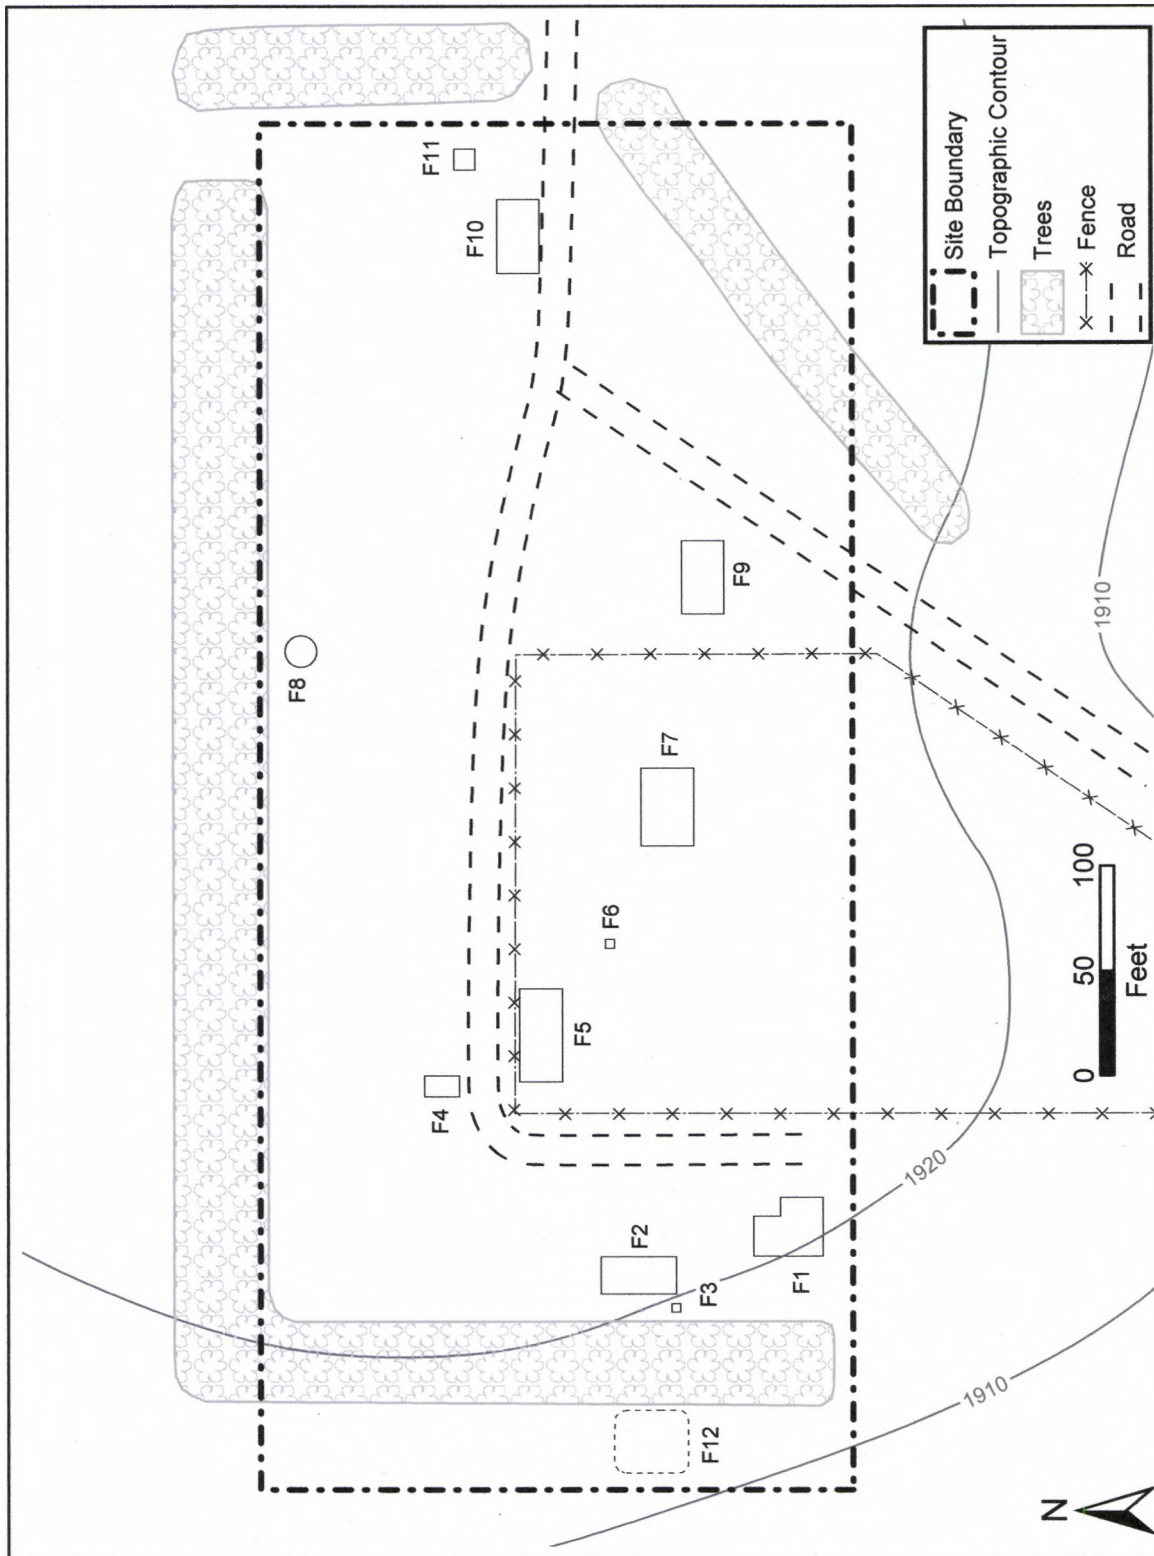
SITE SKETCH MAP

DESCRIPTION: This site is a farmstead that consists of 12 features. The site is surrounded by plowed fields. The site displays fair to good integrity. Feature 12 is described on the NDCRS Archaeological and Historical Site Form.

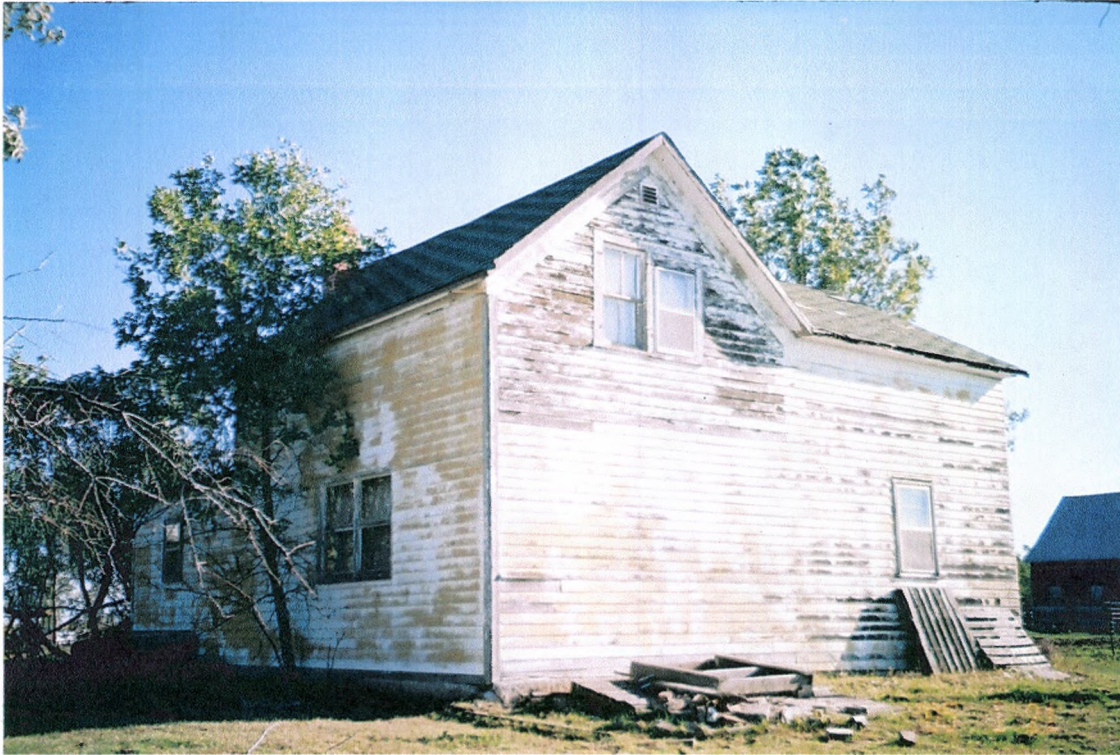
Feature 1, view to the northeast

The integrity of the features at the site range from poor to good. Features 1, 5 and 6 are the original house, barn and windmill constructed in 1907. Feature 1 has had an addition constructed on its north elevation. Features 3 and 11, an outhouse and a shed, were likely constructed around the same time. The features display fair condition; however, none are exceptional in terms of the construction or integrity. Most of the other features were constructed after 1951, and two (Features 9 and 10) were constructed around 1976. Integrity of association and feeling has also been compromised by the addition of the newer buildings.

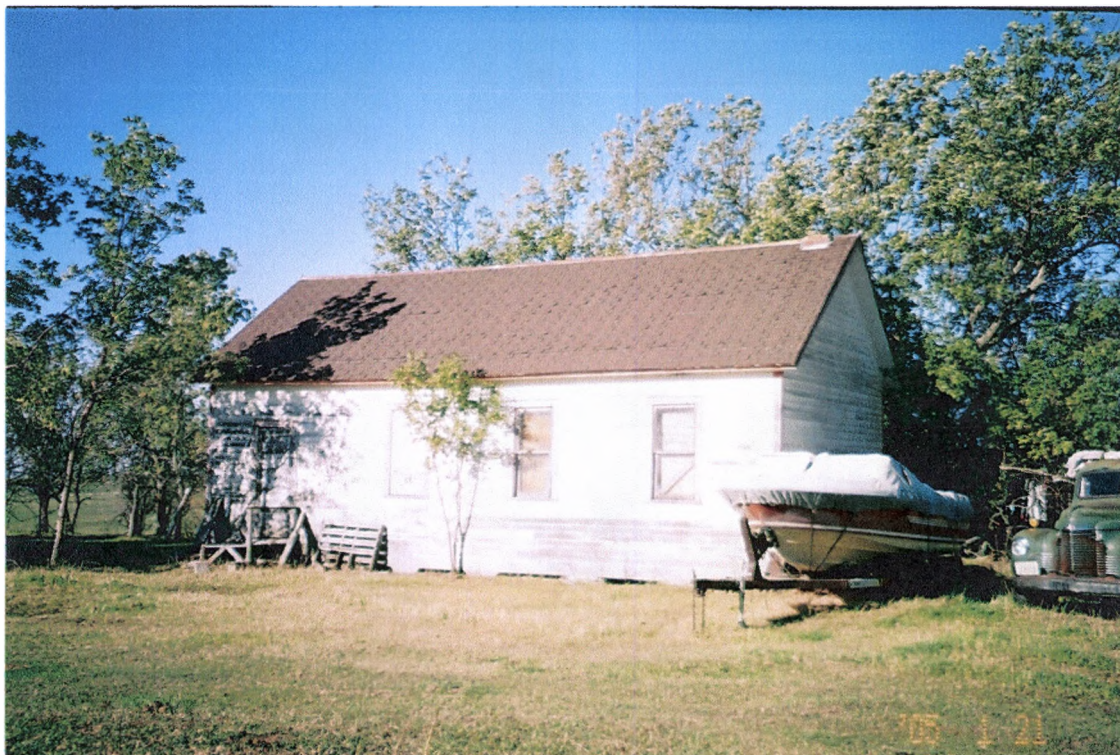
Feature 2 is a wood frame schoolhouse. It measures 36 ft. north-south by 18 ft. east-west. It is sitting on cinderblocks. The building is protected by a side-gable roof topped with brown asphalt shingles, metal ridge cap, endballs, open eaves and enclosed rafters. The walls are clad with lap siding that is painted white. Corner boards that are painted white protect the edges of the building. The east elevation contains a 6 ft. tall by 2 ft. 8 in. wide 5-panel wood door, and three 4 ft. tall by 2 ft. wide 1/1 double-hung windows. One of the windows is boarded-over with plywood. Three 4 ft. tall by 2 ft. wide 1/1 double-hung windows, two of which are boarded-over with plywood, are situated in the west elevation. The south elevation contains one 4 ft. tall by 2 ft. wide 4-light fixed window, and one 2 ft. tall by 2 ft. 6 in. wide 4-light fixed window. A small, 3 ft. square 1-step wood deck made from 2 in. by 4 in. boards provides access to the door. This feature was moved in to this site and was at this location in the 1950s (Lori Hardy, personal communication 2007).

Feature 2, view to the southwest

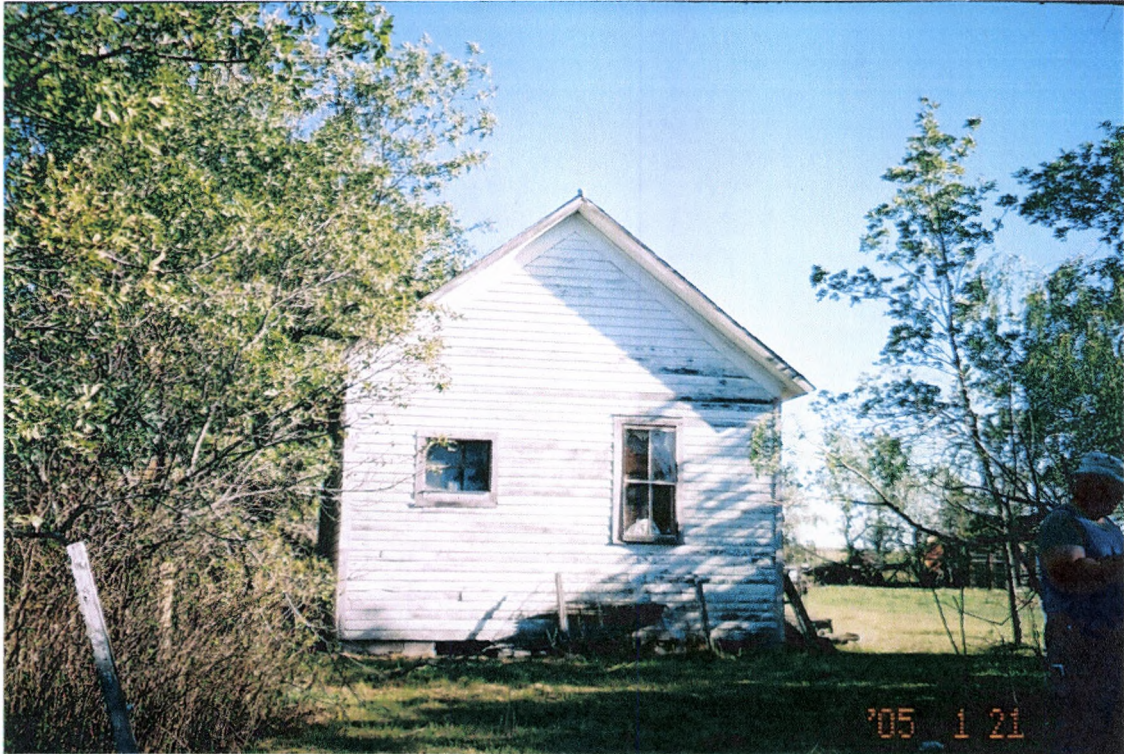
Feature 2, view to the north
