NDCRS SITE FORM  
ARCHITECTURAL SITES  
Page 1

Field Code MLH Site Name FARMSTEAD  
Field Code \_\_\_\_\_ Site Name \_\_\_\_\_

Manuscript/Report Title: Falkirk: A Cultural Resource Inventory of 20,000 Acres in McLean County, North Dakota

PROJECT TITLE: Falkirk 20,000

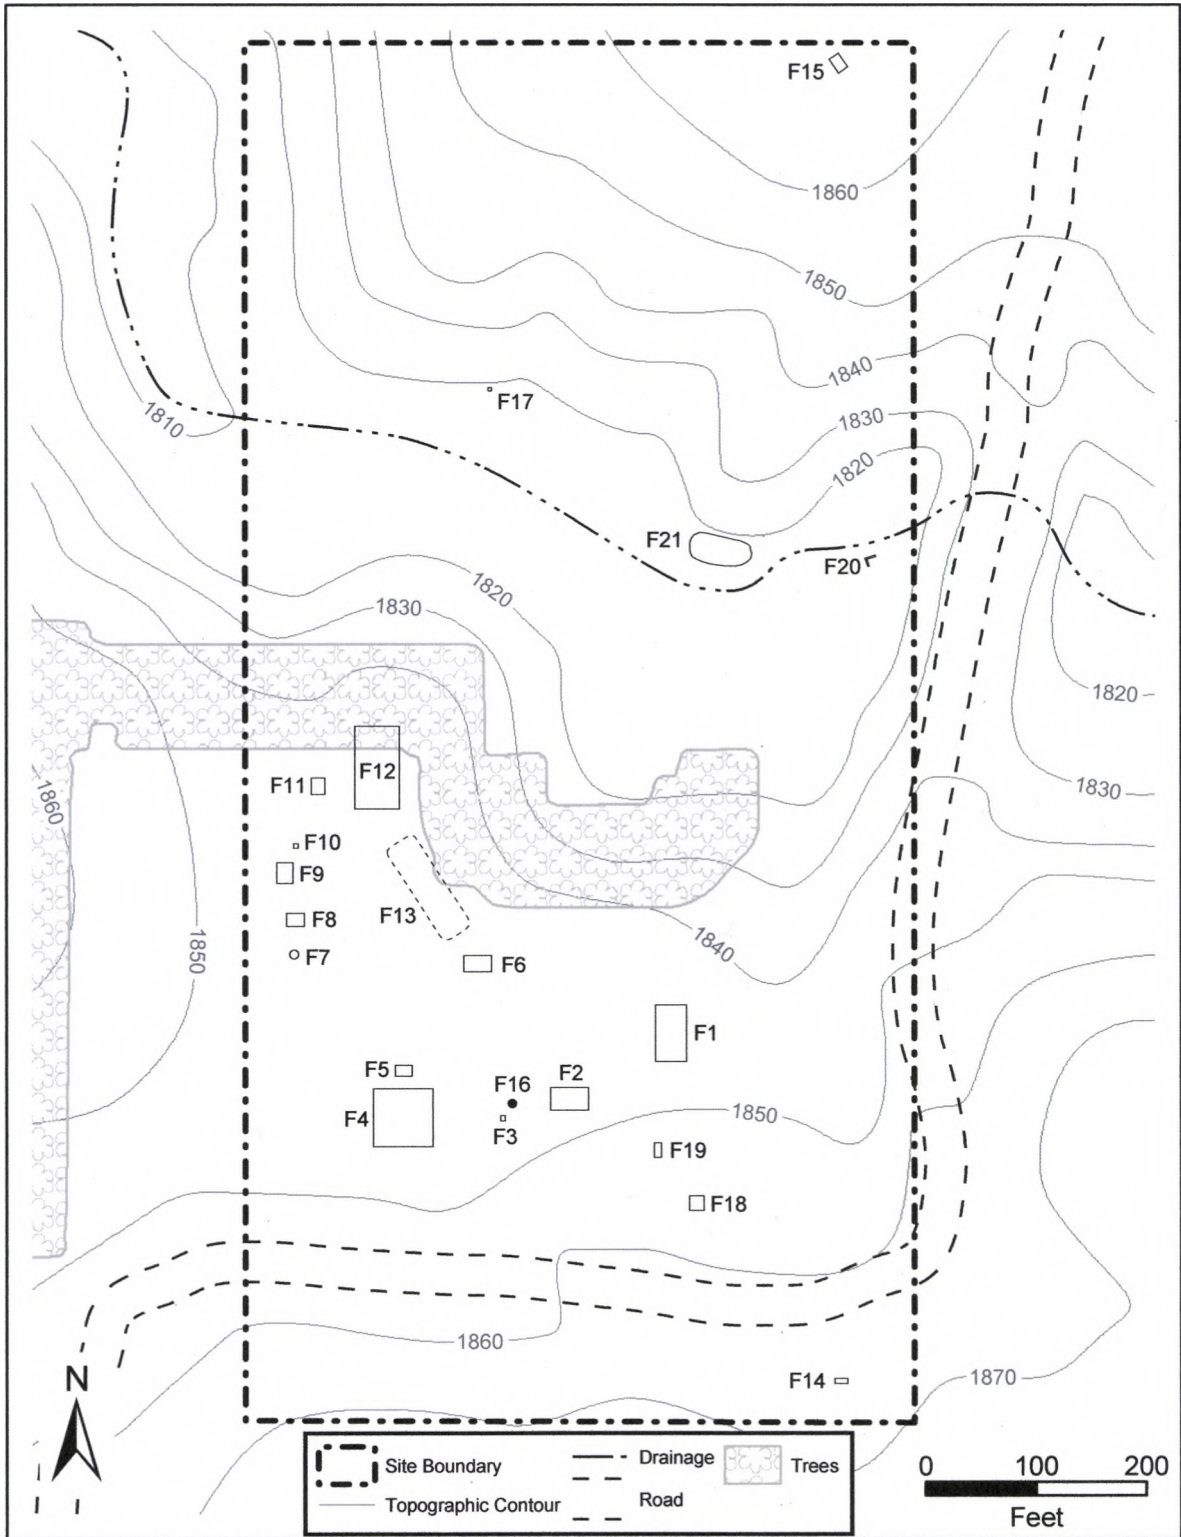
SITE SKETCH MAP

DESCRIPTION: The site is a farm that consists of 21 features. The majority of the site is located on the south slope of a gentle west-east trending drainage. Plowed fields are located to the west and south, and prairie is east and north. Features 18-21 are described on the NDCRS Historical Archaeology Site Form.

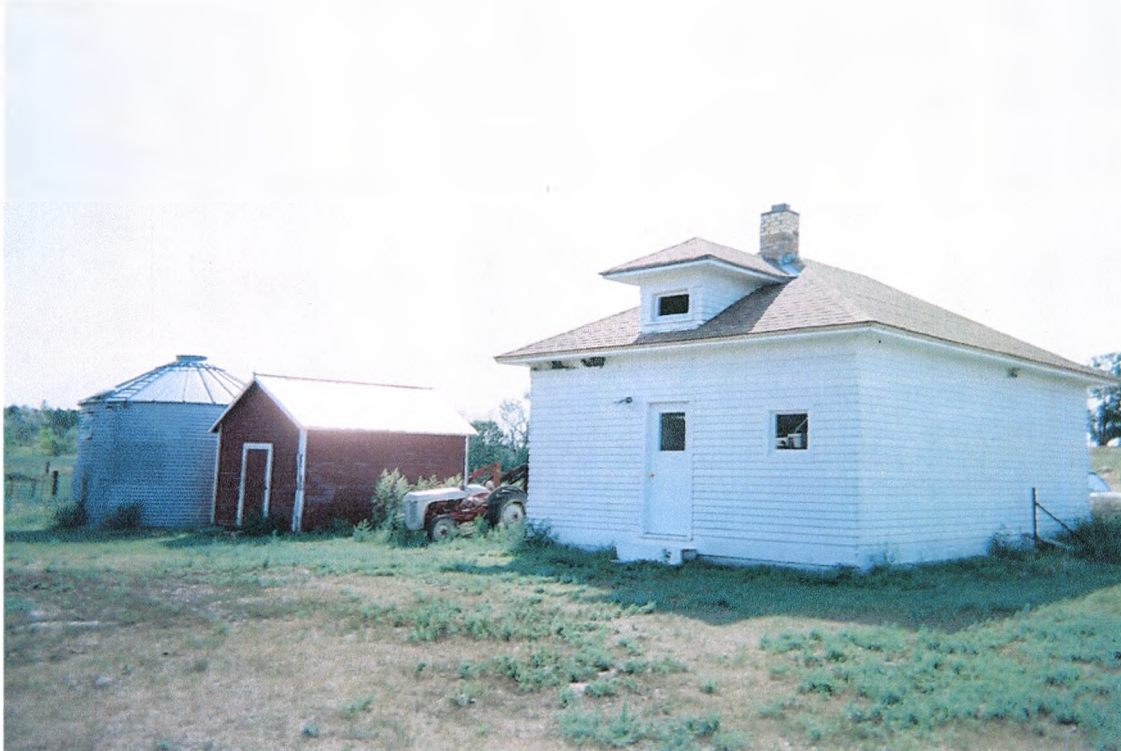
Feature 9, view to the southwest

Feature 9 is a schoolhouse. It measures 15 ft. north-south by 18 ft. east-west. It rests on a concrete foundation. It is covered by a hipped roof topped with white asphalt shingles, a metal ridgecap, and boxed eaves. A hipped dormer sporting a 1-light fixed window extends from the east slope of the roof. A brick chimney projects from near the center of the feature. The walls are clad with lapped siding that is painted white and the corners are protected with white metal corner boards. The east elevation contains a 6 ft. 6 in. by 3 ft. 1-light wood door, and a 1 ft. 6 in. square 1-light fixed window. A 2 ft. 6 in. tall by 2 ft. wide 6-light fixed window, and a ribbon window consisting of six 4 ft. tall by 2 ft. wide 1/1 double-hung windows is in the south elevation. A one step concrete step provides access to the door. Feature 9 is a schoolhouse that has been moved several times over the years and was recently moved onto this property by the Millers. Feature 9 was brought to the site in 2001 or 2002. It was the original school for the Buffalo Lake School District 69 (Mary Jane Miller, personal communication 2007).

Feature 9 is a schoolhouse. It was the original school for the Buffalo Lake School District 69 and was brought to the site in 2001 or 2002 (Mary Jane Miller, personal communication 2007).

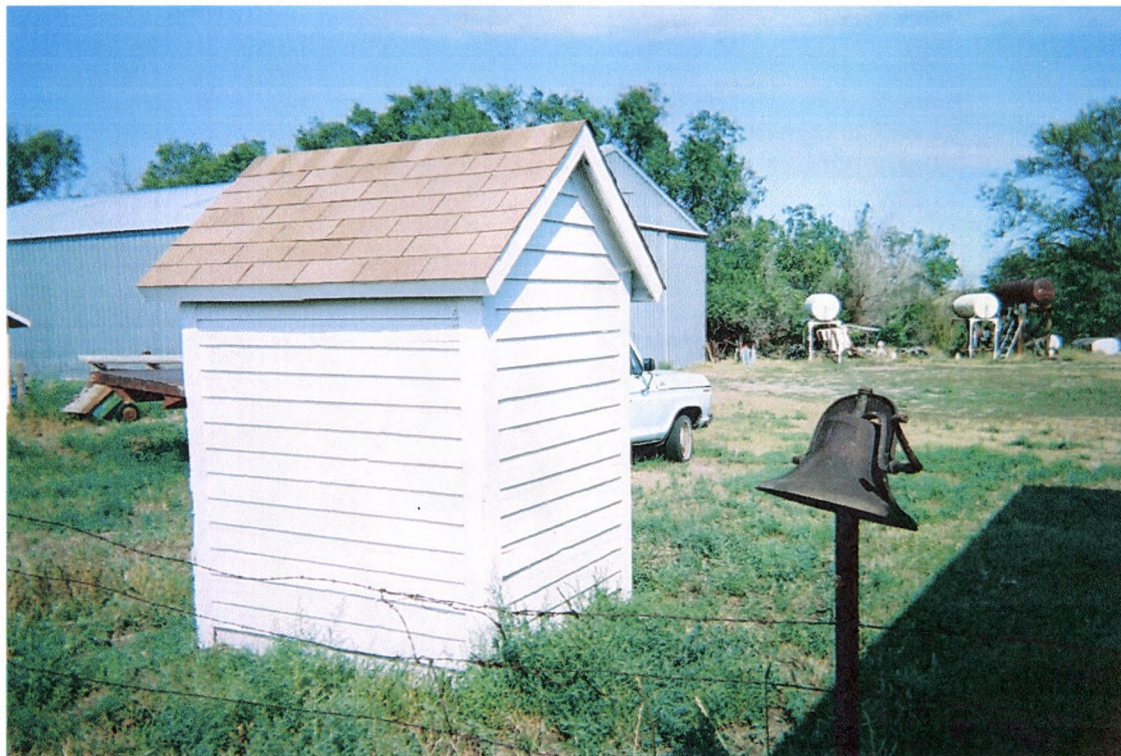
Feature 10, view to the northeast
