## NDCRS ARCHITECTURAL FORM PAGE 1

Field Code Kost Sch	ool	_	5	SITS# 32 ML	1253
Map Quad Turtle Creek S Map Quad	:W	Site		School	
LTL T144 N., R LTL TN., R LTL TN., R LTL TN., R	81 W., Sec. 8 W., Sec W., Sec	_ QQQ <u>8</u> of _ QQQ of _ QQQ of	the <b>QQ</b> <u>8</u> the <b>QQ</b>	of the <b>Q</b> <u>8</u> of the <b>Q</b> _ of the <b>Q</b>	Subsection 1 = N½ 2 = E½ 3 = S½
NAD 1983 UTM NAD 1983 UTM	5242125 577 S SW Rural Ctural Features:		_		4 = W½ 5 = NE¼ 6 = SE¼ 7 = SW¼ 8 = NW¾
Fieldwork Date: 09/2  Reconnaissance Survey	4	Intensive Su	rvey		
Project & Principal Investi Apex Discovery Wind Proj		storian			
Contracting Firm or Agen Quality Cultural Resource	-	Form:			
Additional Information:					
SHSND USE  Component  Component  Component	Study Unit	Verified S	Site	_ CR Type	
Recorded By:	Kristyn Wa	ırd	Date R	ecorded:	09/20/2023

Field Code Kost School	SITS# 32 ML 1253

Small One Room School (Kost School)

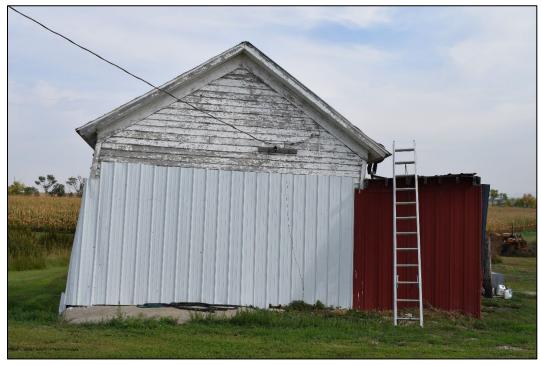
Figure 2. Feature 1 facing east. K. Ward 09/20/2023.

[2023] The north and west facade have updated corrugated sheet metal siding that covers the windows and double door mentioned in the site from from 2011. Wood block and sheet metal patches are on the eastern facade. A flat roofed addition was added to the south side of the schoolhouse. Walls on the south and west portion of the addition are enclosed with corrugated sheet metal. The east side is open. This addition appears in the photographs from the 2011 report but were not addressed in the description. The roof on both the original structure and the addition are missing roofing pieces and have deteriorated further in comparison with the photographs in the 2011 report.

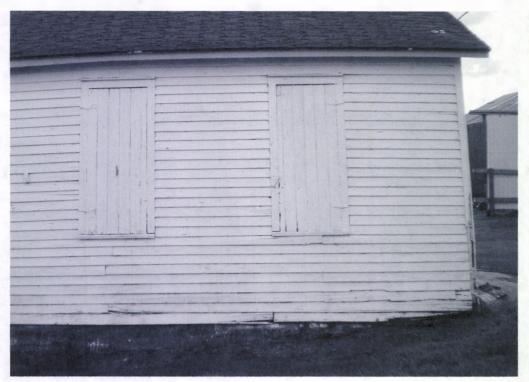
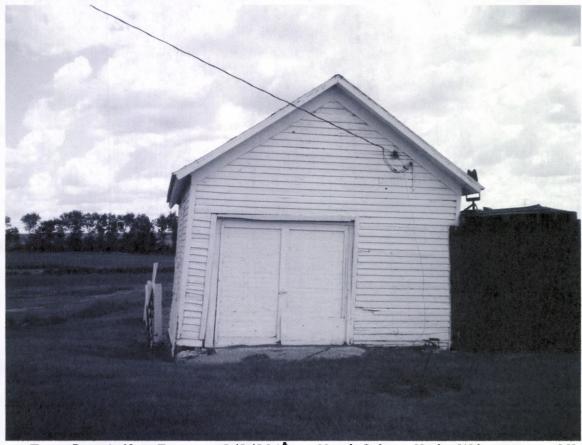
Top – Dennis Kost Farm 8/9/2012 Bottom – Dennis Kost Farm 8/9/2012

This small building has been on the Kost farmsite for many years and nothing is known about the original location of the building. It measures 16 feet north to south and 20 feet east to west. It has two windows on the north wall and one on the south wall along with the entry door. It has wood lap siding on the outside and wood siding inside with about 1/3 of the bottom of the wall simple wainscoating. The ceiling is tongue and groove and the floor is a simple wood floor. The owner doesn't know when it was moved onto the farm but he does know that It sits on concrete foundation that was poured by Rudy and Ruth Kost about 1940. I think it is a much older school as there is no insulation. It did not have electricity before it was moved to the farm to be used for storage. The west side of the bulding has a double door for easier access to the inside. The building is beginning to list to the south. The roofing is very tired and looks to be old asphalt and the chimney is almost gone.

North Side West Side Kathy Wilner Kathy Wilner

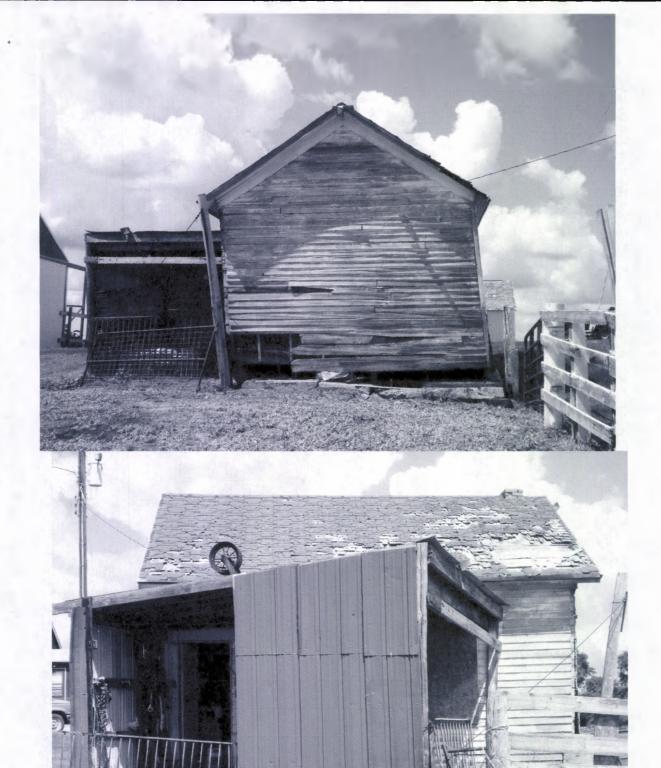
Top – Dennis Kost Farm 8/9/201 Bottom – Dennis Kost Farm 8/9/201

East Side South Side
