## NDCRS ARCHITECTURAL FORM PAGE 1

Field Code Greatstone	School #2	Ş	SITS# 32 ML <sub>_</sub>	1402
Map Quad Horseshoe Valle Map Quad	у	Site Name Grea		
LTL T149 _ N., R8′ LTL T N., R LTL T N., R LTL T N., R LTL T N., R NAD1983 UTM NAD1983 UTM City: Street Number: Street Name:19th Ave N	M., Sec. 26 Q W., Sec. Q W., Sec. Q W., Sec. Q 5284392 Z 350436	QQ 5 of the QQ 5 QQ of the QQ Q QQ of the QQ Q QQ of the QQ  Zone 14N	of the Q 6 of the Q of the Q of the Q of the Q	Subsection 1 = N½ 2 = E½
Urban Legal Description:				
Total Number of Architectu	ıral Features:1	<u> </u>		
Fieldwork Date:05/31	/2021			
Reconnaissance Survey	<u></u>	itensive Survey		
Project & Principal Investiga Country School House Proje Kathy Wilner 366 43rd Ave SE, Bowdon, N	ct			
Contracting Firm or Agency	Completing the Forr	m:		
Additional Information:				
SHSND USE  Component  Component	Study Unit	Verified Site	_ CR Type	
Recorded By:	Kathy Wilner	Date R	ecorded:	06/06/2021

Greatstone Township School

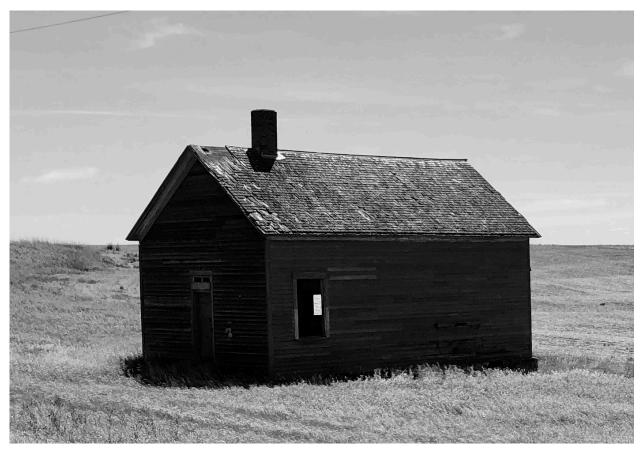
North Side

The siding begins with a rake board under the eaves at the peak ends of the school. All other siding is 6 inch wood lap with 6 inch corner trim. On the south wall there is a fuel door near the east end of the building. A double hung window opening, near the east end of the school on the north side, is located in the coatroom. A bank of 5 double hung window openings is located on the south side with a bit of framing and no glass. There is a single concrete step leading to the entry door opening, the door is gone. A small, covered transom sits above the entry door. Inside the entry there is a fuel storage room to the left and coat room to the right. A 5 panel wood door leads into that coat room from a small vestibule. Another opening on the west wall of the entry leads into the school room, the door lays on the floor inside the school room. The ceiling of the entry has lathe and plaster while the ceiling in the school room was finished with wallboard panels. Much of the ceiling has fallen in. The walls are wallboard. There are blackboards on the north half of the west and west half of the north wall. Wainscot can be seen on all walls in the school room. The floor is tongue and groove hardwood. I wonder if the building was used for grain storage at some point, a small opening on the south side at floor level could have been used to get grain out. There is also evidence of ropes and board lumber that held the walls together north to south. No evidence that electricity was ever used here.

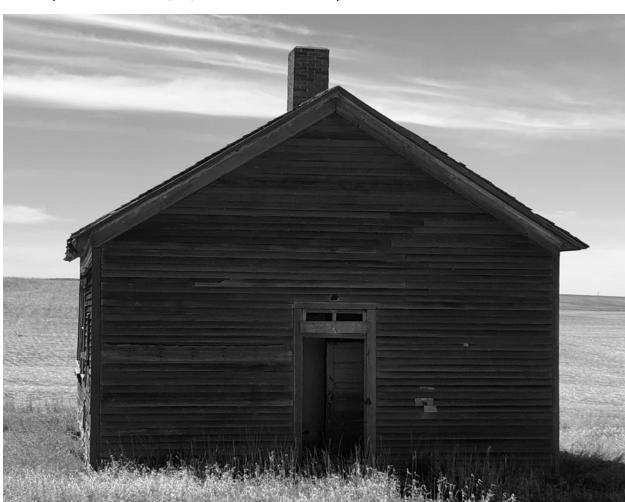
East Side

This feature is a one room prairie school on a poured concrete foundation. The gable roof of the school is mostly covered with wood shakes. Remnants of metal capping are seen at the peak. A red brick chimney sits at the peak near the east end of the roof. The soffits are closed. The building measures about 20 feet east to west and 18 feet north to south.
