### NDCRS ARCHITECTURAL SITE FORM

Field Code MAC-H8-HS2

SITS# 32 MN 869

Report Title & Author(s):  
Highway 8: A Class III Cultural Resources Inventory in Mountrail County, North Dakota - Ed Stine

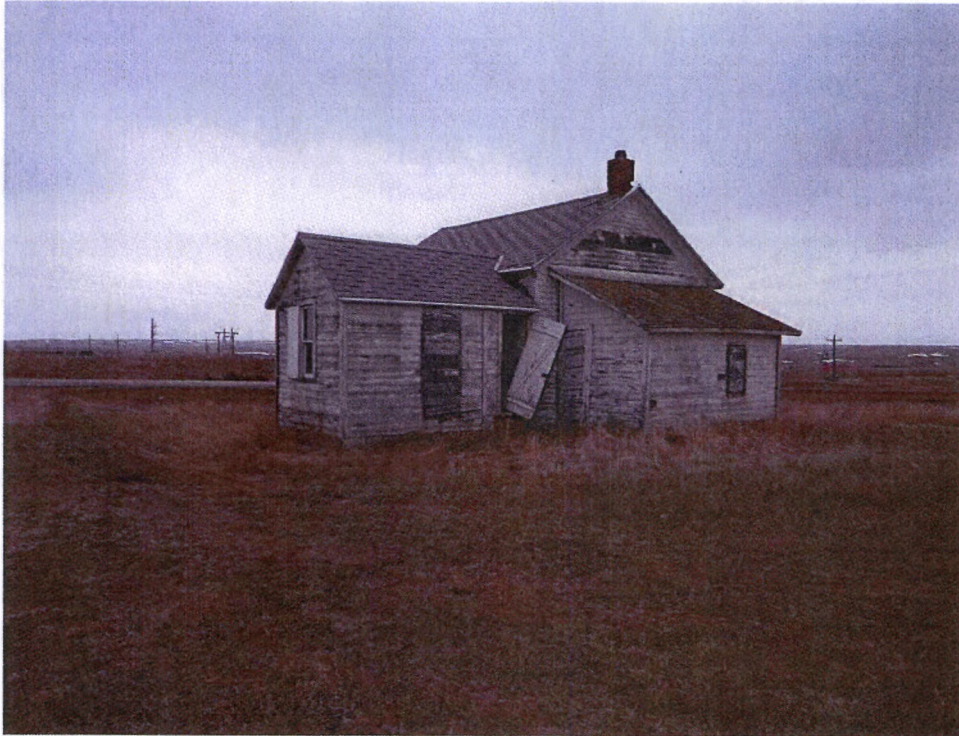
The feature is an abandoned school house/township hall. It is a single story feature with three attached rooms. It has a wood frame with horizontal wood planked siding and shingle roofing and is on a stone-concrete foundation. The structure measures approximately 10 meters north-south x 12 meters east-west. The attached front entry porch faces west and measures 3 meters north-south x 2 meters east-west. An attached smaller room faces the south and measures 5 meters north-south x 3 meters east-west. The third room is attached to the west side and measures 4 meters north-south x 2 meters east-west.

The structure is in poor condition. Much of the exterior paint is peeled off from weathering; a back entry door is broken off its hinges; all of the windows are boarded up with plywood. Most of the shingled roof is intact. Due to the lack of maintenance over time and long exposure to the elements, the site has deteriorated and lacks original feeling, design, materials, workmanship, and association.

Figure 2: View of MAC-H8-HS2; Feature 1 looking northwest (Photo #330).

It is recommended as ineligible for the National Register of Historic Places (NRHP).

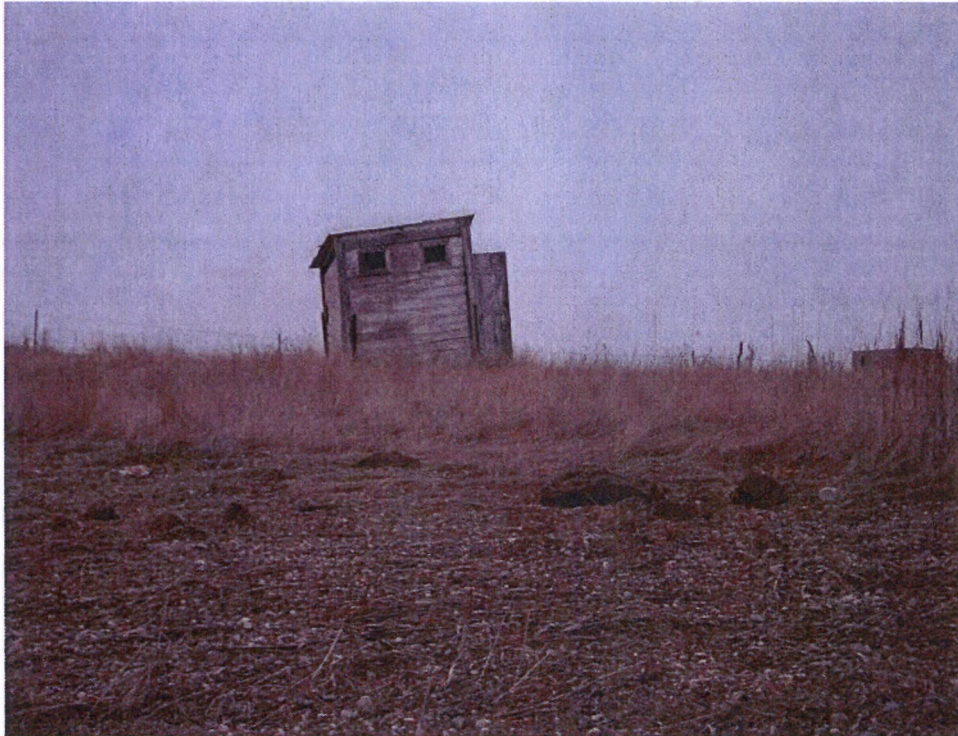
Feature 2 is a privy associated with Feature 1. The feature is constructed of horizontal wood siding with a flat shingled roof. Four square windows, approximately 30 cm x 30 cm diameter are situated on the east and west sides of the structure with a row of smaller openings along the upper north wall. The entryway faces south.

The structure is intact, but in poor condition. Due to the lack of maintenance over time and long exposure to the elements, the site has deteriorated and lacks original feeling, design, materials, workmanship, and association.

**Figure 3: View of MAC-H8-HS2; Feature 2 looking east (Photo #348).**

The site is recommended as ineligible for the National Register of Historic Places (NRHP).

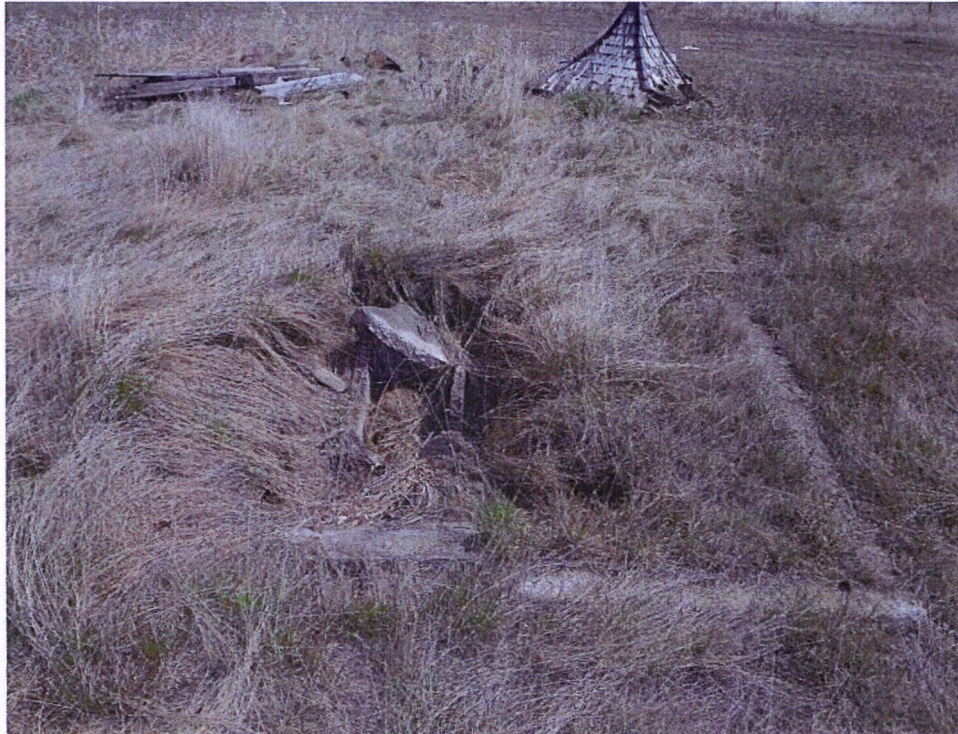
Feature 3, the privy structure is destroyed. All that remains is the concrete foundation. Due to the lack of maintenance over time and long exposure to the elements, the feature has deteriorated and lacks original feeling, design, materials, workmanship, and association. The well, Feature 4, lacks the pump housing..

**Figure 4: View of MAC-H8-HS2; Feature 3 looking east (Photo #327).**
