# NDCRS ARCHITECTURAL SITE FORM PAGE 1

SITS# 32 MN 00879

# NDCRS ARCHITECTURAL SITE FORM PAGE 2—Feature Data

Rugland School

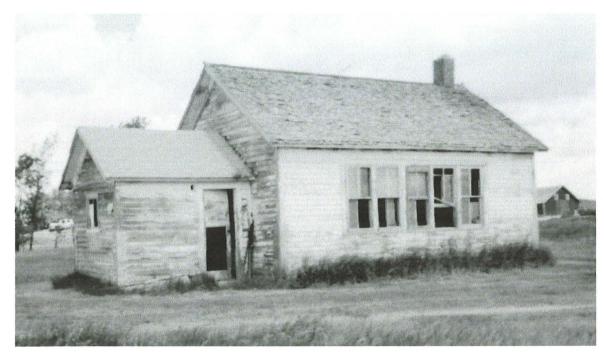
South Side

The feature is a one room prairie school on a foundation of concrete block. The school has wood shakes on the roof of the main body, metal capping with finials, and the entry is roofed with asphalt shingles. There is a red brick chimney at the east end of the roof peak. The soffits of the school are closed. The building measures 18 feet north to south and 24 feet east to west, I do not think that includes the entry.

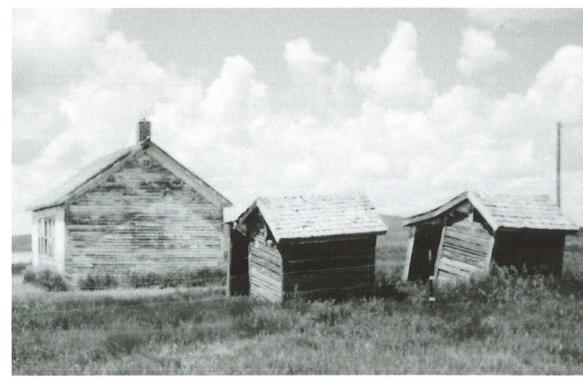
### East Side

There are two outhouses to the east of the school building.
