NDCRS ARCHITECTURAL SITE FORM PAGE 1 SITS# 32 MN

NDCRS ARCHITECTURAL SITE FORM PAGE 4—SITE DESCRIPTION

Field Code Farmvale School

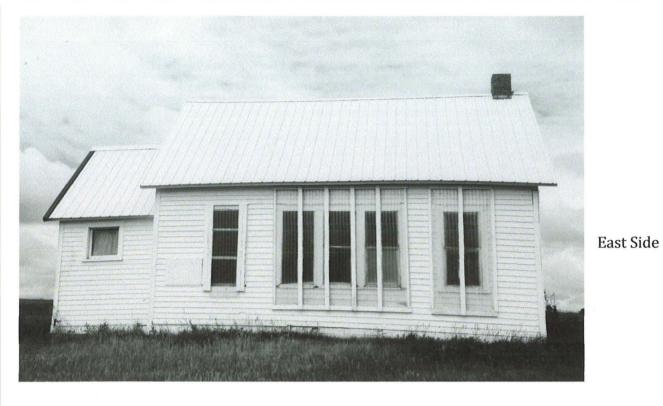
Farmvale School

The feature is a one room prairie school on a foundation of poured concrete. The gable roof of the school is covered with metal sheeting. There is a red brick chimney located at the north end of the peak of the roof. The soffits are closed. The school measures 24 feet north to south and 18 feet east to west with the entry measuring 14 feet east to west and 10 feet north to south.

The siding begins with a wide trim board under the peak end of the roof. The remainder of the siding is 6 inch wood lap with 4 inch corner trim. The paint appears to be very recent. Two concrete steps lead to a concrete platform that gives entry to the school. There is a 5 panel wood door with a covered opening at the top that was likely a transom window. There is one small fixed pane window on the east wall of the entry. The entry walls are finished with wood lap inside. Another wood door with decorative windows across the top gives entry to the school The walls inside the school room are finished with wallboard. The east wall has 5 double hung, one over one, windows with much of the glass remaining and all are covered with translucent plastic on the outside. The window trim is wide boards with a decorative finishing piece at the top of each window. The ceiling of the school room is beadboard covered with ceiling tiles. The ceiling is slanted to the walls on both the east and west sides. The floor is tongue and groove hardwood. There are blackboards on part of the west wall and also the south wall to the entry door. Electricity is present with wires and fixtures apparent.
