NDCRS ARCHITECTURAL SITE FORM PAGE 1

SITS# 32 MN 1427

Project Title & Supervisor:
Country Schoolhouse Project

Manitou School

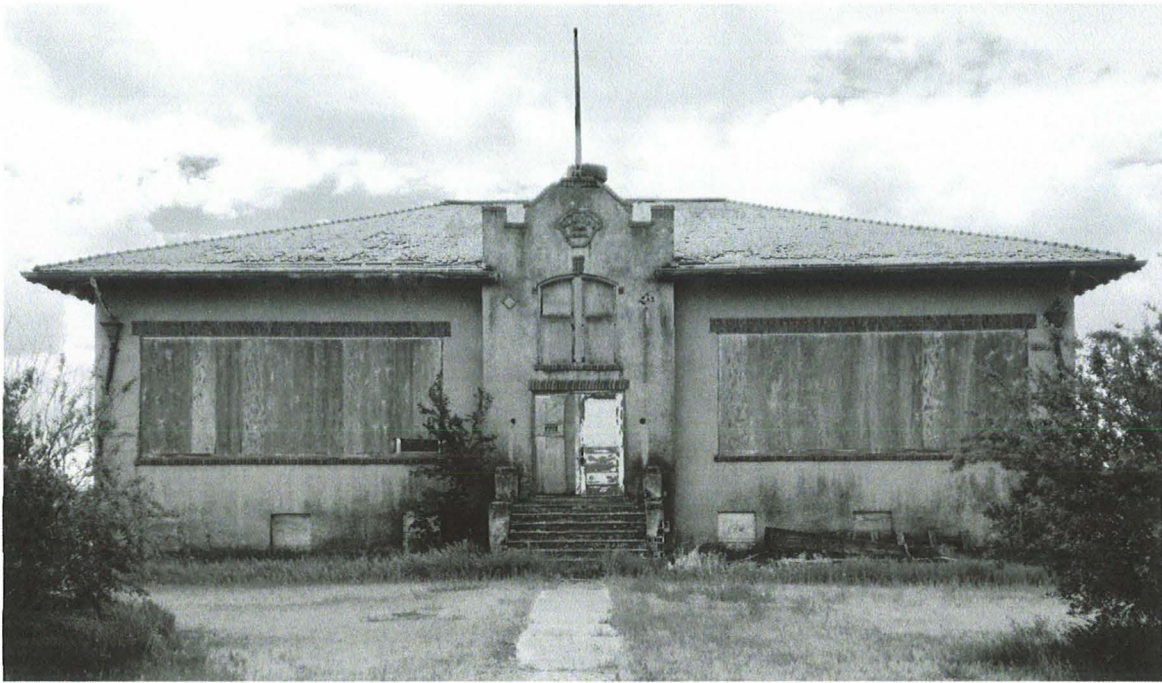
North Side

The siding on this building is wood framing with stucco covering all four sides. On the south side there are two multipane, double hung windows. On both the east and west sides there is a bank of 6 multipane, double hung windows. Most are uncovered and there is some glass missing. The north side has covered windows on both sides of the front entry. The basement has several small windows, three to either side of the main entry, 7 on the east side, four on the west with a small shed/entry built to give access to the basement. The south wall also has a small shed attached to it and there are two more basement windows. There is a flagpole rising above the entry which originally had double door with large, decorative windows above the door. I spoke with a former student of the school and learned that it started out as a one room school with teachers quarters on the main level and the basement has bathrooms for both the girls (northwest corner) and the boys (northeast corner) and included a furnace room, storage and gym down there. The upstairs later consisted of 4 school rooms. Each had blackboards and I could see one of the blackboards on the south wall of the southeast room. The walls are lathe and plaster with a picture rail running about a foot down from the ceiling. Also lathe and plaster ceiling. Light fixtures and wiring indicate electricity was present. There was wainscot on the walls and the floor was tongue and groove oak. The entry led into a coatroom and another door led into the classrooms while stairs either side of the entry led to the basement. The school closed in 1961.
