NDCRS ARCHITECTURAL FORM

Site Name Oakland Township School

## 1. Feature Description, Integrity, Eligibility:

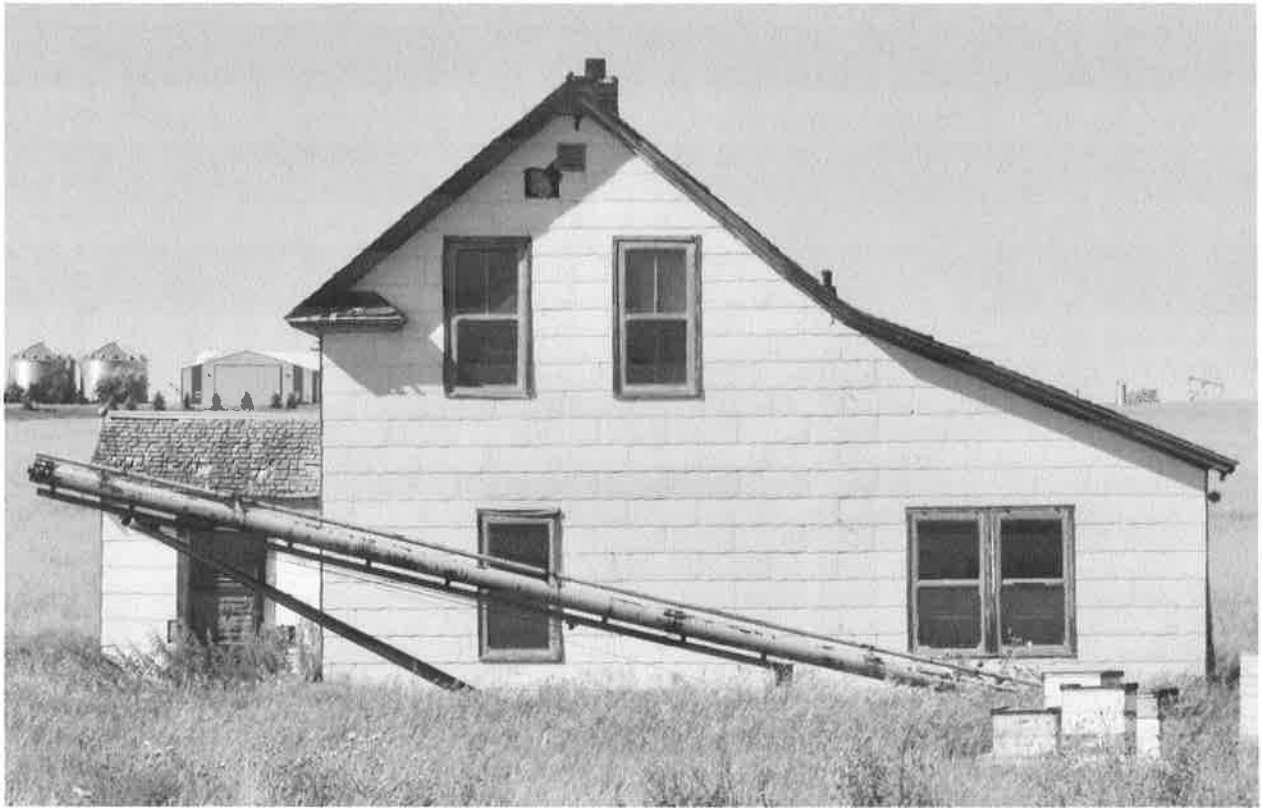
South Side

This feature is noted as a school on the ND DOT maps. It is a house today. The gable roof of the building, as well as the gable roof of the west entry and the shed roof of the newer addition are covered with wood shakes with metal capping and finials at the peaks. The shakes are starting to fall off or blow away. There are cornice returns at the north and south corners at the eaves on the west side of the roof. One of the hints that this was the look of the school roof before the east addition was put on. There is a red brick chimney at the center of the roof peak. There is a metal pipe on the east slope of the roof near the north side. The soffits are closed.

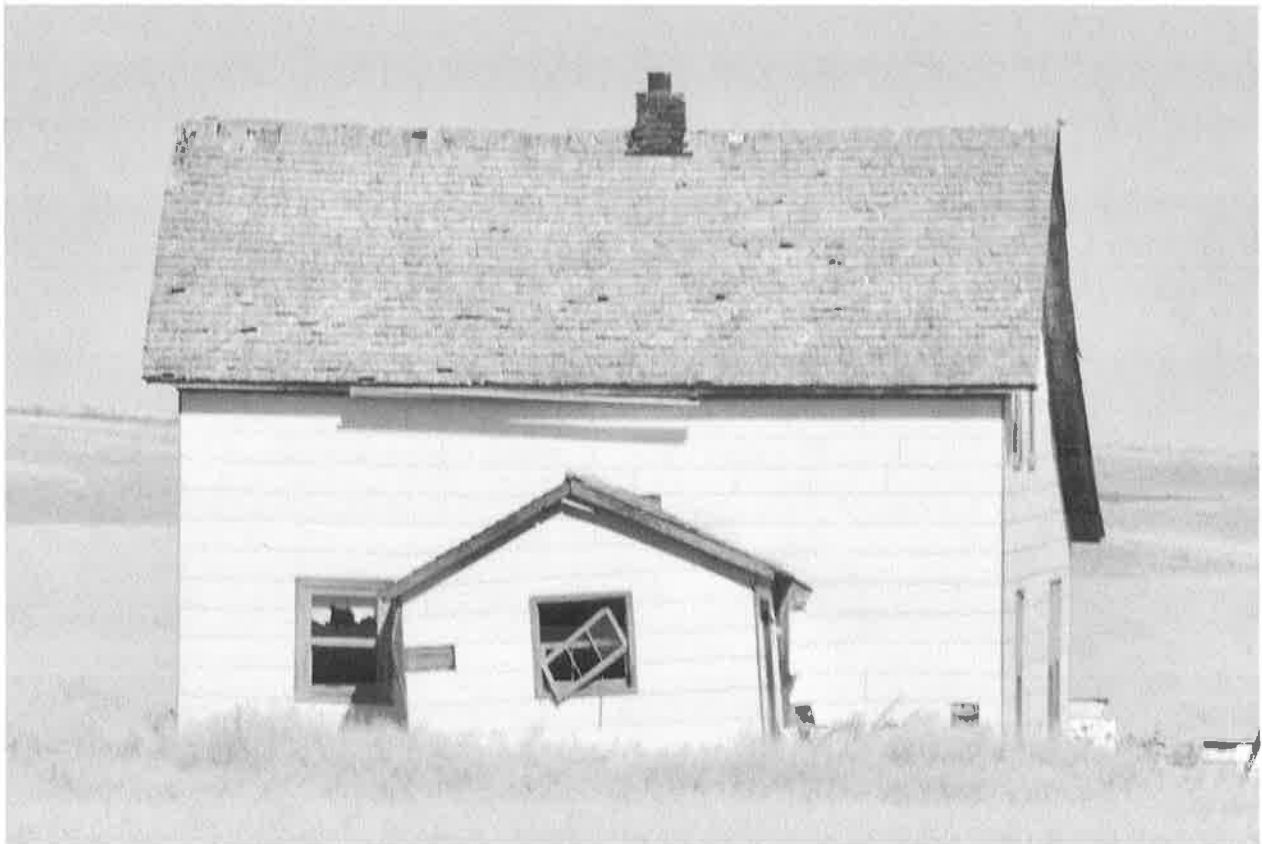
West Side

The siding of this building is cementitious siding. There is a small entry on the west side of the building with a warped wood entry door. A piece of the siding is missing on the west wall and shows 6 inch wood lap siding hidden underneath. A small window opening on the west wall of the entry shows framing and little glass. There are several windows on the east and south walls of the building, all double hung with storm windows. Glass in these windows is mostly intact. Two windows, two over one, are located under the peak on the second floor. There is a single window below the two with a pair of windows located in the addition. Two more windows are located on the east side and are on either side of a wood entry door. No information about the interior. Light fixtures at both doors would indicate electricity.
