## NDCRS ARCHITECTURAL SITE FORM PAGE 1

SITE IDENTIFICATION			
Field Code Gartner Farms School	Site Name		
Map Quad Crown Buffe Creek NW Map Quad	Site Name		<del></del>
LTL TWP138	QQQ	QQ QQ	Q <u>7</u> Q Q
UTMN	ZONE NAD 1927	NAD 1983	Subsection: 1 = N½
City:			2 = E½ 3 = S½
Street Number:			4 = W½ 5 = NE¼
Street Name: 59th Ave			6 = SE1/4 7 = SW1/4
Urban Legal Description:			8 = NW1/4
SITE DATA			
Total # Architectural Features: 1	-		
Fieldwork Date: 8/19/2014			
Reconnaissance Survey <u>✓</u> Intensiv	ve Survey		
Project Title & Supervisor:			
Country Schoolhouse Project			
Report Title & Author(s):			
Additional Information:			***************************************
SHSND USE Area of Significance Ecozone Area of Significance Ecozone	Verified Site Non-Site	CR Type	2
Recorded By Kathy Wilner	Date R	ecorded	1/23/2015

Gartner Farms School 8-19-2014 Kathy Wilner MO

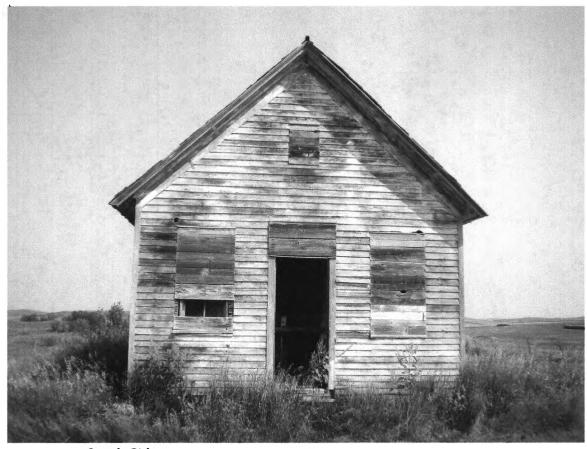
South Side

All the windows on the west side of the school are covered with wood, looking from the inside of the building I see all the glass is gone and little framing remains. Windows on the south are mostly covered but once inside the school I see that the window frames as well as some of the glass remains. There was a transom above the door which is now covered with wood. There is no porch. The entry, with door missing, leads into the school and there is a small coat room to the right, another small room to the left. Walls in the entry and main body of the school are all lathe and plaster with much of the plaster falling in. There is wainscoating in the main body of the school. The blackboards used to hang on the north wall. There is also evidence of the location of the stove on the north wall with a chimney extending from the floor to the ceiling. The ceiling is high with curved side above the windows as well as on the opposite wall. Most of the plaster in the ceiling has fallen in. Holes in the roof allow a lot of daylight and weather in. The floor is tongue and groove.
