NDCRS ARCHITECTURAL SITE FORM PAGE 1

SITE IDENTIFICATION			
Field Code Square Butte #5	Site Name Squ	uare Butte #5	
Map Quad Swut Brian Map Quad	Site Name - -		
LTL TWP139	QQQ _ QQQ _	QQ QQ	Q 6 Q Q
UTMN	ZONE NAD 1	927 NAD 1983 _	
City:		-	2 = E½ 3 = S½
Street Number: 3307			4 = W½ 5 = NE¼
Street Name: County Road 139A		·	6 = SE¼ 7 = SW¼
Urban Legal Description:			8 = NW1/4
SITE DATA			
Total # Architectural Features: 1	all-recognision		
Fieldwork Date: 8/9/2014			
Reconnaissance Survey Intens	ive Survey		
Project Title & Supervisor:			
Country Schoolhouse Project			
Report Title & Author(s):			
Additional Information:			
SHSND USE Area of Significance Ecozone Ecozone Area of Significance	Verified Site Non-Site	CR Ty	/pe
Recorded By Kathy Wilne	er	Date Recorded	1/23/2015
(First Name & Last Name)			(mm/ad/vest)

Square Butte #5

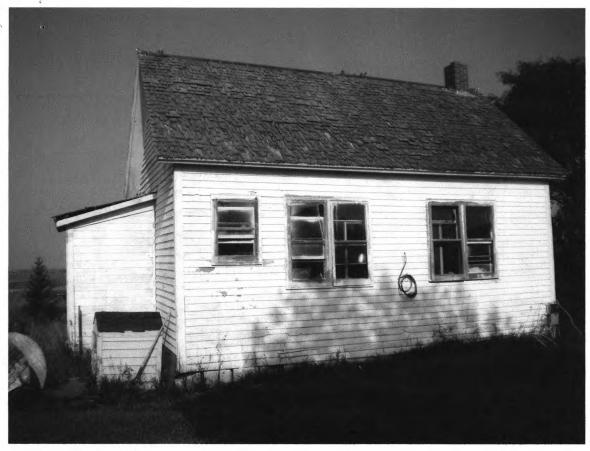
East Side

The siding of the school is 6 inch wood lap with 4 inch wood corner trim boards. There are two pairs of double hung windows and one smaller window on the east side of the school. The windows have intact glass and they also have a storm window for cover. The school sits on concrete blocks. Inside the entry porch three walls and ceiling are all bead board with the school building wall the same lap siding as the remainder of the school. It looks like the entry, 8 1/2 feet by 5 feet, was tacked on at a later date. The bottom panel of the door is missing.

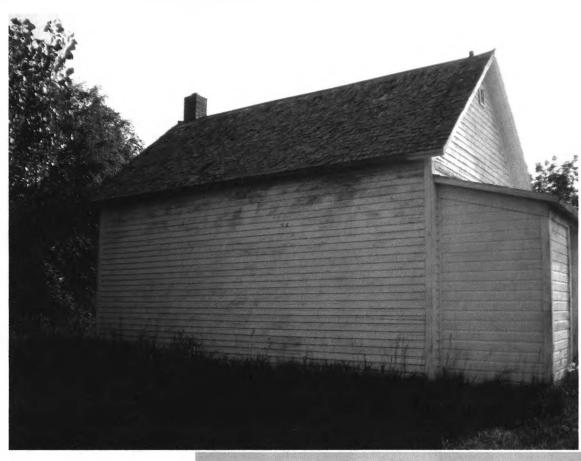
West Side

Inside the school the black board remains on the west wall. The walls themselves are lathe and plaster with some type of wall board on the ceiling. There is no stove in the building but the chimney and stove pipe hole are present on the north wall. The floors are wood tongue and groove.
