NDCRS ARCHITECTURAL SITE FORM
PAGE 2—Feature Data

NORTH DAKOTA CULTURAL RESOURCES SURVEY

Base Data Form

1. County McKenzie 2. Site Number 32MZ445
3. Site Name (s) _____
4. Type of Resource: A. Archaeological Historical Architectural Paleontological
B. District Site Building Structure Object _____
5. Map Reference: U.S.G.S. Sather Lake, 7.5' Quad. (1972)
6. Location: NW $\frac{1}{2}$, NW $\frac{1}{2}$, NW $\frac{1}{2}$ Sec. 16 T. 48 N / R. 103 W
Plat: _____ Block _____ Lot _____
UTMG: A. _____ B. _____
C. _____ D. _____
7. Access: Travel south of Highway 68 for 2 miles and west along the section line road about 0.6 mile to the building.

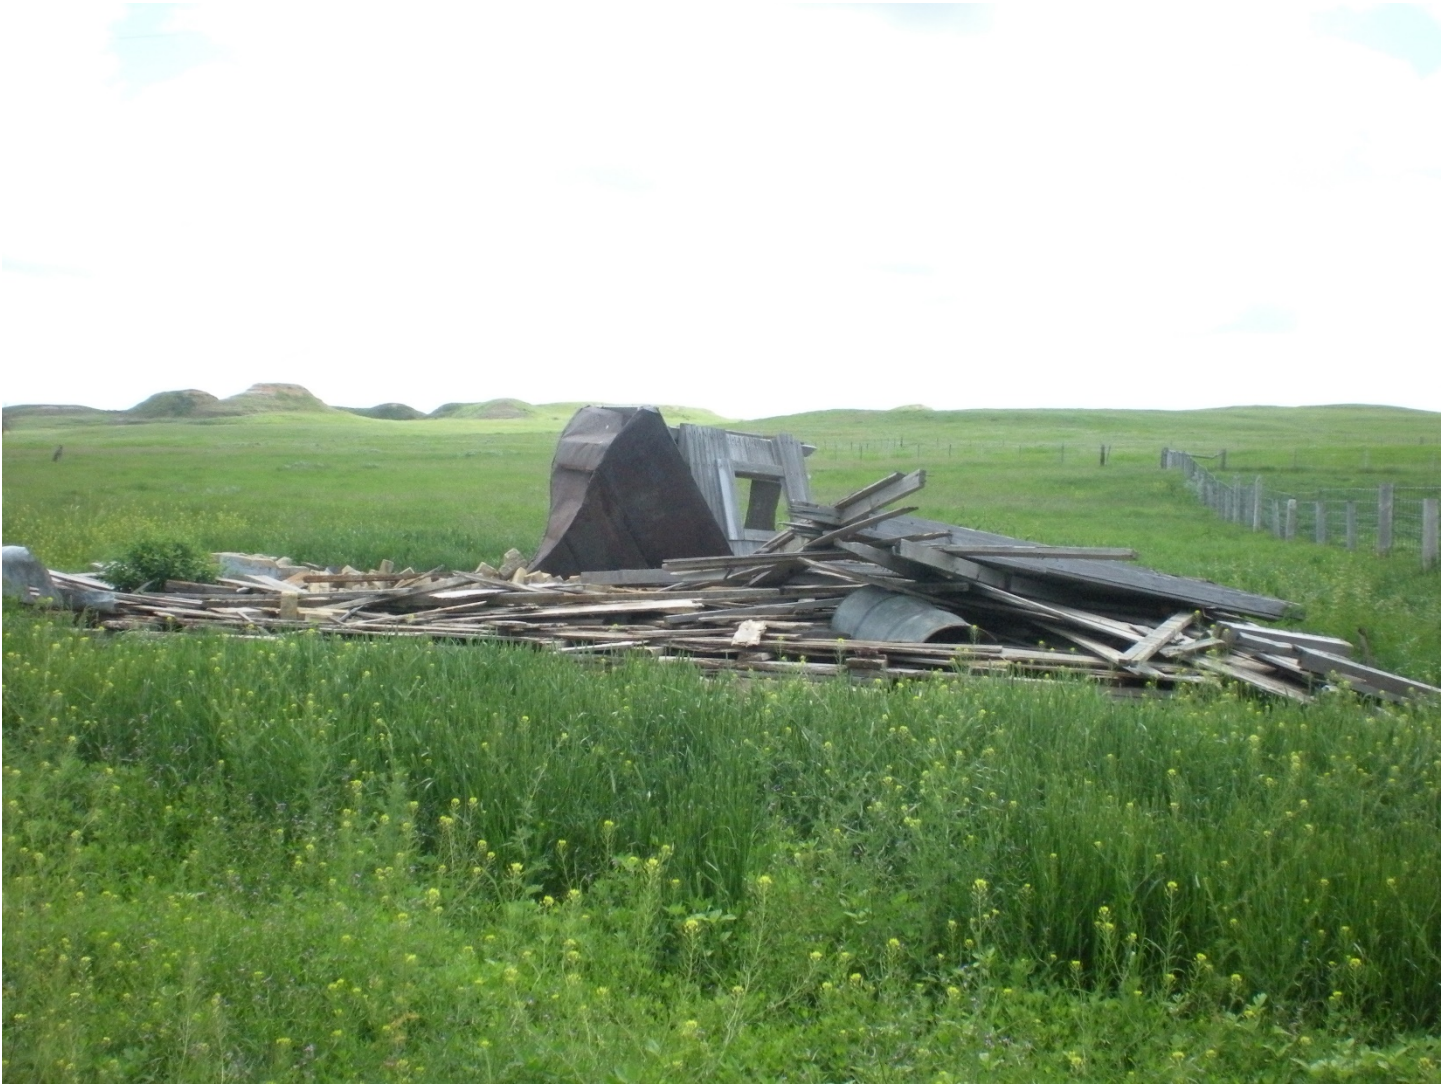
Photo taken summer 2010 by SHSND intern Alicia Liebel

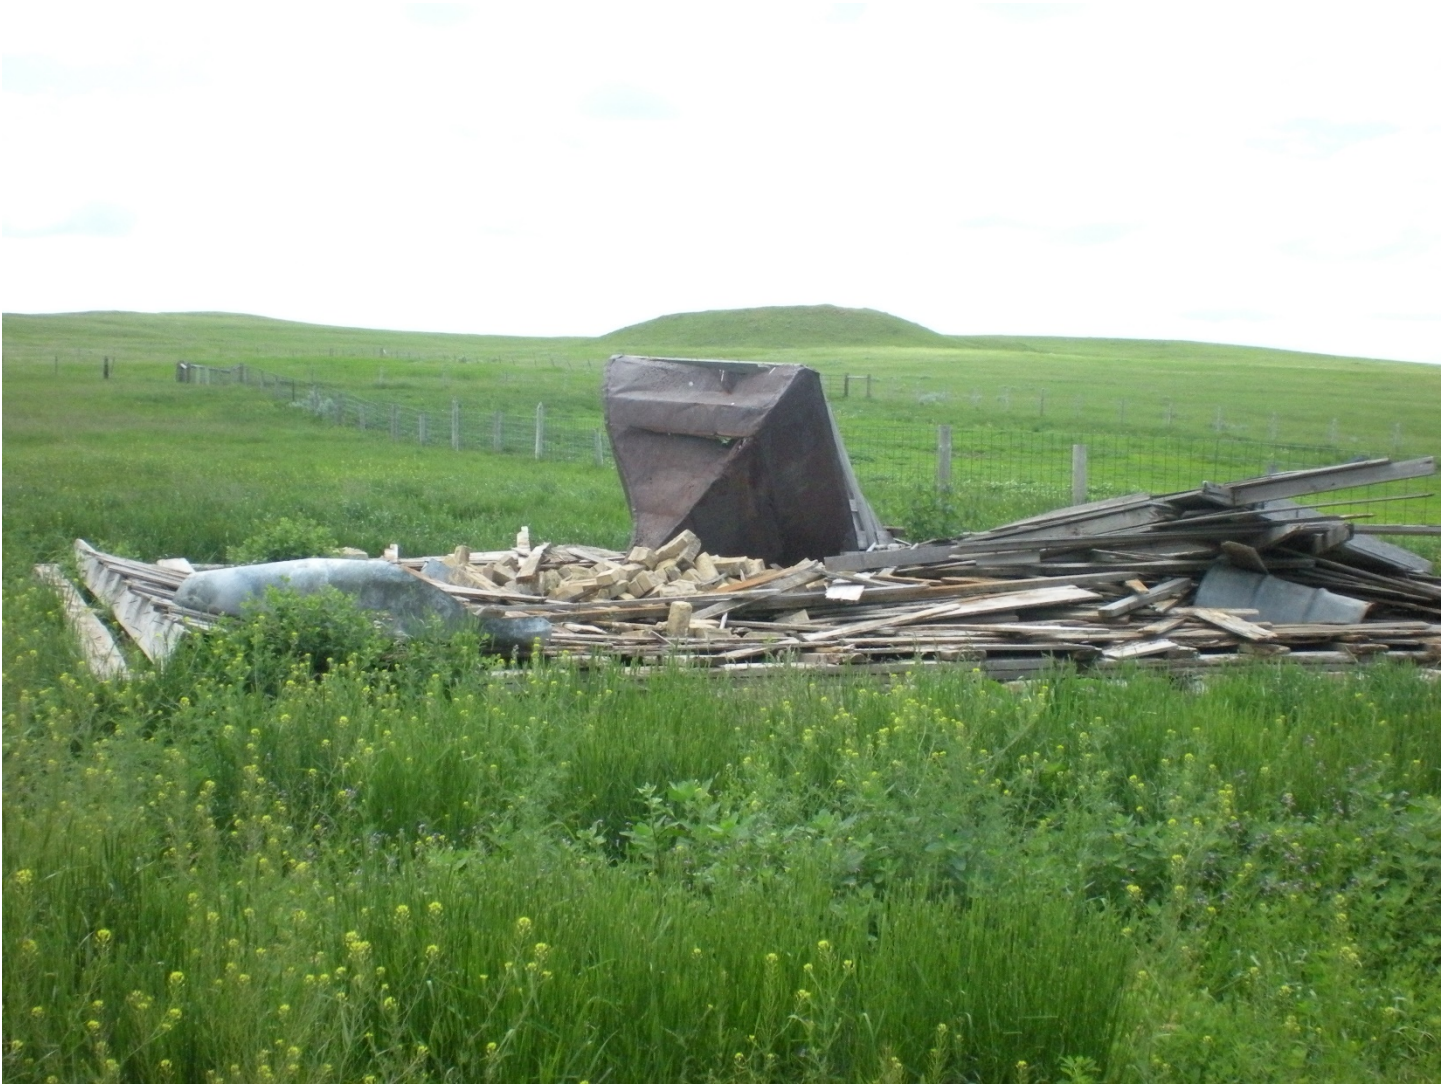
Photo taken summer 2010 by SHSND intern Alicia Liebel

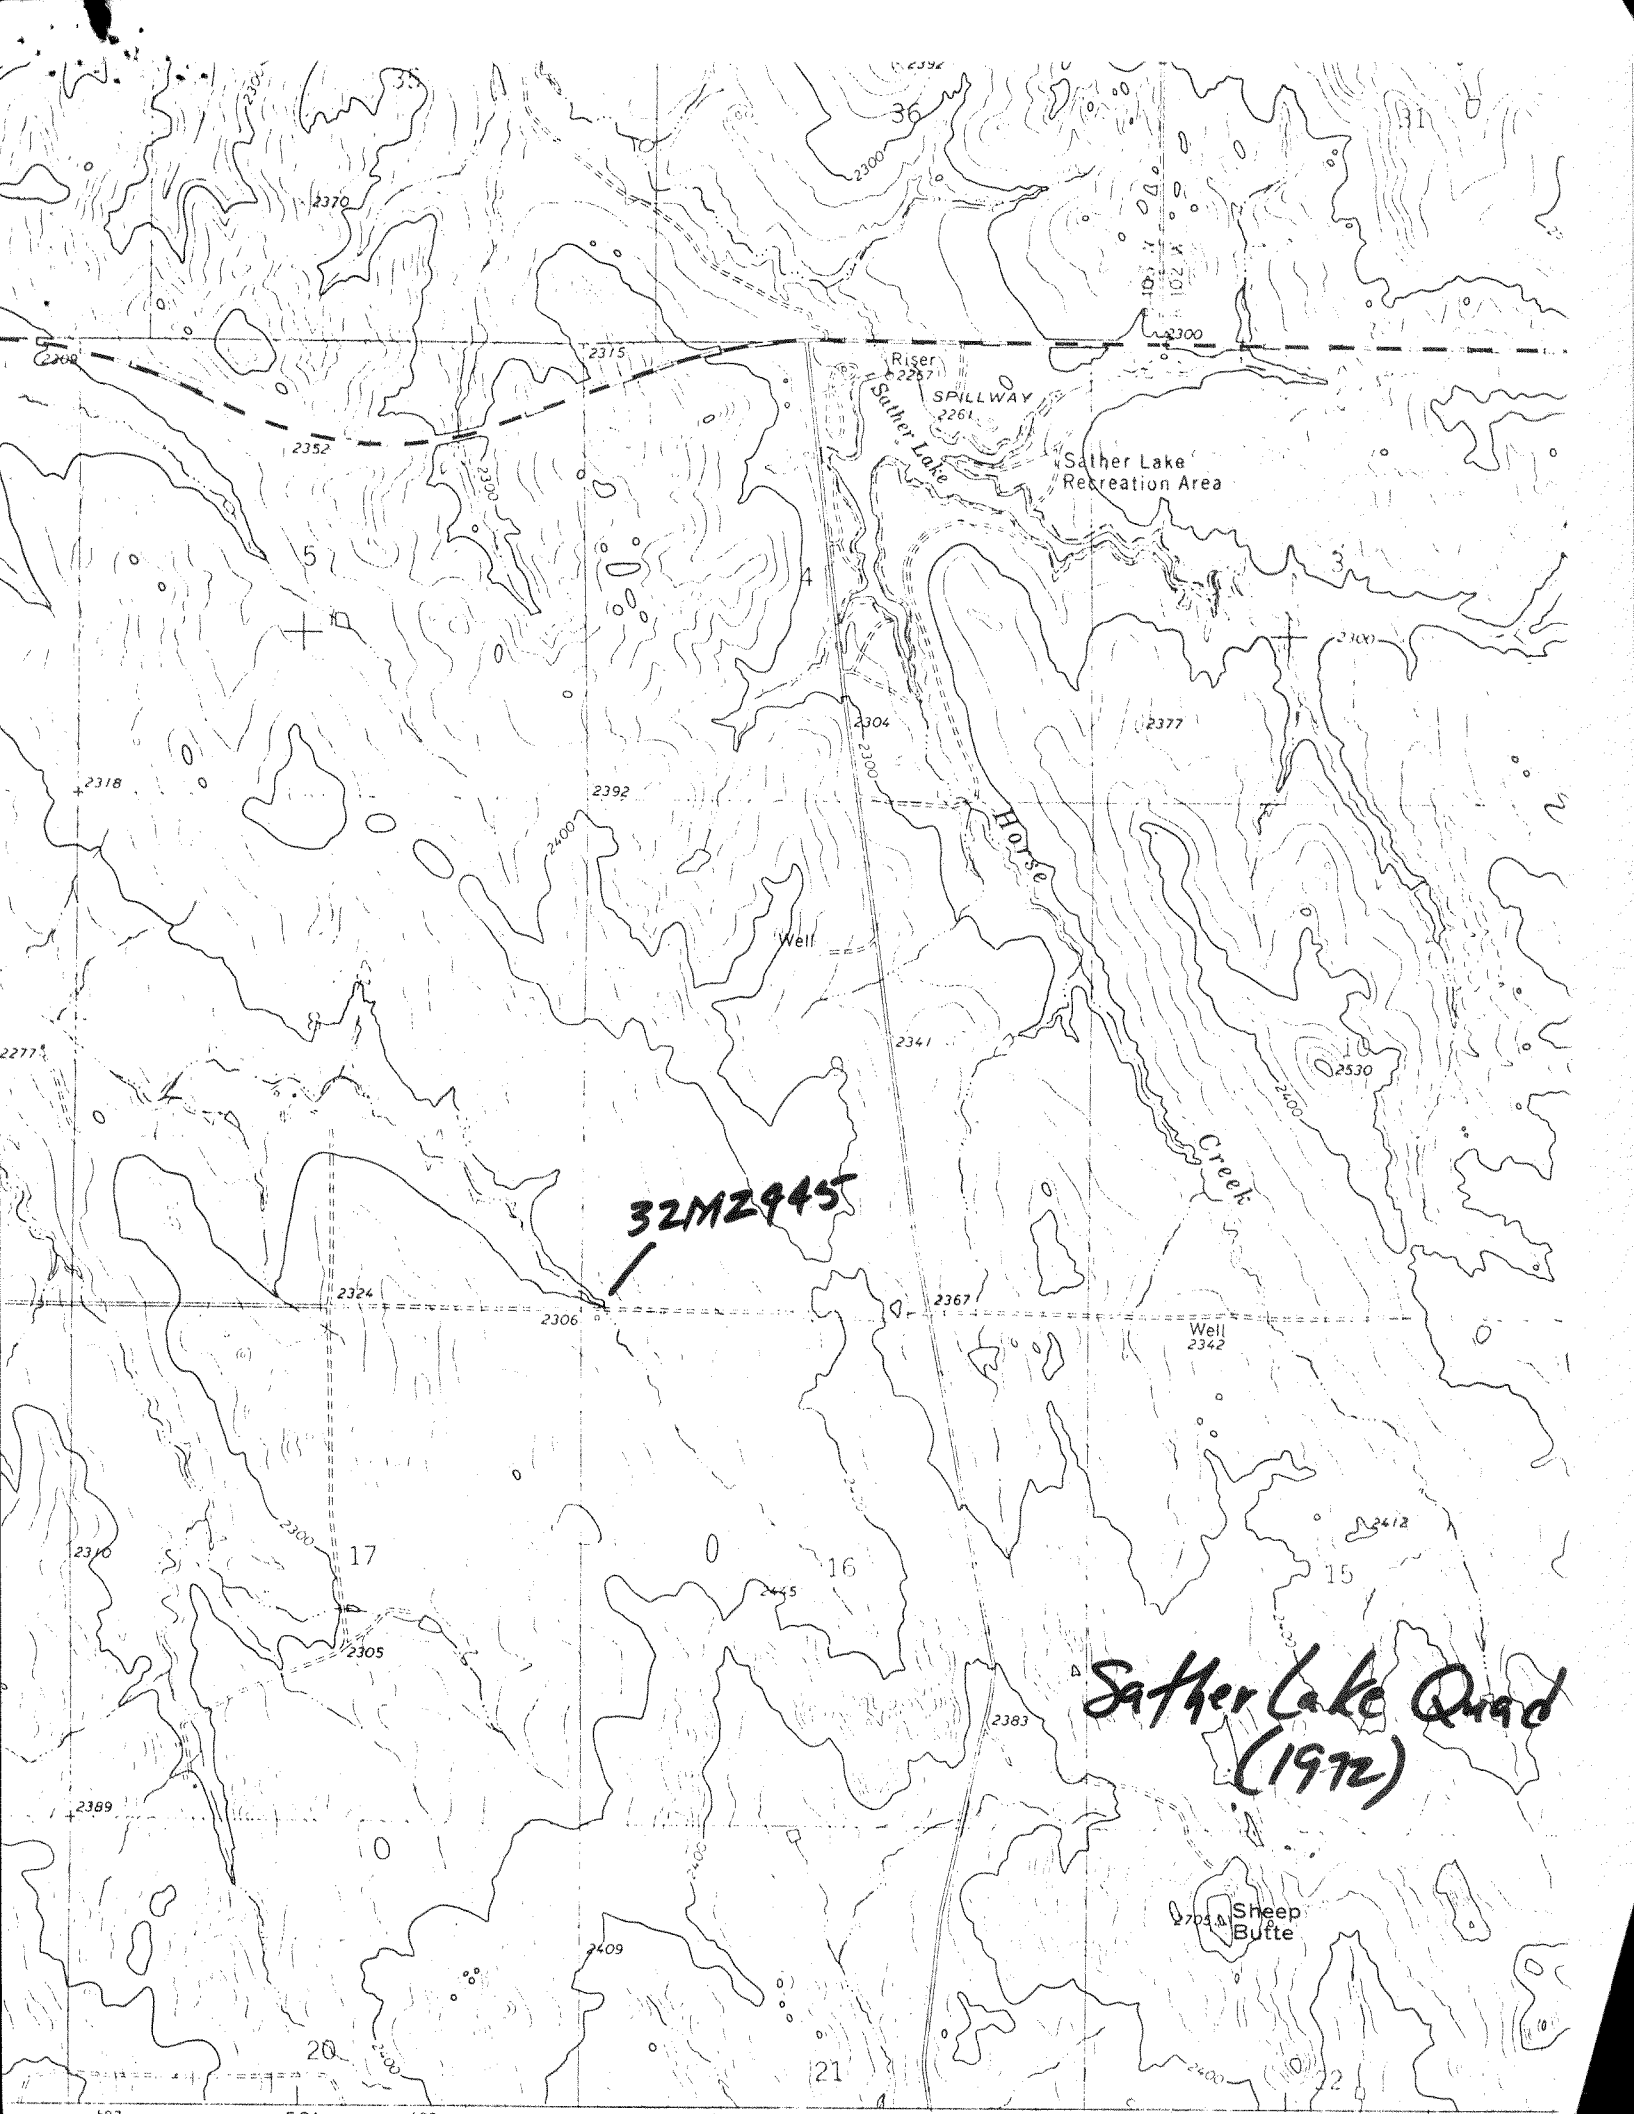
Building is still standing and in good condition. Roof is peaked about 20 feet high. Building is 25' X 15' and sitting on a rock - mortar foundation.

North side has 5, 3' X 5' windows. South and east sides have no windows. Door and two side windows on west side. Door is 3' X 8' with two small 1 $\frac{1}{2}$ ' X 1' windows over it. Door is gone - frame remains. Two windows are 2' X 2'.

Chimney and wood burning potbelly stove to the south of center near the east wall. Chimney center of east wall.

All construction frame - floor is frame. Ceiling gone - once at 10'. The bell tower is still on west side. Frame and tin square temple type top. Flat post still off the top.
