NDCRS ARCHITECTURAL FORM  
PAGE 1

Site Name Clear Creek Township School

Clear Creek Township School

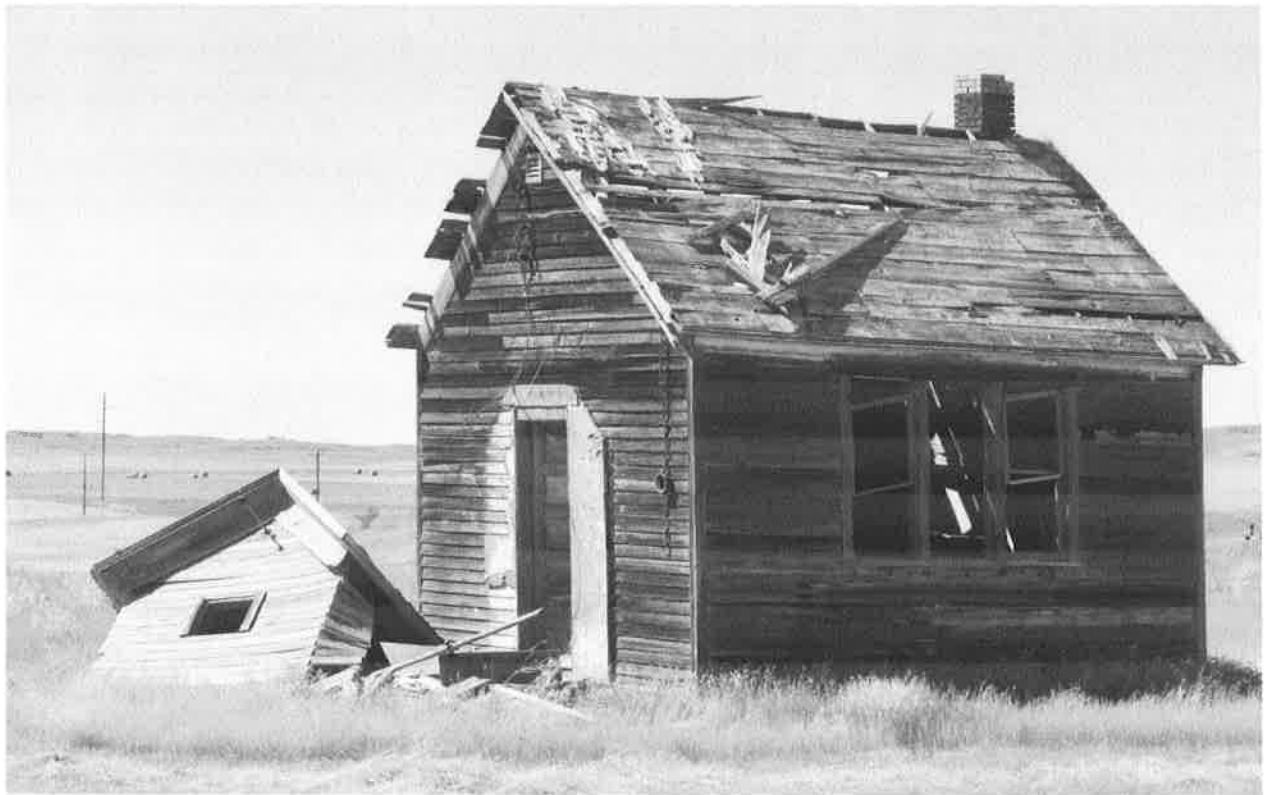
South Side

The siding is 6 inch wood lap with 6 inch wood corner trim. The siding is beginning to fall away from the school. The entry collapsed and is in a pile at the south side of the school. There is a 5 panel wood door on the south side of the school. The east wall has three double hung window openings with very little framing and no glass. The walls look to be lathe and plaster. The ceiling has collapsed. There are blackboards painted green along the entire west and north walls. Wiring on the south side of the school would indicate electricity at some point.
