NDCRS ARCHITECTURAL FORM

Field Code Charbonneau School

Site Name Charbonneau School

**NDCRS ARCHITECTURAL SITE FORM
PAGE 1**

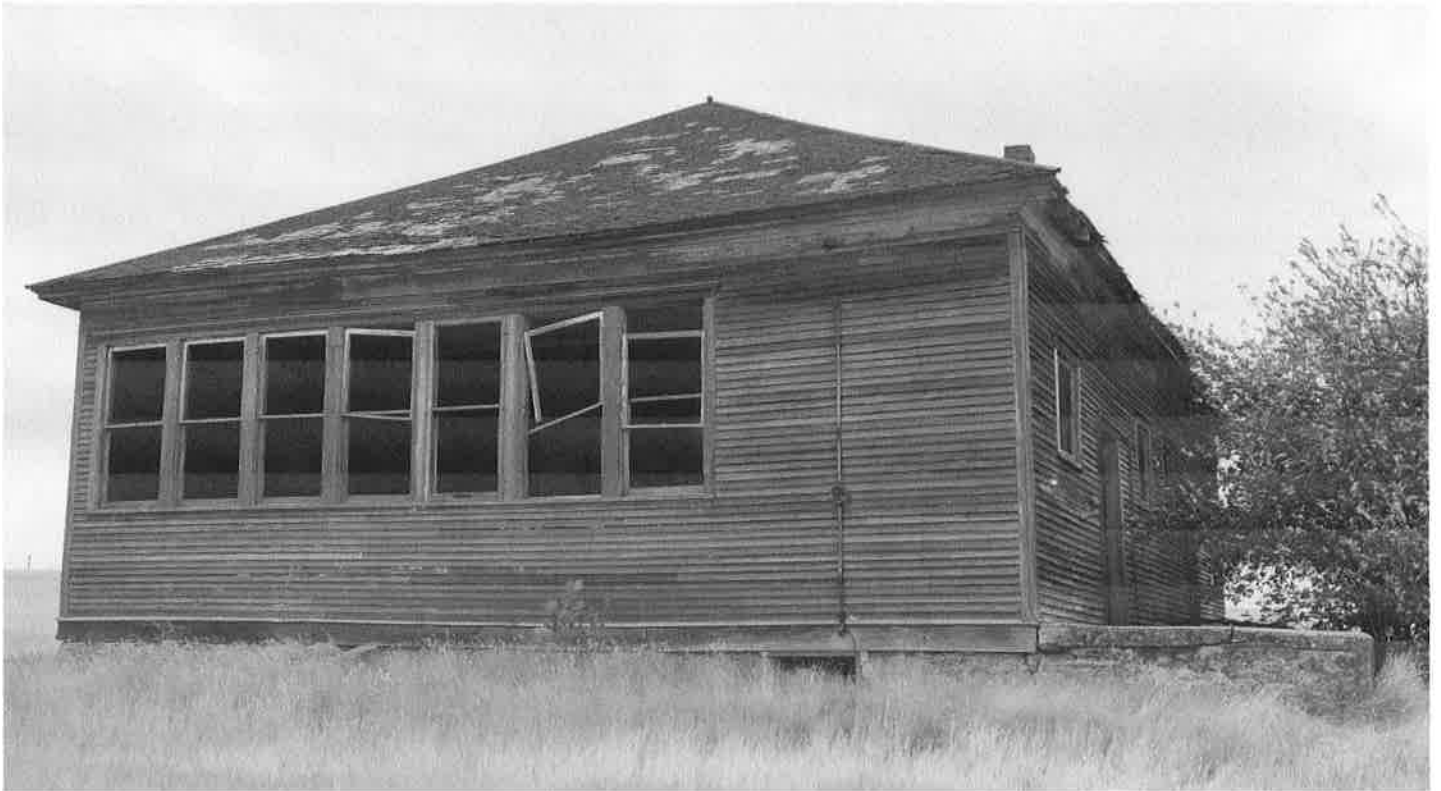
North Side

The feature is a large, two room prairie school on a poured concrete basement. The school served the small village of Charbonneau. The hip roof of the school has remnants of both asphalt shingles and wood shakes with horizontal slats visible. Metal capping with finials can be seen at the peak of the roof with remnants on the ribs of the roof. There are holes in the roof. The soffits were closed at construction but today much of that is failing. There is a red brick chimney at the south end of the west slope. The building measures 36 feet east to west and 45 feet north to south.

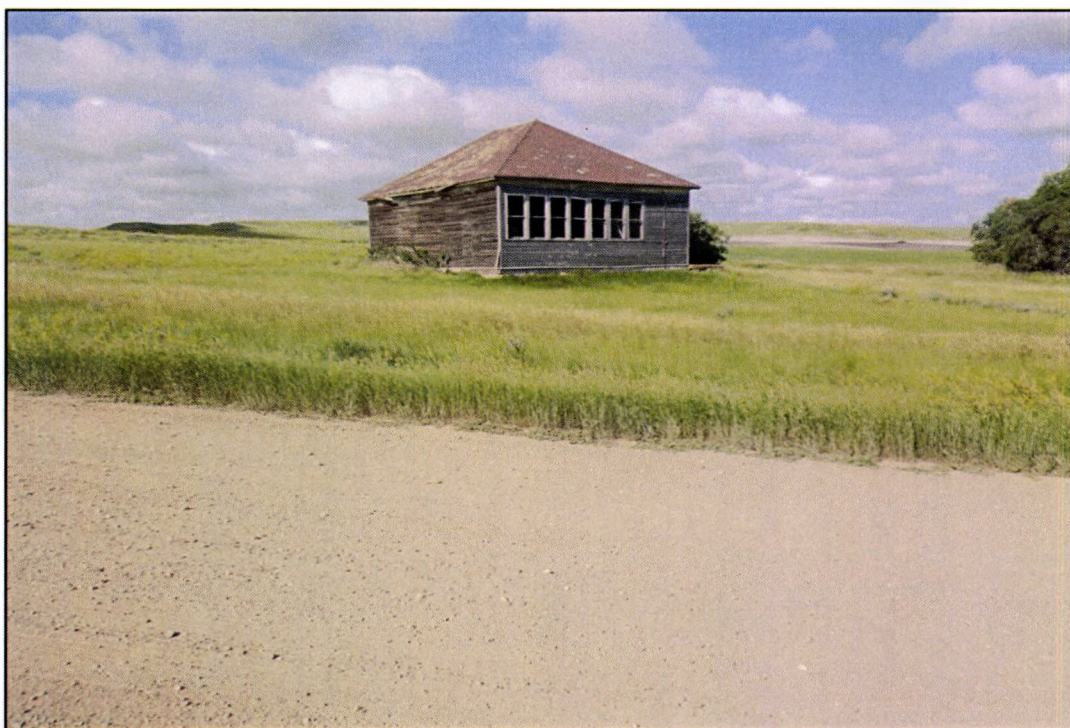
Feature 14 is located at the southern boundary of the town of Charbonneau. It is 40' x 50' with a hipped roof and vertical wood siding. It is highly weathered but paint remnants suggest it was white. It has a row of seven windows on the northeast wall and a chimney on the northwest side. Its location and layout suggest it was not residential and may have been a schoolhouse, town-hall or some other type of public meeting place. Due to the deteriorated condition which is a result of neglect, this structure has lost most of its historic integrity and should be considered non-contributing to the town site of Charbonneau and not eligible for the National Register of Historic Places.

View of feature 14 facing southwest. A. Behan 07/14/2014.

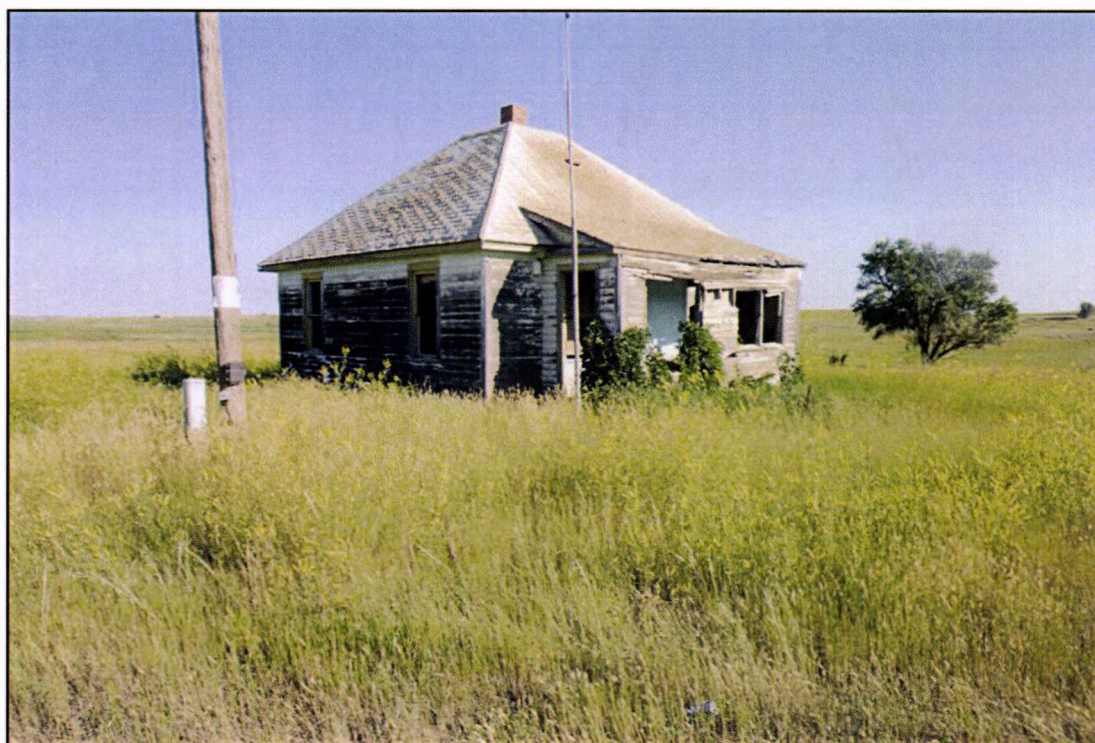
View facing west of feature 15. A. Behan 07/14/2014.

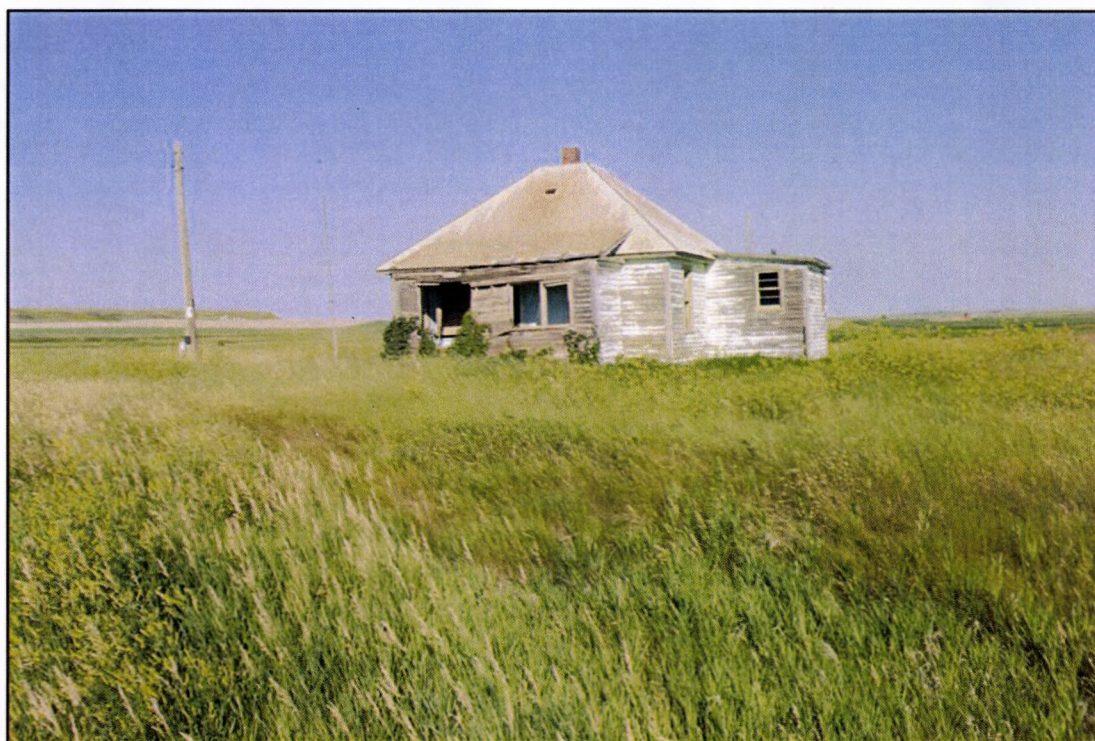
View facing southwest of feature 15. A. Behan 07/14/2014.
