NDCRS ARCHITECTURAL SITE FORM PAGE 1

Project Title & Supervisor:
Project Title: Basin Electric- North Killdeer Loop
Supervisor: Emily Sakariassen

Report Title & Author(s):
Report Title: Visual and Historic Sensitivity Analysis for Proposed North Killdeer Loop (NKL) Transmission Project
Author: Emily Sakariassen

Additional Information: Site lead: One schoolhouse, one trailer, and one historic house.

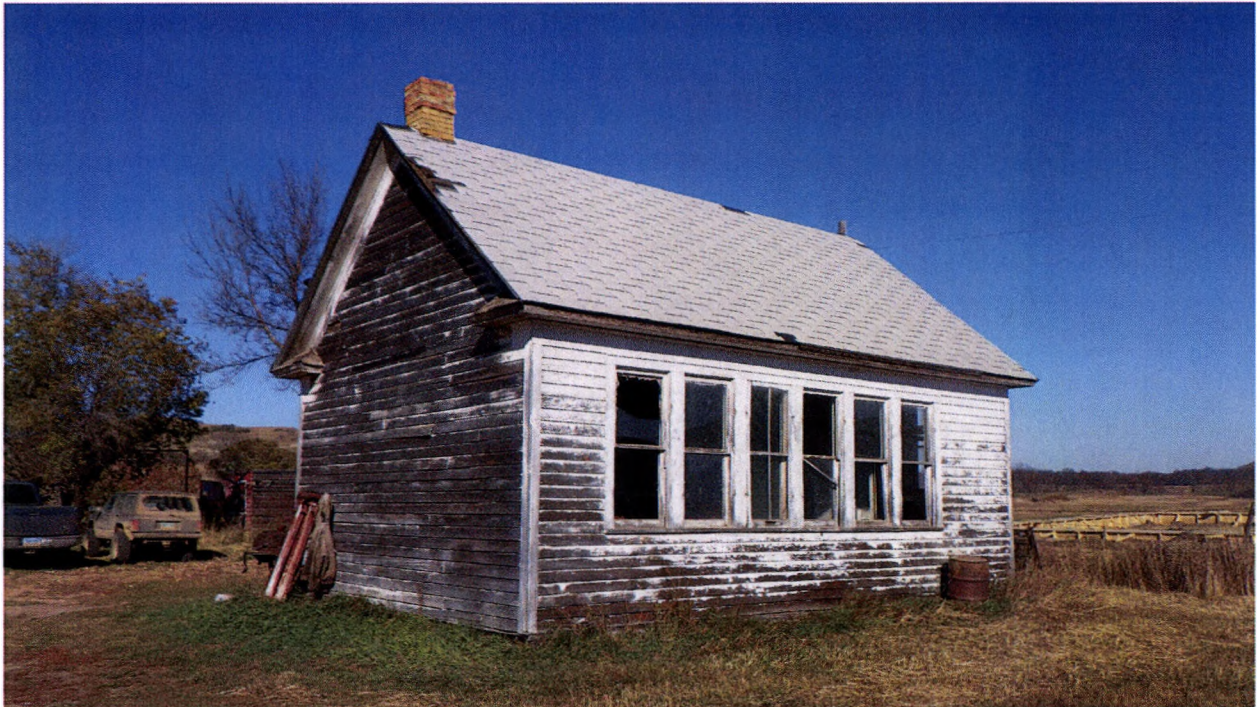
Figure 1: Site MAC-NKL-60x, Feature 1, view northeast (Image 5719).

DESCRIPTION: Feature 1 is a one-room schoolhouse. It has horizontal wood clapboard siding, originally painted white, though the paint has mostly faded. The structure has a front-gabled roof with cornice returns, and interlocking gray asphalt shingles. There is a brick chimney located at the west end of the roof. Part of the cornice is missing on the south facade. A bank of six double-hung windows is located on the south facade. Glass is missing in most windows, leaving only two extant, while a two-over-two storm window is present over one of the center windows. The primary entrance, located on the east facade, is a wooden door with a two-light transom above. One large single-hung window, missing its top pane, is located south of this door. Another opening, north of the door, has been boarded up. A rusted louvered vent is located beneath the roof apex on this facade. Electrical hook-ups are present on the east facade. No fenestration is present on the north facade. Original wood shingles are still present on the north half of the roof, while the south half has asphalt shingles. No fenestration is present on the west facade. The wood siding is coming off on this facade, and the paint is almost completely faded. Wood shingles are still present on the eave returns on the west facade. The lathe is exposed on the interior of the structure, and tongue-and-groove wainscotting is visible.

INTEGRITY: Feature 1 is in fair condition, and retains integrity of design, workmanship, and feeling. Integrity of location and setting are lost due to the fact that the structure was moved here from its original location. Integrity of materials is reduced by the loss of and boarding up of windows, loss of shingles, and the structure's general deterioration.

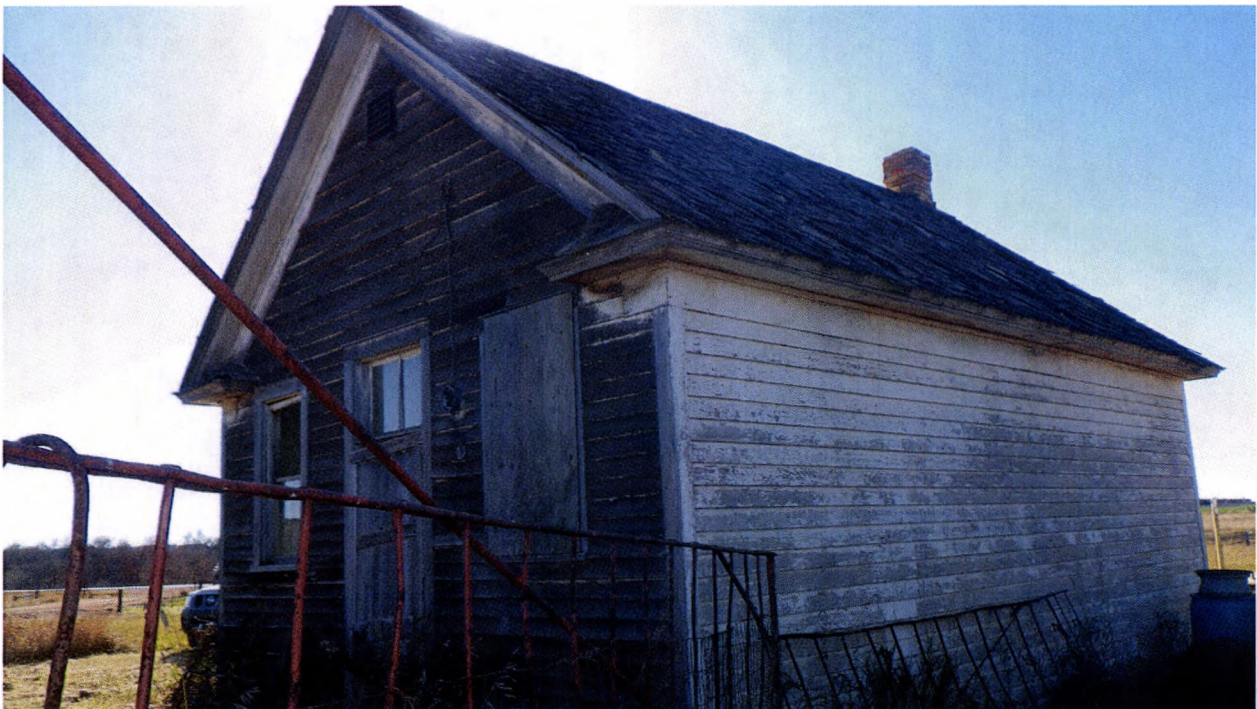
Figure 2: Site MAC-NKL-60x, Feature 1, view southwest (Image 5728).
