NDCRS ARCHITECTURAL SITE FORM
PAGE 1

Field Code Melrose #4 Site Name Melrose #4

Project Title & Supervisor:
Country Schoolhouse Project

Field Code Melrose #4SITS# 32 NE**Complete one Page 2 for each architectural feature at the site.**Architectural Feature # 1Construction Date 1907Feature Type 9Condition 7Feature Date 3Context 7Plan Shape 5Structural System 25Primary Exterior 26Style Other Style

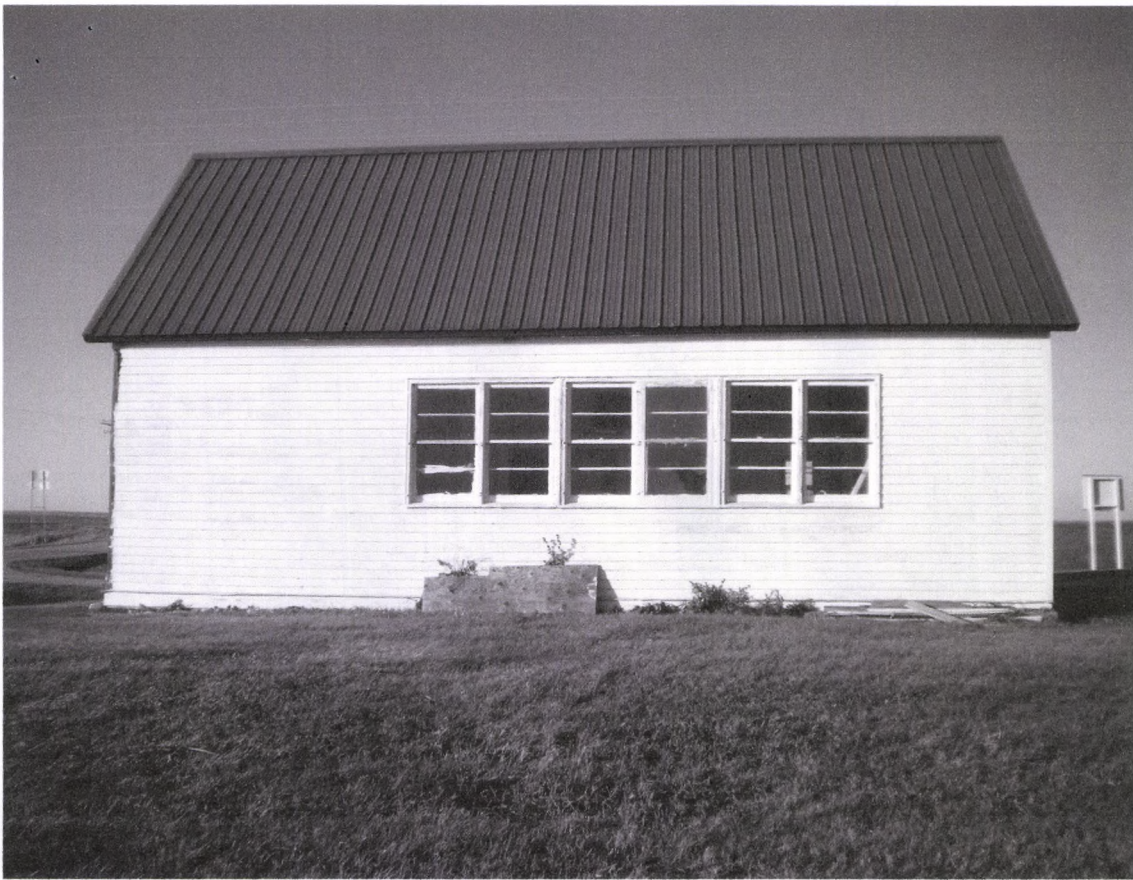
South Side

There is a wide header located under the eaves at either peaked end of the school. On both the east and west ends there are vents near the peak. The siding is wood lap with 4 inch wood corner trim with great paint. There is a new entry door at the east end of the school, top half has windows. Also on the east end are two double hung windows. These are a newer style. There is a bank of 6 wide, double hung windows on the south side. One more window is located on the north side.
