NDCRS ARCHITECTURAL SITE FORM PAGE 2—Feature Data			
Field Code Wamduska #1		SITS# 32_NE	
Complete one Page 2 for each	architectural <u>feature</u> at th	e site.	
Architectural Feature #1			
Construction Date 1888	Feature Type <u>9</u>	Condition 7	
Feature Date 2	Context 7	Plan Shape <u>5</u>	
Structural System 25	Primary Exterior <u>26</u>	Style <u>Other Style</u>	
Original Owner's Ethnicity	Secondary Exterior	Architect/Builder	
Other Information:			
Foundation Railroad ties		Stories <u>1</u>	
Roof/Cornice			
Window 2 pane double hung, with shutt	ers		
Dating Method(s): School records			
Feature Preservation Recommend	ation(s) (Check all that ann	Iv).	
Individual nomination		<i></i>	
Contributes to a potential district			
No nomination potential			
Will not contribute to a district			
Potential district—feature would be a contributing element if other properties constitute a district			
Thematic nomination potential

### NDCRS ARCHITECTURAL SITE FORM PAGE 3—Feature Data

Field Code Wamduska #1

### NDCRS ARCHITECTURAL SITE FORM PAGE 4—SITE DESCRIPTION

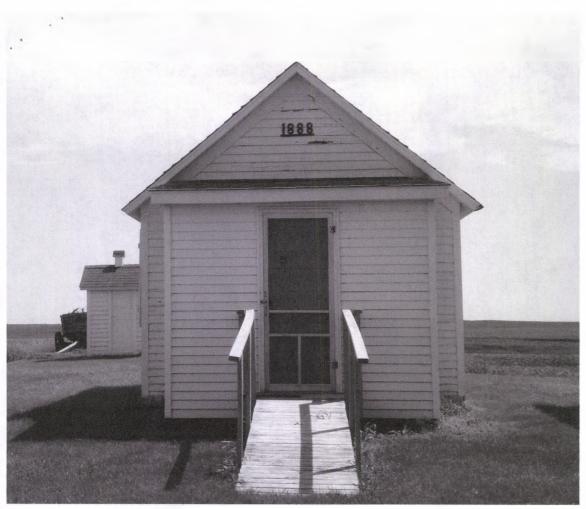
North Side

The exterior of the main body has 6 inch wood lap with 4 inch wood corner trim. The entry is new construction and is covered with finyl siding. The entry has a shed roof. There are two double pane, double hung windows on the north and two on the soudh, they all have shutters to the right side of the window for protection in the winter. The entry has two sets of three pane windows on the north and south. The door is a modern, solid core door with a screen door. The entry is reached by a ramp for easy access for viewing by all. The walls and ceiling in the main body of the school are covered with wainscoating. The go up to 8 feet and then slope up to the ceiling. The walls and ceiling of the entry are sheet rock. The maple tongue and groove floor was badly damaged by water so they took it all out, straightened it and put it back in on new joists and subfloor. The black boards would have been on the south wall, there is one on the north half at this time. It is decorated inside with township hall items on the east side and one room school decor on the west half.

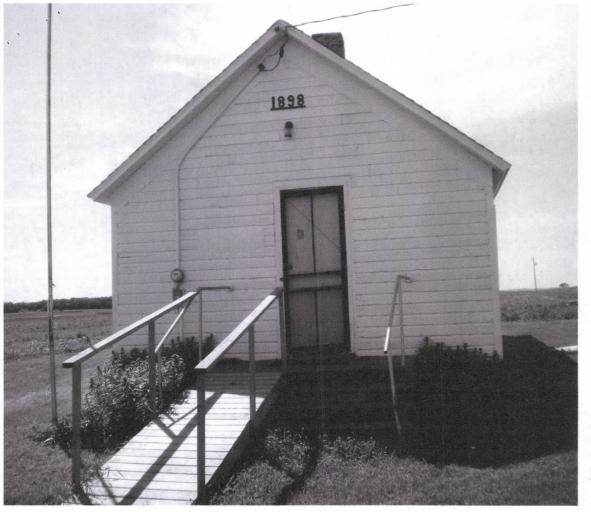
East Side

There is an 8 inch header under the eaves of the east side of the entry and the west side of the school. Siding is 6 inch wood lap with 4 inch wood corner trim. This school was in pretty good shape when it was restored. There are two pane, double hung windows on both the north and south side of the school. The north side has two windows and the south side as two sets of two windows. All have shutters that are open during the summer. There are also windows in the entry, one double hung on the north and another ont he south. There is a solid core, security door at the entry which is reached by concrete steps or a ramp. A screen door is also present. There is a metal post railing on both sides of the concrete step. Electric wires and a meter are on the east entry wall.

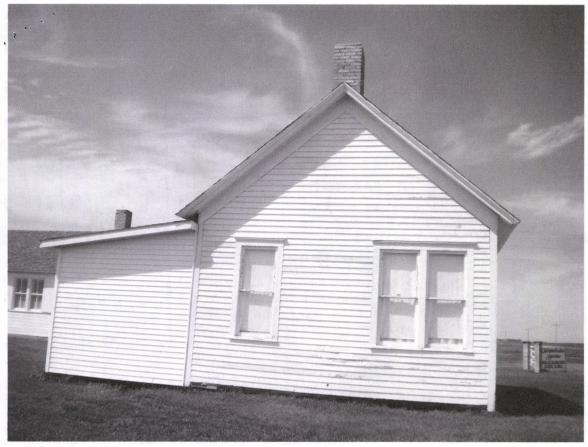
South Side

The main body of the school has a 8 inch header under the eaves at either end. Siding on the main body of the school is 6 inch wood lap with 4 inch wood corner trim. The entry and west addition have 6 inch lap vinyl siding with vinyl corner trim. The interior of the school was gutted after it was moved and the walls and ceiling in all parts are sheet rock. This school has 10 foot ceilings with a fixed pane glass window over the entry door to the main body of the school. This is original to the school. There are also double hung windows on the east and and south sides, 5 on the east wall and three on the south. Lots of light inside the school. The floor in the school is maple tongue and groove. There are lights in the school and the addition, all wiring and etc. done at the time of refurbishing. Black boards were on the west wall. This building houses more museum artifacts as well as desks and other school items.
