NDCRS ARCHITECTURAL FORM PAGE 1

Field Code Forde #3	_	SITS# 32 ^{NE}	437
Map Quad Binford NW Map Quad	Site Name Fo	orde #3	
LTL TN., R61W., Sec20	QQQ of the QQ QQQ of the QQ	of the Q of the Q	1 = N½ 2 = E½
NAD <u>20221983</u> UTM 5284193 NAD <u>20221983</u> UTM 537935 City: Street Number:	_Zone <u>14N</u>	oi trie u	3 = 5½ 4 = W½ 5 = NE¼ 6 = SE¼ 7 = SW¼ 8 = NW¼
Street Name: 98th Ave NE	-		
Urban Legal Description;			
Total Number of Architectural Features:	1		
Fieldwork Date:10/30/2022			
Reconnaissance Survey	Intensive Survey		
Project & Principal Investigator: Country School House Project Kathy Wilner 366 43rd Ave SE Bowdon ND 58418			
Contracting Firm or Agency Completing the Fo	orm:		
Additional Information:			
SHSND USE Component Study Unit17 Component Component	Verified Site	CR Type	2
Recorded By: Kathy Wilner	Date	Recorded: 11/	05/2022

This feature is a one room school moved to the farm for storage. It is sitting on the ground, no foundation. The gable roof is covered with metal sheeting. The chimney is gone. The soffits are closed. The school measures 34 feet north to south and 20 feet east to west.

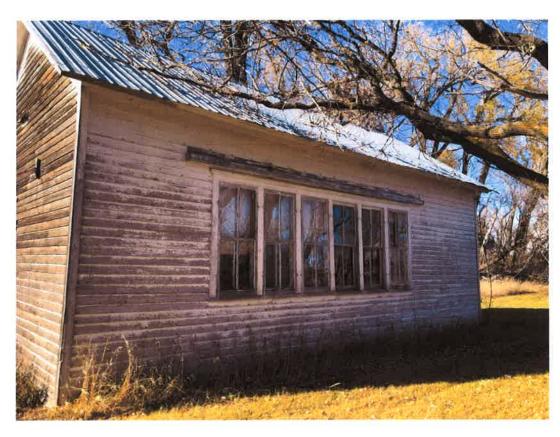
East Side

The siding begins with a rake board under the peak roofed ends. The remainder of the siding is 6 inch wood lap with 6 inch corner trim. There is a 5 panel wood door on the north wall giving entry to the school. Inside the door is an entry with 5 panel wood doors leading into the school proper located at both the east and west ends. Coat hooks are seen on the entry wall. A double hung window is located on each side of the entry door. A bank of 6 double hung windows, with glass intact, are located on the east wall. 4 of the six windows have storm windows. A plywood door was added on the south end of the school. Wallboard covers all walls and the ceiling with wainscot at the lower third of the walls. The floor is hardwood. Light fixtures indicate electricity was present at some point. There are blackboards on the west wall and the south wall either side of that south door.
