SITE IDENTIFICATION

2. Site Description: The Price School site was revisited in 2013 by UND Anthropology Research personnel during survey work for the Southwest Water Pipeline Project, Center Service Area (Contract 7-9F).

16. Report Title & Author(s): Center Service Area Changes 2013 Class II-III Cultural Resources Inventory, Southwest Water Pipeline Project, Mercer and Oliver Counties, North Dakota: SWPP Contract 7-9F.

NDCRS ARCHITECTURAL SITE FORM PAGE 1 UPDATE

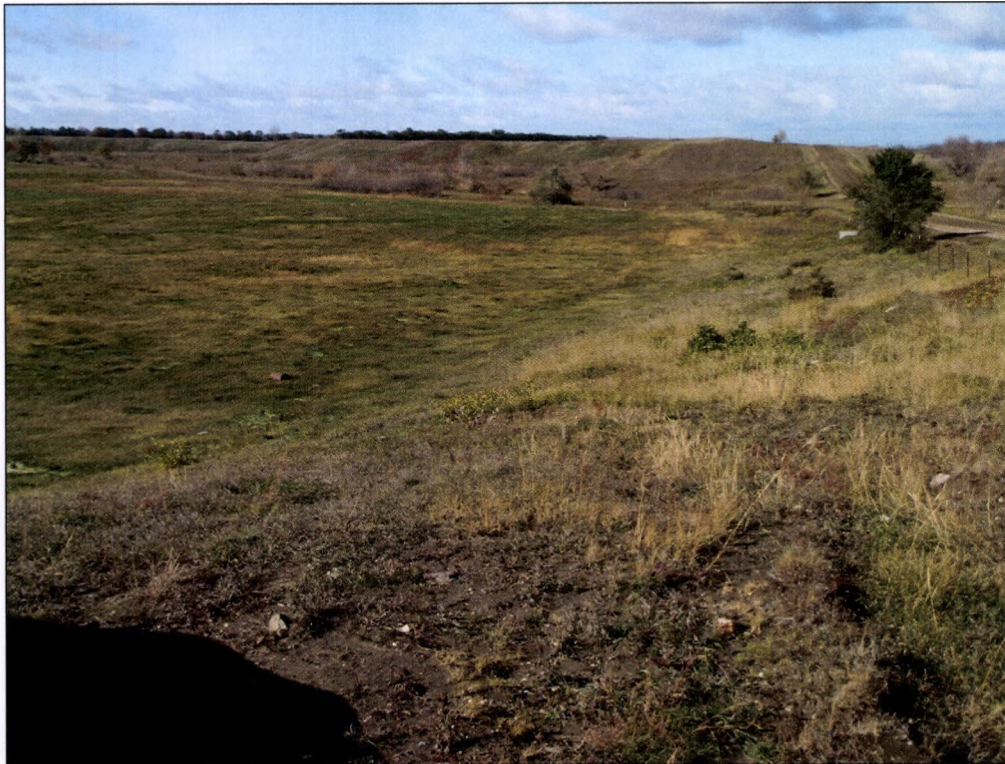
Site overview, view NNW (79F13-080).

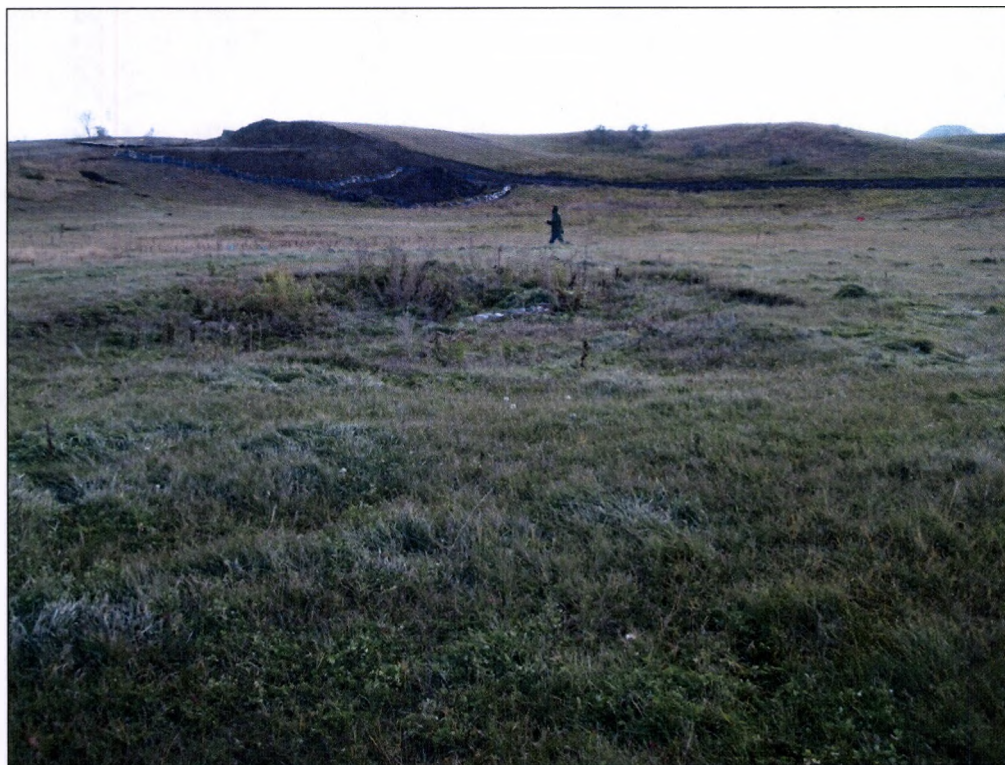
- **Feature 1:** The feature is the schoolhouse foundation. The foundation is constructed with concrete and stone. It was partially pushed into the center of the depression apparently when the building was removed. Some broken window glass fragments and bits of coal were seen here. The foundation condition is disturbed and poor. Aerial photographs of the locale indicate the schoolhouse was removed sometime between 2006 and 2009.

F1 school, disturbed foundation, view SSE (79F13-059).

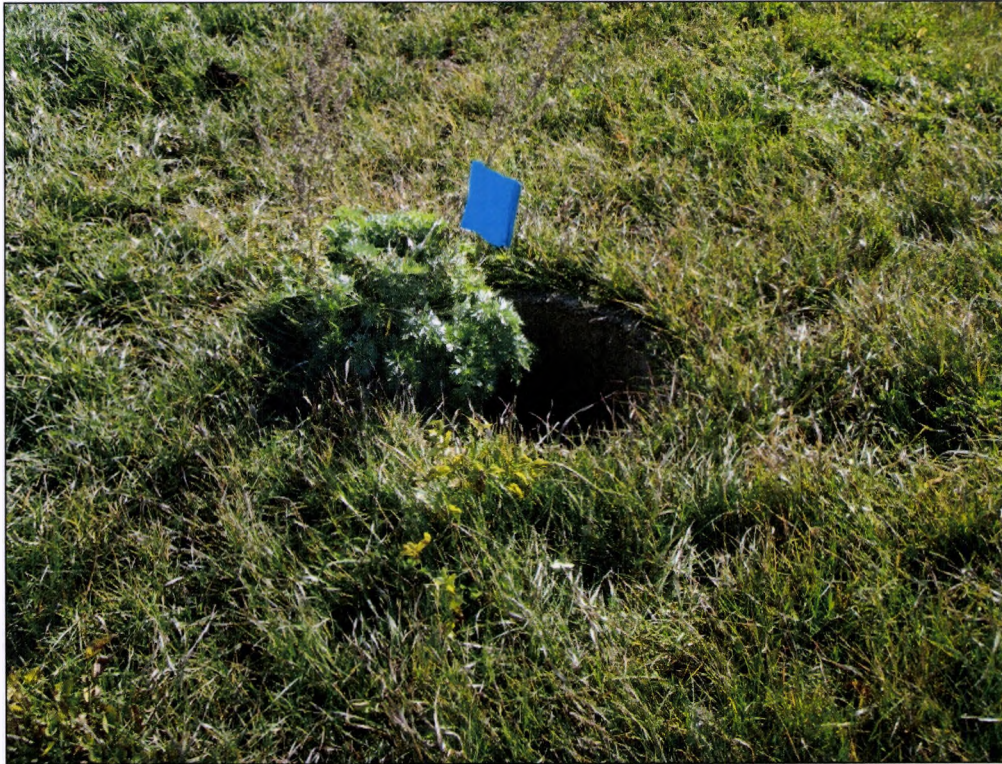
- **Feature 2:** The feature is a circular well shaft. It is unchanged since 2004.
- **Feature 3:** This is the concrete privy base/foundation. It is mostly unchanged since its 2004 recordation. The wood platform top/seat that was present in 2004 is now gone; some weathered wood boards are located north of the foundation. These appear to be the badly weathered remnants of the original wood frame outhouse building. Soda pop boxes were used to case the concrete upright, as previously noted, and these left reverse imprints in the concrete. The phrase "Drink Orange Crush" appears on the SW upright, "Cocoa-Crush" appears on the SE side, "Orange Crush" is on the NE side, and the NW upright is blank.

F2 well, view SSE (79F13-063).

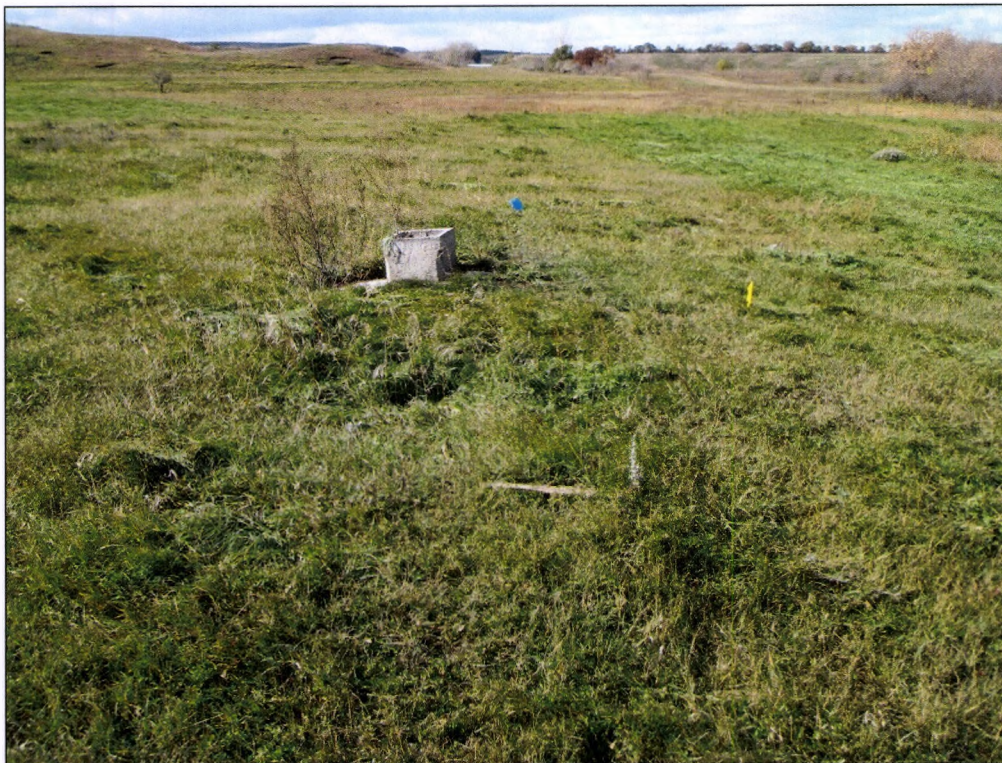
- **Feature 4:** It is a privy depression newly identified in 2013. It is located immediately east-southeast of the F3 privy concrete based. The depression is roughly 3-m square and has a maximum depth of 20-cm.

F3 outhouse concrete platform (background) and F4 outhouse depression (foreground),
view NNE (79F13-067).

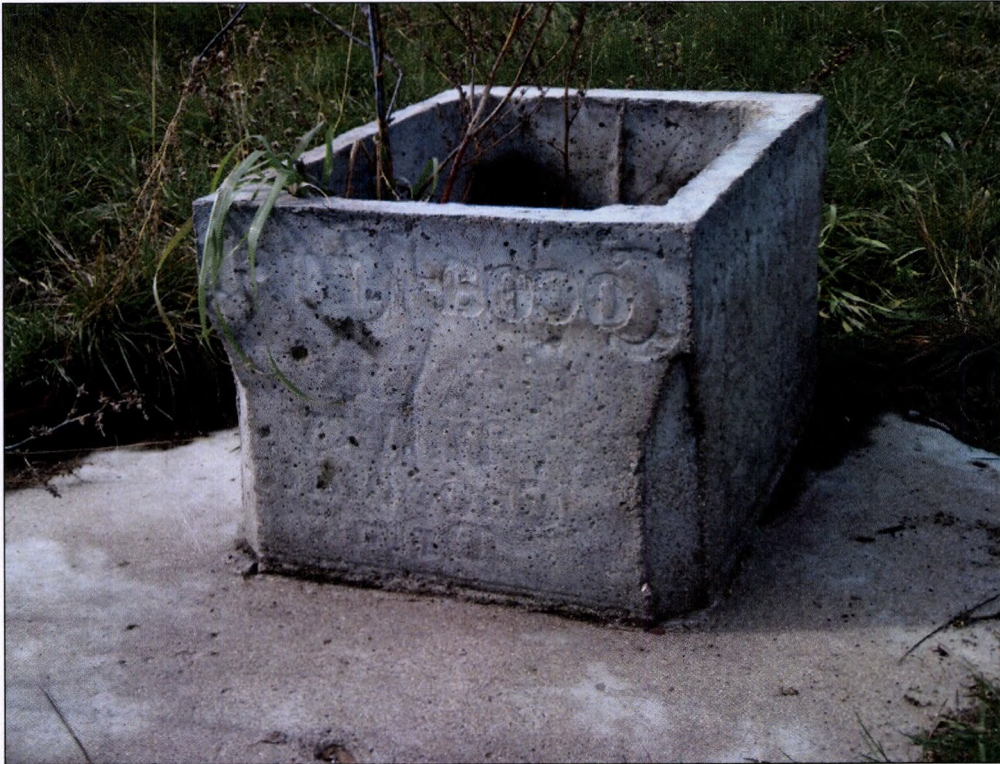
F3 concrete platform, detail (79F13-071).

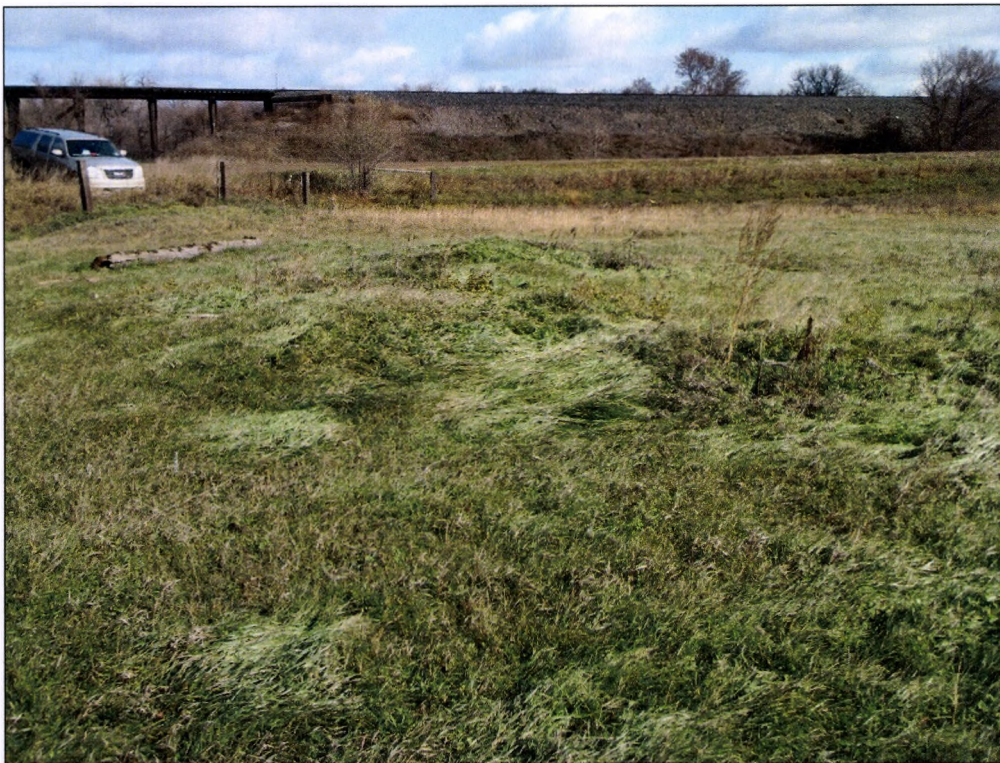
- **Feature 5:** It is an amorphous U- or V-shaped earth berm that was also newly identified in 2013. This may be a disturbed foundation or could simply be a dirt spoil pile leftover from when the school building was removed.

F5 earth berm, view ENE (79F13-075).

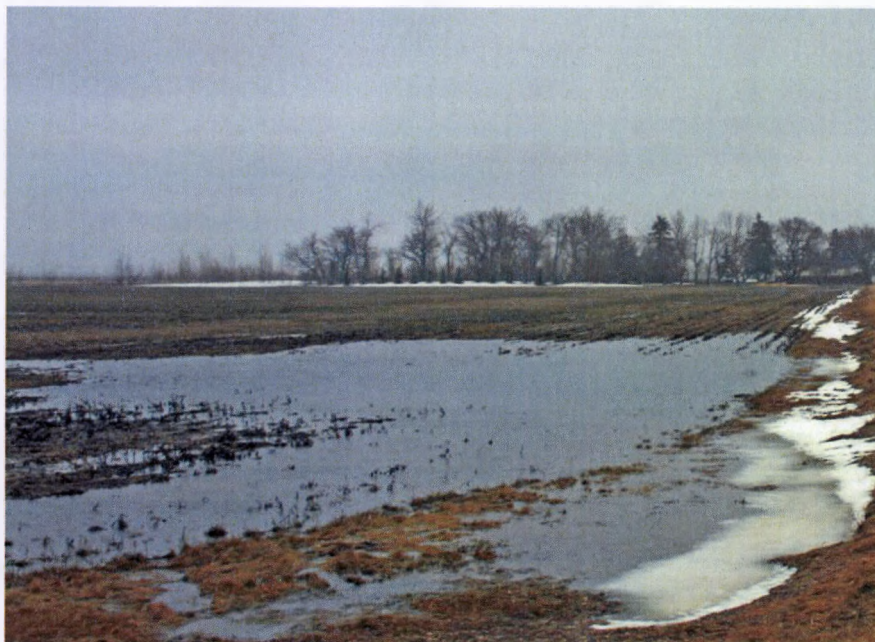
April 19 2011 view to east of former Price School. Demolition date unknown.

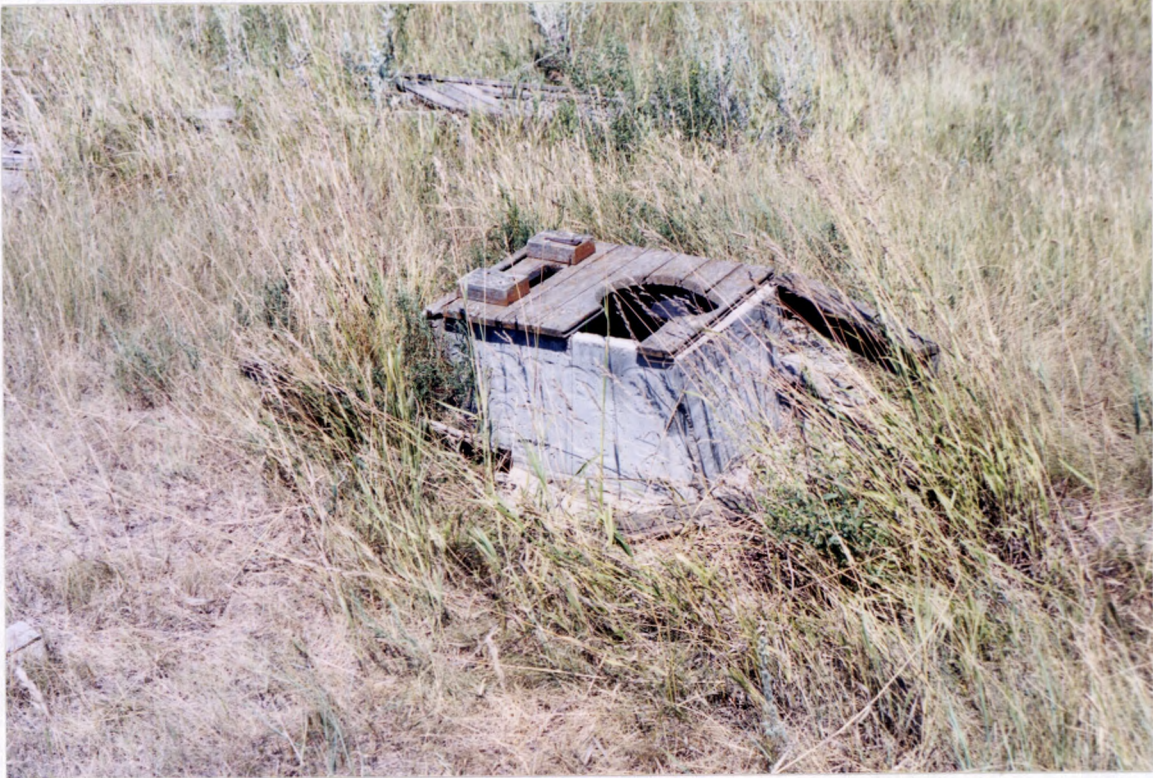
This feature is a poured concrete privy base. The stool base sits at a diagonal, and its walls appear to have been formed using "Orange Crush" brand shipping crates, for that trademark name is imprinted in reverse image on them. While the toilet seat remains, partially intact, the privy's walls and roof have collapsed and only portions of them were found scattered around the feature. The

This feature retains integrity of location and setting. It has lost, in varying degrees, integrity of materials, design, workmanship, feeling and association as a result of the collapse of its walls and ceiling. The feature does not, in our opinion, retain sufficient integrity to qualify as a contributing element to the site.

Feature 3, view from west.

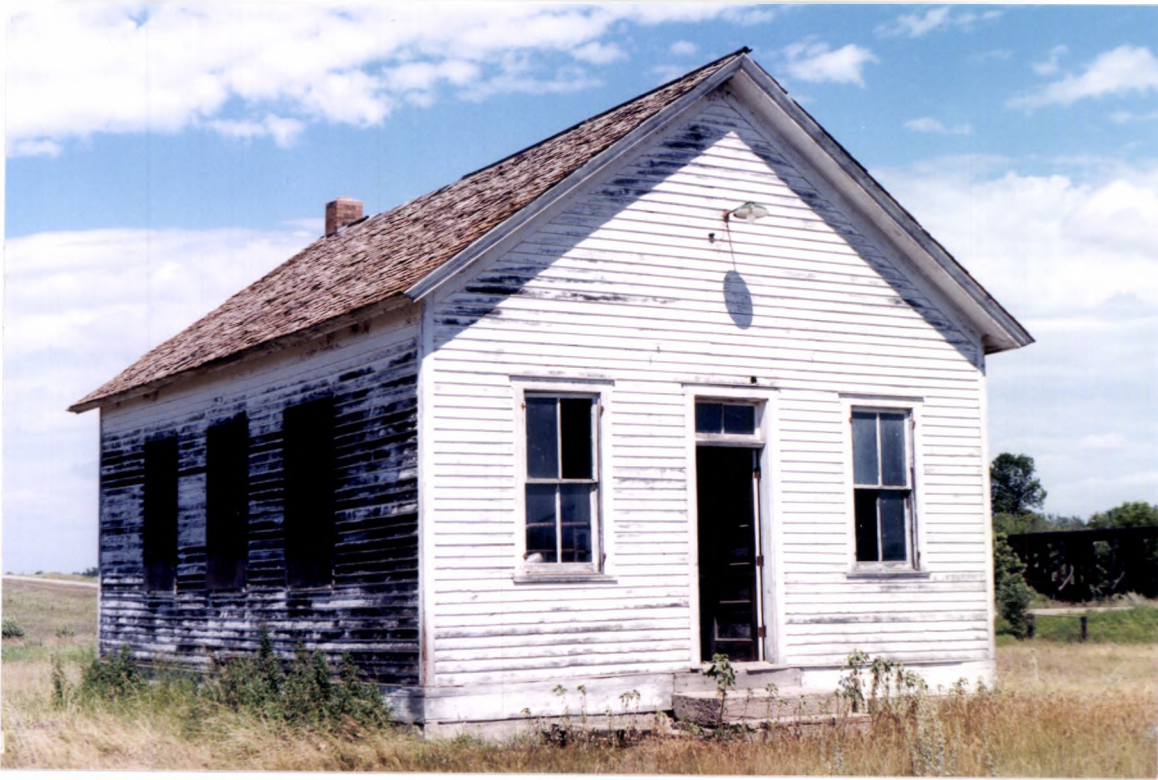
This feature is a one-room, gable roofed, wood framed schoolhouse. It measures approximately 24' (E/W) x 33' (N/S). The building has boxed soffits, wide under-eaves trim boards, corner boards and, at the base of the walls a wide trim board beneath a drip cap. Siding is weatherboard. The long walls of the building each contain three evenly spaced 2/2 double-hung windows. The south (primary facade) has a centered entry flanked by 2/2 double hung windows. The entry has a two-light transom and recessed panel, five-panel, door. Centered on the gable peak wall above the entry is a shaded light fixture with a single incandescent bulb. The building's roof is shingled with wood shingles; the galvanized metal ridge cap is partially missing. An interior chimney projects from the roof ridge from just inside the rear wall of the building.

Feature 1, view from the southwest.

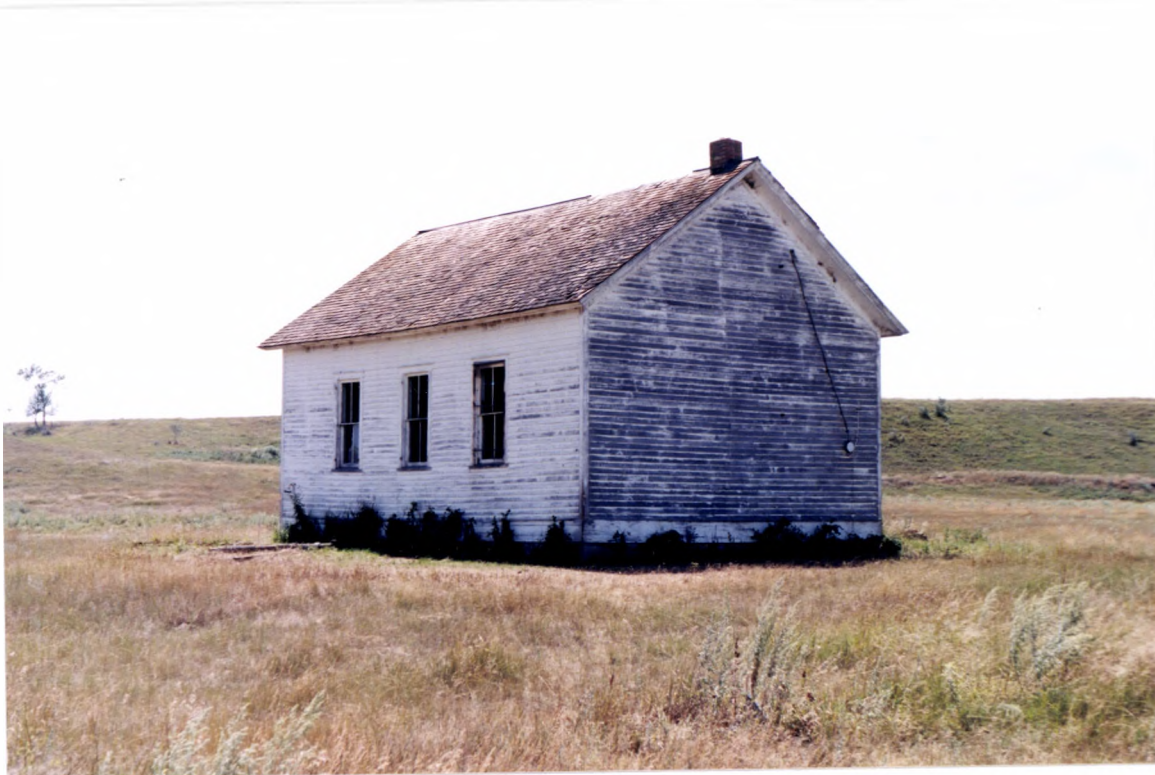
Feature 1, view from the northeast
