NDCRS ARCHITECTURAL FORM
PAGE 1

Field Code RB1-049-ARCH

Project & Principal Investigator:
Red Butte Wind Energy Center; Melinda McCarthy

Feature Type 9 - School; Church school

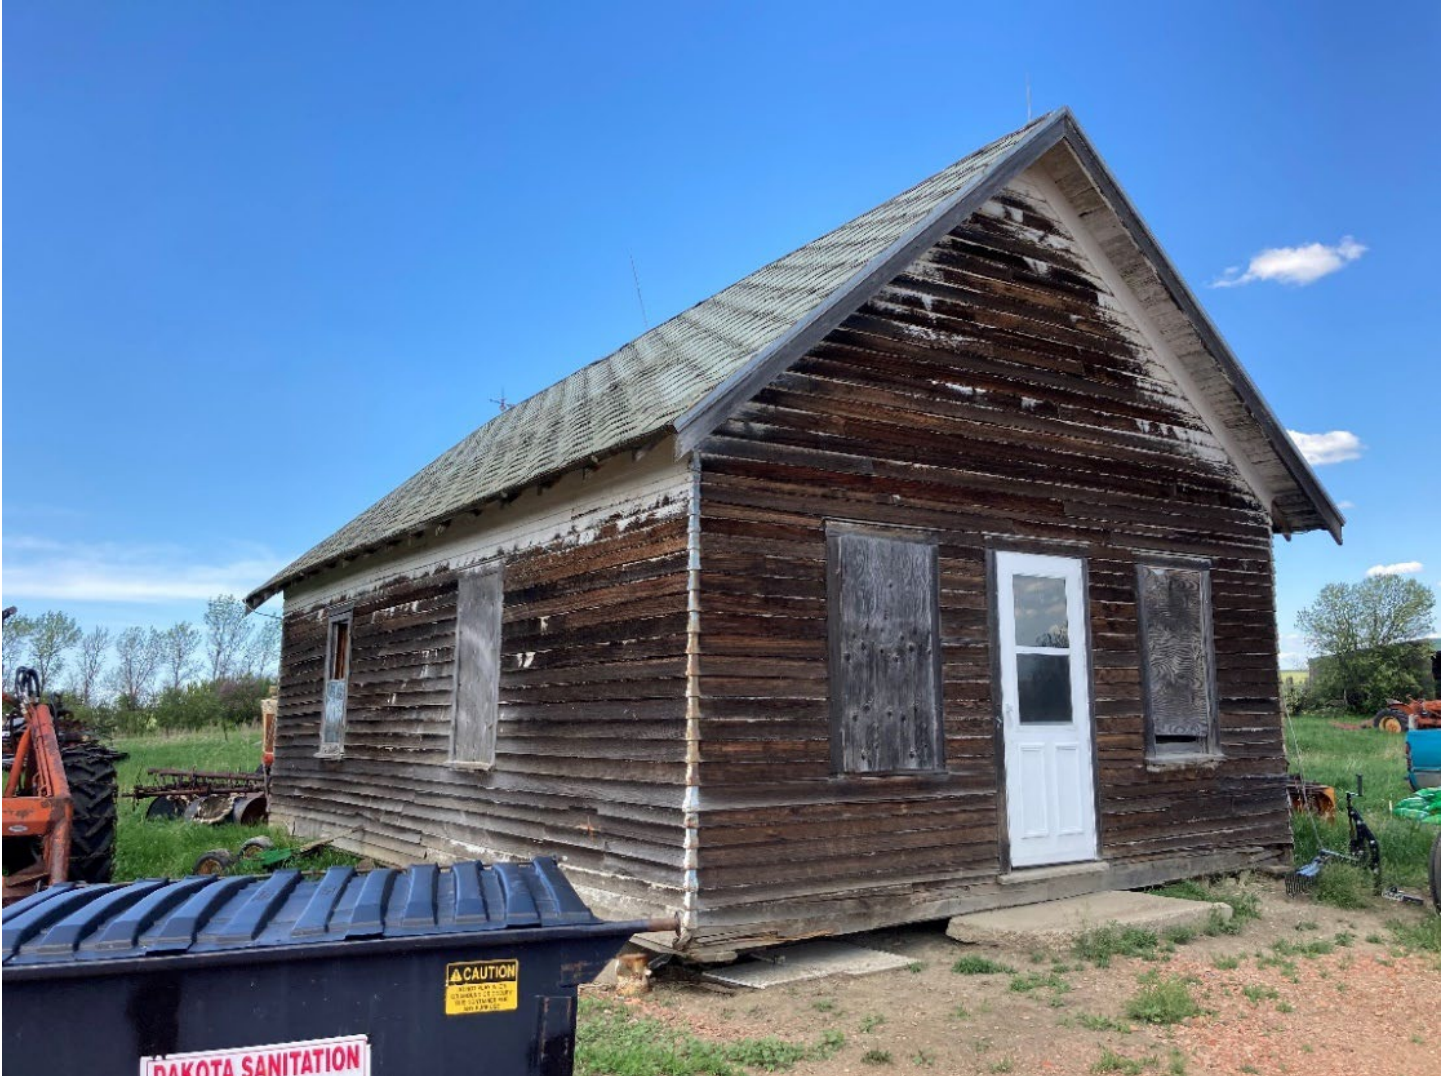
Overview of the historic schoolhouse on site, looking northeast. [Taken from report.]

The simple rectangular wood-framed building has exposed rafter tail under a small overhang along the sides. The roof is clad with asphalt shingles and the building itself appears to have a couple jacks under the front corners. The entry door is modern and very little paint remains but what does indicates it was painted all white. There are metal corners capping the lap siding.

The schoolhouse appears to pre-date the 1930s, and the school building was moved to the site sometime after 10/27/1957 but before 9/27/1995 (aerials). The feature lacks historic integrity due to condition, alteration, and movement, and does not represent outstanding examples of architectural design or workmanship. Research was unable to document an association with significant persons or events. Therefore, the school is recommended not eligible for the NRHP under criteria A, B, or C. As a moved feature used for a new purpose, the potential for the site and features to yield information important to the history of the area is highly unlikely so the school is recommended not eligible for the NRHP under criteria D.
