NDCRS ARCHITECTURAL SITE FORM
PAGE 2—Feature Data

Map Quad Wyndmere SE Site Name Danton School #1

**1. Feature Description, Integrity, Eligibility:**

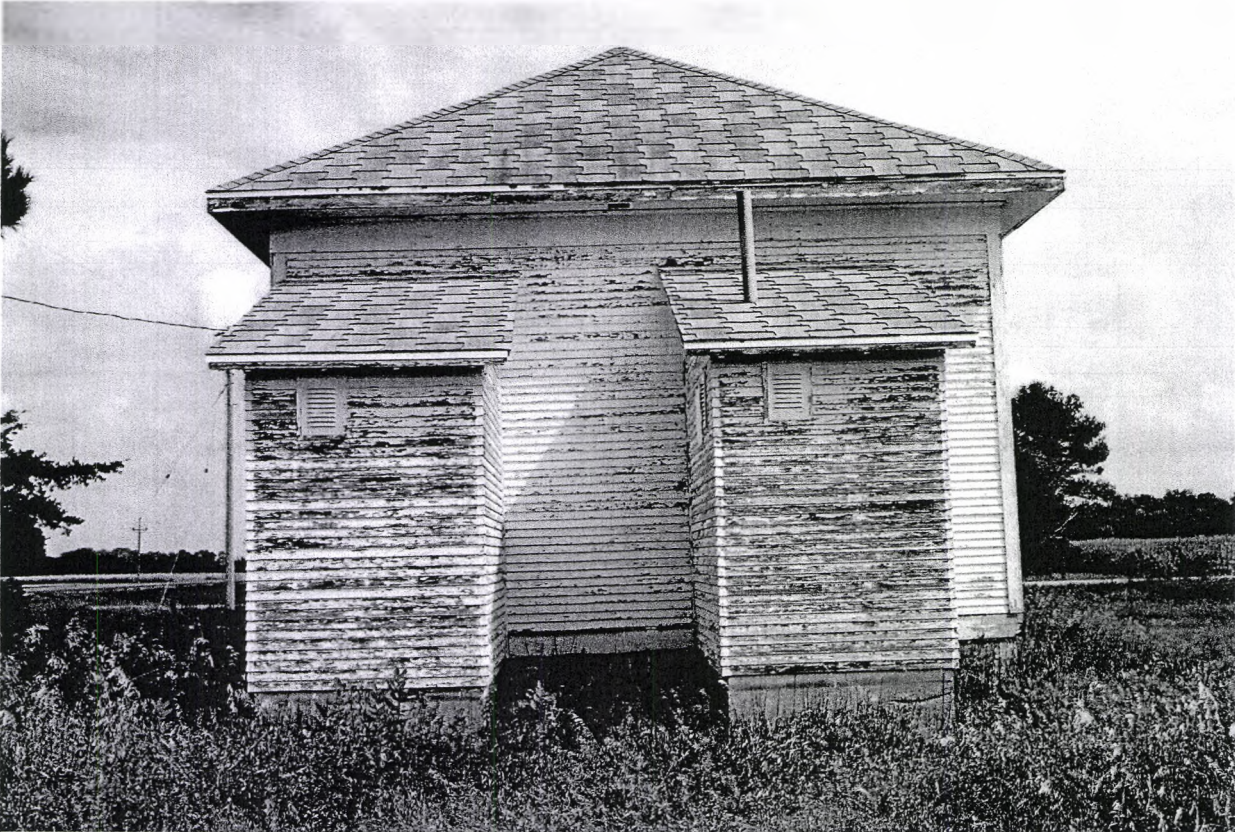
Danton School, west

The school has a full basement that houses metal vents and has wood support poles under a beam on a cracked concrete floor. A three-lite window to the basement is visible on the west side of the school and the interior photo shows two six-lite windows that have been covered, one on the north wall at the west end and one on the west end near the center. On the east end, front, there is a five-panel wood door at ground level that opens to a half flight of stairs to the basement. Stairs also lead up into the classroom. A second door is a modern flush steel door and has concrete steps (with a metal pipe rail) outside the entrance so the door opens directly onto the main floor. Above this door is a single pane transom and a 1:1 window is on each side. A hipped dormer has vertical siding covering it and there is no longer an opening. The north side has a band of six 1:1 windows that begins at the west end and runs the length of the interior classroom. The west end has two shed-roofed additions that housed the toilets. The south side has one 1:1 window near the east end. All of the roofs have the same asphalt shingles covering them.
