NDCRS ARCHITECTURAL SITE FORM

Map Quad Wyndmere Site Name Danton School #1

Map Quad Wyndmere SE Site Name Danton School #1

**NDCRS ARCHITECTURAL SITE FORM
PAGE 4—SITE DESCRIPTION**

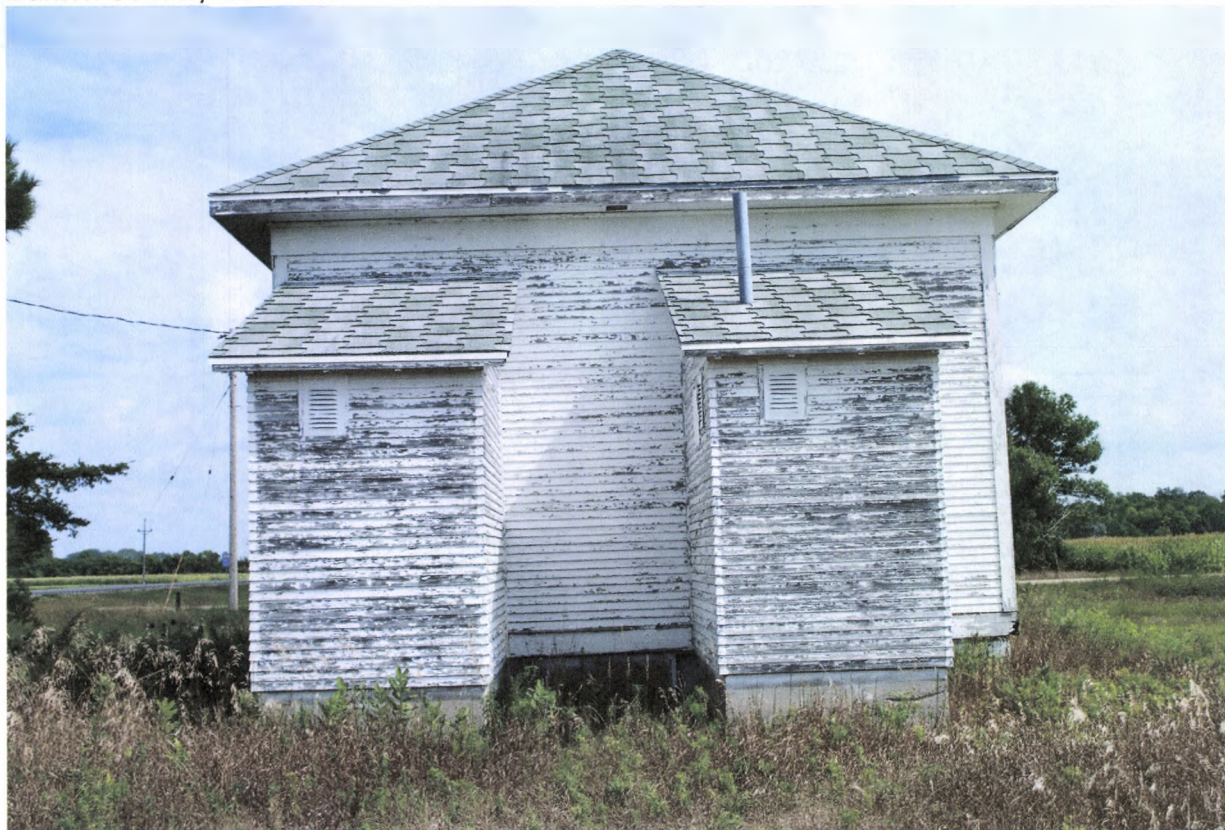
Danton School, west

The school has a full basement that houses metal vents and has wood support poles under a beam on a cracked concrete floor. A three-lite window to the basement is visible on the west side of the school and the interior photo shows two six-lite windows that have been covered, one on the north wall at the west end and one on the west end near the center. On the east end, front, there is a five-panel wood door at ground level that opens to a half flight of stairs to the basement. Stairs also lead up into the classroom. A second door is a modern flush steel door and has concrete steps (with a metal pipe rail) outside the entrance so the door opens directly onto the main floor. Above this door is a single pane transom and a 1:1 window is on each side. A hipped dormer has vertical siding covering it and there is no longer an opening. The north side has a band of six 1:1 windows that begins at the west end and runs the length of the interior classroom. The west end has two shed-roofed additions that housed the toilets. The south side has one 1:1 window near the east end. All of the roofs have the same asphalt shingles covering them.
