# NDCRS ARCHITECTURAL SITE FORM PAGE 1

Field Code The Vold School

Project Title & Supervisor:  
Country Schoolhouse Project

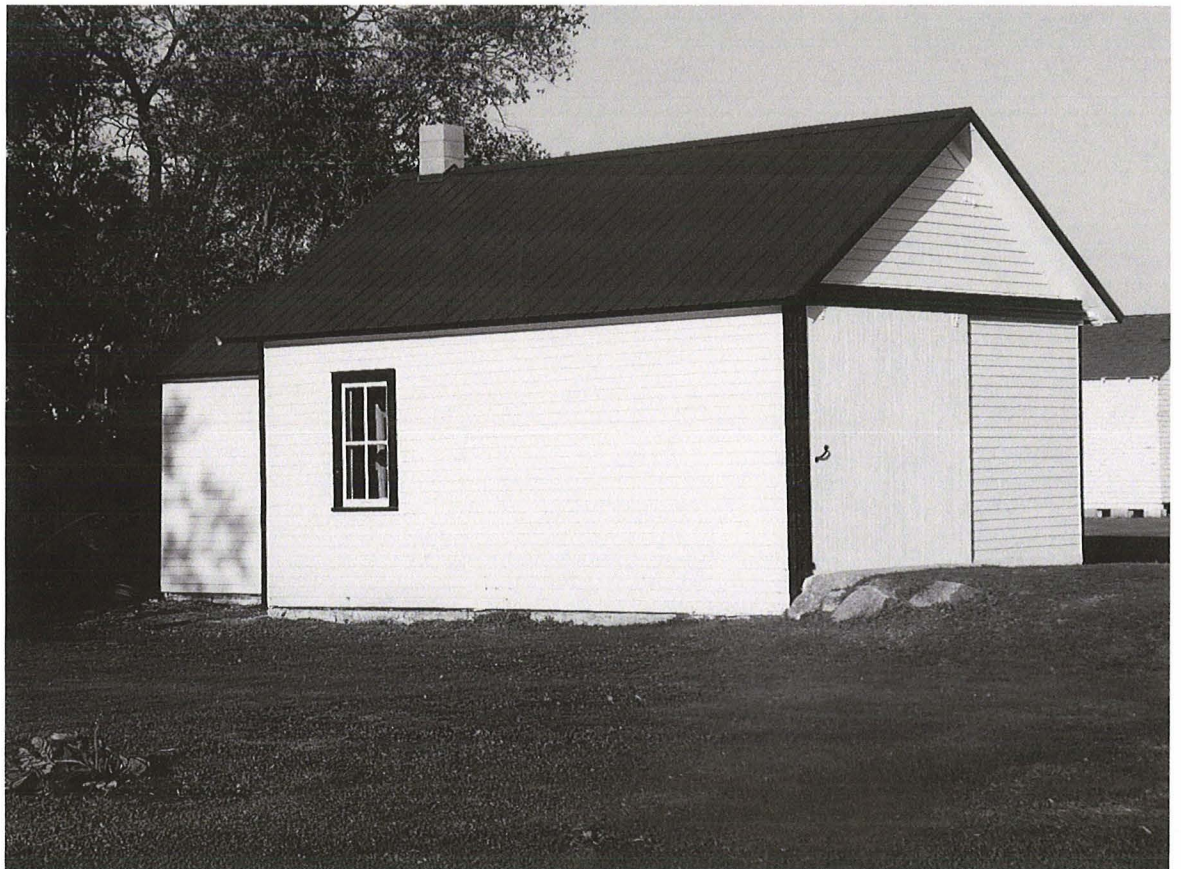
West  
Side &  
South  
Side

The siding on the school begins with a wide trim board under the peaked ends of the roof. The remaining siding is 6 inch wood lap with 6 inch wood corner trim. The south side of the building has been opened to accommodate storage and a sliding door was added to give access. There is a bank of 5 double hung windows on the east wall, all shuttered. The windows can be seen from the inside of the building and the glass is intact. There is one newer, double hung window on the west wall near the north end of the school and according to the present owner there were 3 more windows on that wall, all sided over. There is a smaller, 4 pane fixed window on the north wall of the entry. The entry door, which faces east, was deteriorating and was replaced with a modern solid core door. The walls of the entry are covered with beadboard. The walls and ceiling in the main body of the school are covered with pressed tin. At the top of the walls the ceiling tin curves around the corner and extends down about 6 inches. The floor is hardwood. There is a blackboard on the west all of the school just to the south of the window. This blackboard was most likely situated on the south wall since there was a number of windows on the west wall in the past. A furnace, added at a later date, is seen at the north end of the main room of the school. There is no electricity.
