### NDCRS ARCHITECTURAL FORM PAGE 1

#### Field Code Birklid School

1. Feature Description, Integrity, Eligibility:

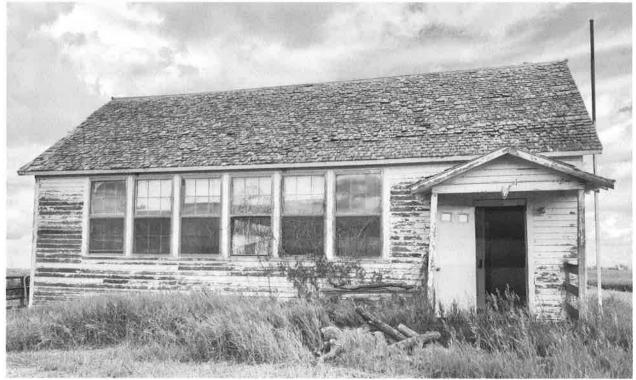
## South Side

The feature is a large, one room prairie school on a foundation of rocks in cement. The gable roof is covered with wood shakes, metal capping and finials. The north addition shed roof is also covered with wood shakes. There is a red brick chimney on the north slope of the wall close to the east end. The soffits are open. The school measures 36 feet east to west and 20 feet north to south while the addition measures 6 feet by 20 feet. A gabled roof covers a portico at the entrance. A flag pole can be seen at the southeast corner of the school.

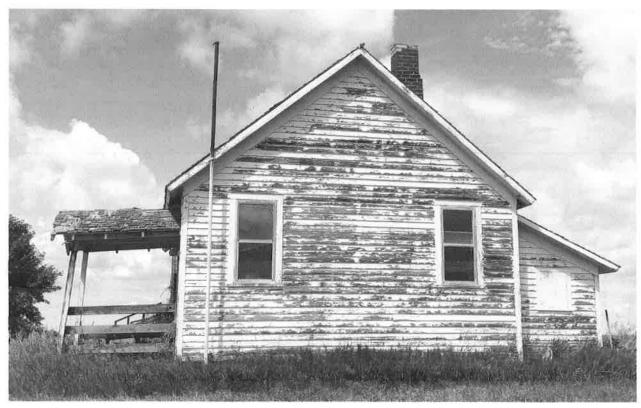
# East Side

A rake board begins the siding at the peak ends of the school. The rest of the siding is 6 inch wood lap with 4 inch wood corner trim. Two wood steps take you to the portico at the entrance to the school. Wood columns at the outside corners help to support the roof. A solid core door gives entry to the school. You step into the coatroom and all the walls in here are covered with pressed tin. There is one double hung window on the east wall of the entry. Coat hooks run along the east wall at two different heights. There are two doors leading from the entry, one (two panel wood) goes to the left into the school room and another (5 panel wood) goes to the north into a large alcove off the school room, it looks like this area was used for the wash room. Another double hung window is in the alcove on the east wall. The school room has 6 large multipane double hung windows along the south wall with intact glass. All have screen windows and most have remnants of window shades. The floor throughout is tongue and groove hardwood. The walls in the school are wallboard with a wide trim board at the floor. The ceiling has acoustical tile. Light fixtures and switches indicate electricity. There are wood framed blackboards on two walls, one on the north wall at the west end and another on most of the west wall. A collection of maps hangs next to the north blackboard. The addition on the north side was used for a small kitchen. A small window located just to the left of the addition door was used as a pass through for children getting their lunch. The wall at the back (east) of the class room has a built in shelf unit for books. This school was closed in 1950.
