NDCRS ARCHITECTURAL FORM
PAGE 1

Field Code Springer School #5

Architectural Feature # 1

1. Feature Description, Integrity, Eligibility:

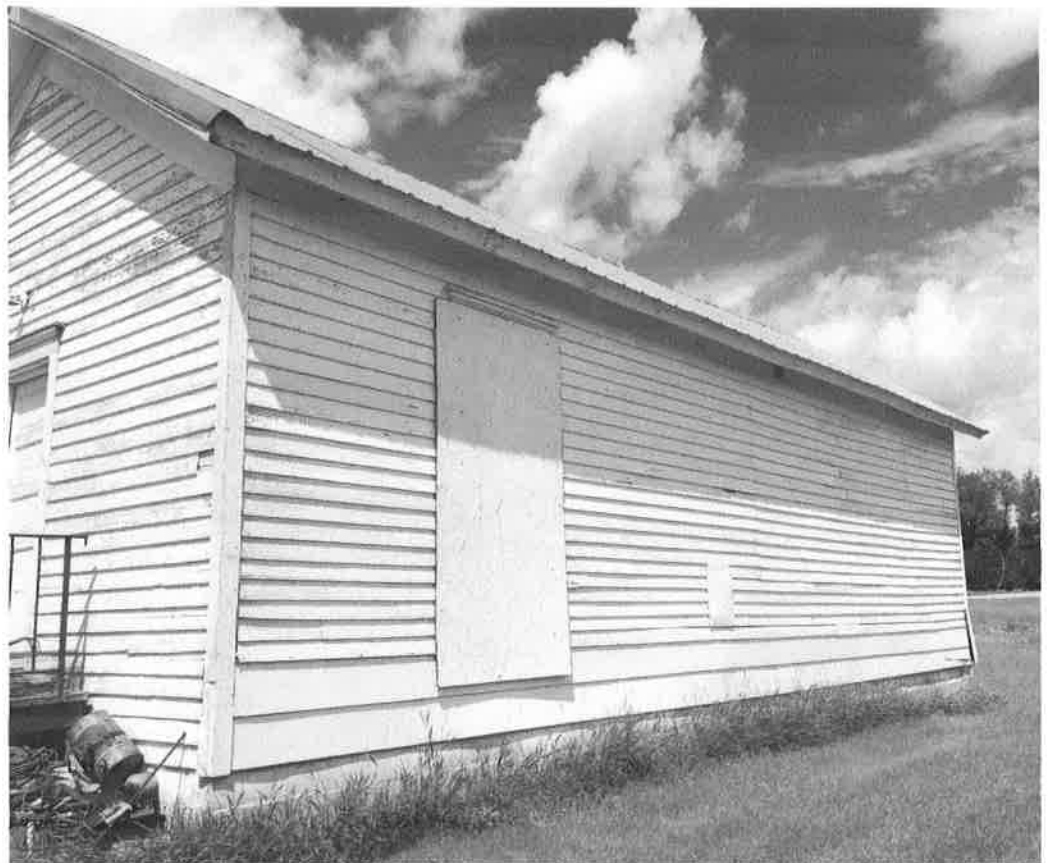
East Side

A rake board at both of the peak ends, under the eaves, begins the siding. The remainder of the siding is 6 inch wood lap with 4 inch wood corner trim. On the east side of the school siding was used to fill two window openings in the main part of the school. One more double hung window with glass, located in the coatroom, is covered with a sheet of plywood. The windows on the west side are two over two double hung windows with much of the glass intact. There is one window closer to the south end that is located in the storage room to the left of the entry door. There are four 4 over 4 windows on the west side of the class room, two are covered with plywood and two have storm windows. Three steps lead up to a wooden porch with metal railings to either side. The entry door is a 5 panel wood door with a large patch near the bottom and a decorative cornice above. Stepping into the building there is a 4 panel wood door immediately to the left that leads into a large area that may have been used for storage. The walls in this area have house siding up about 2/3 of the way on the wall and the remainder if open between the studs. The entry/coatroom itself has beadboard on the walls. The door leading into the school room is 5 panel wood with a transome above it. All the interior doors have decorative cornices above them. The school room walls and ceiling are all finished with beadboard. There is a stage at the north end of the room. The blackboard runs along that north wall. The floor is tongue and groove hardwood. Electricity is present with lights both inside and out.
