NDCRS ARCHITECTURAL SITE FORM PAGE 1

The feature is a one room prairie school sitting on a concrete foundation. The school was moved from Nanson to this museum complex in 1989. This is a wonderful example of a one room school, decorated with items of the time. The desks, books, maps and other items are original to the school.

Nanson School

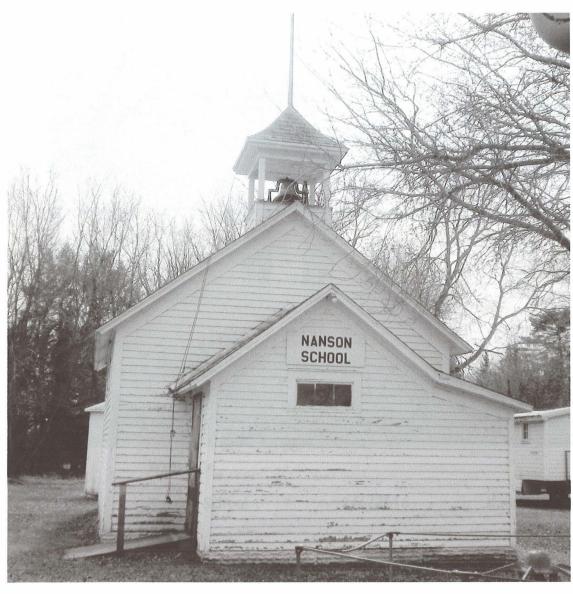
North Side

The gable roof of the school and entry are covered with asphalt shingles. There is a bell tower at the peak of the north end of the roof. The base of the tower is a square structure with 6 inch lap siding with four posts holding up the pyramid roof, also covered in asphalt shingles. There is a flag pole at the peak of the bell tower. There is a red brick chimney at the peak of the roof at the south end of the school. The soffits are closed. The roof on the entry is gable with extension shed roof to the west. The building measures 24 feet north to south and 18 1/2 feet east to west with the shed measuring 8 feet north to south by 14 feet east to west.

There is a wide trim board under the soffits at the peak ends of the school as well as the entry. The siding is 6 inch wood lap with 4 inch wood corner trim. The concrete foundation is skirted with metal sheeting. There is a plywood door on the entry and this is kept locked. Inside the entry there is a plank door giving access to the west 1/2, used for storage today. The floor in the entry was replaced with newer 4 inch wood planks. The floor in the main body of the school has tongue and groove hardwood.
