NDCRS ARCHITECTURAL SITE FORM PAGE 1

SITS# 32 RY 404

Field Code _____ Site Name Second Grand Harbor Townsite
Site Name _____

Report Title & Author(s):
Highway 2 from the West to East Devils Lake NDDOT District Boundary, Class III Cultural Resource Inventory, Pierce, Benson, Ramsey, and Nelson Counties; Michelle Sadlier

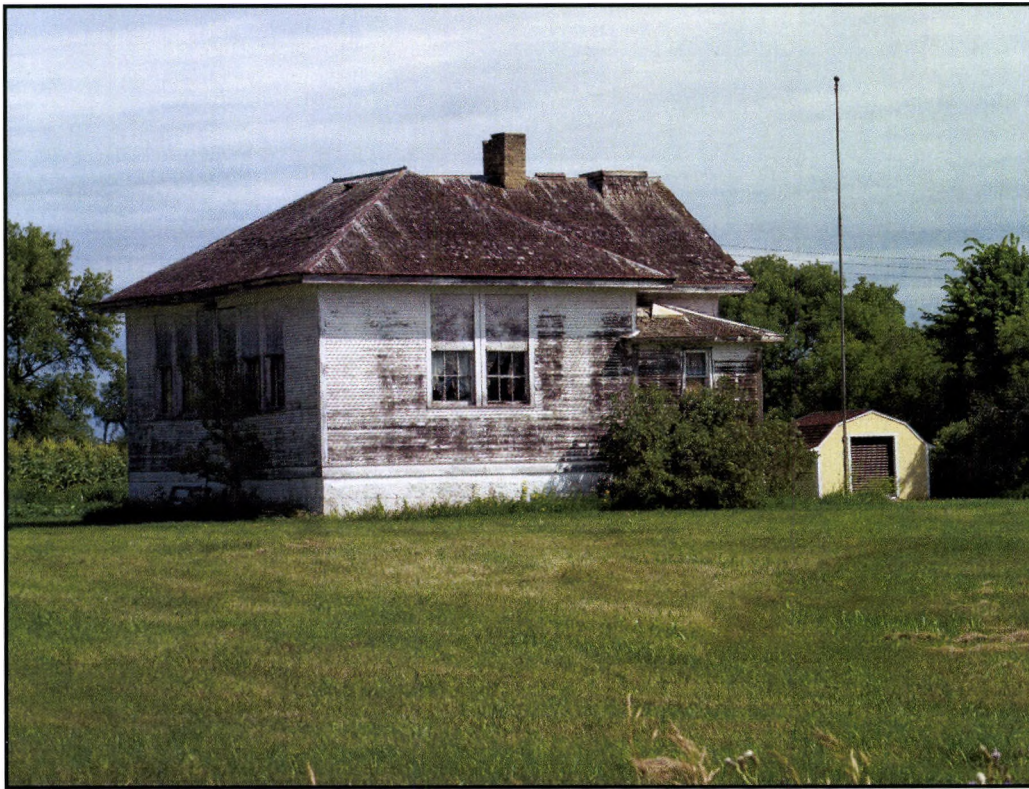
Figure 2: The Grand Harbor schoolhouse at Site 32RY404, the only architectural feature recorded in 1976 which appears to be extant. View north from highway ROW.

To reflect the loss of most originally-recorded buildings, Juniper recommends the site boundary be adjusted to include the school property only.

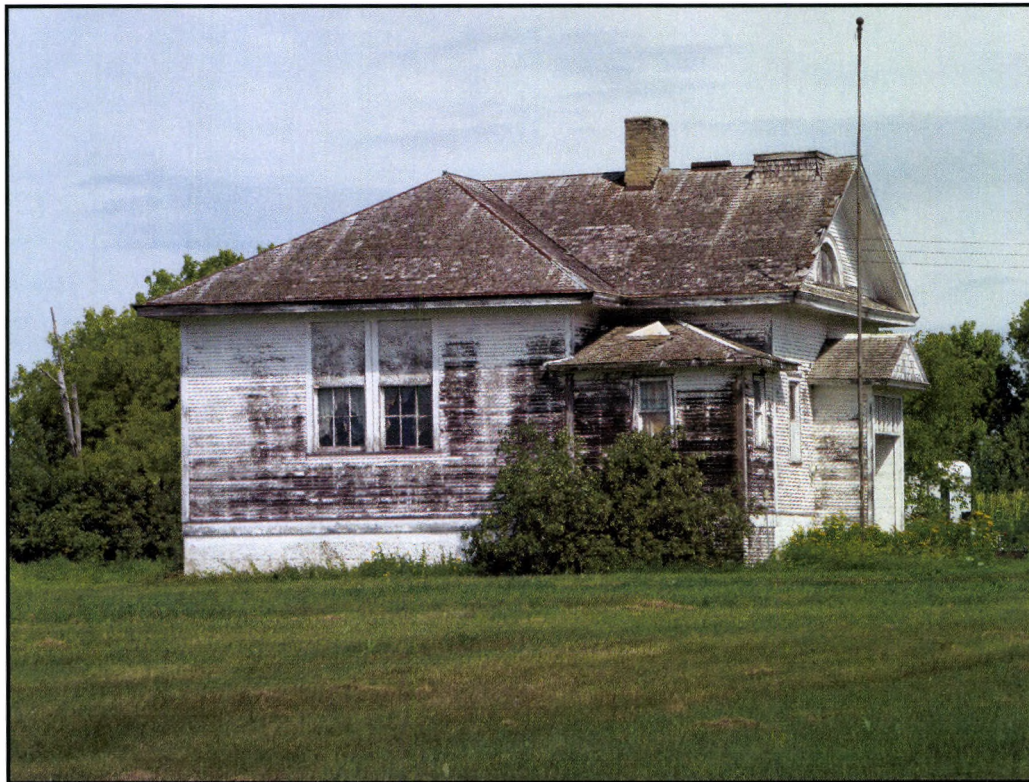
Figure 3: South and east elevations of the former schoolhouse. Domestic curtains and some alterations indicate that it may be used as a residence today.

Of the features described on the original site form, only the school appears to remain. The schoolhouse's exterior appearance indicates that it may have been converted into a residence. As a rural schoolhouse, the building has the potential for thematic nomination for the National Register of Historic Places. Because the interior could not be accessed during the current inventory, further survey would be required to determine the building's material integrity.
