5. MAPS CONSULTED. U.S.G.S. Topographical map: Crete Quad. North Dakota Highway Department County Map: Sargent County.
6. PROJECT TITLE: Garrison Diversion Unit Project
LaMoure-Oakes Resurvey

Base Data Form

1. County Sargent 2. Site Number Oakes East 21
3. Site Name (s) Bert Dill Farm, Original settler: George Dill
4. Type of Resource: A. Archaeological Historical Architectural Paleontological

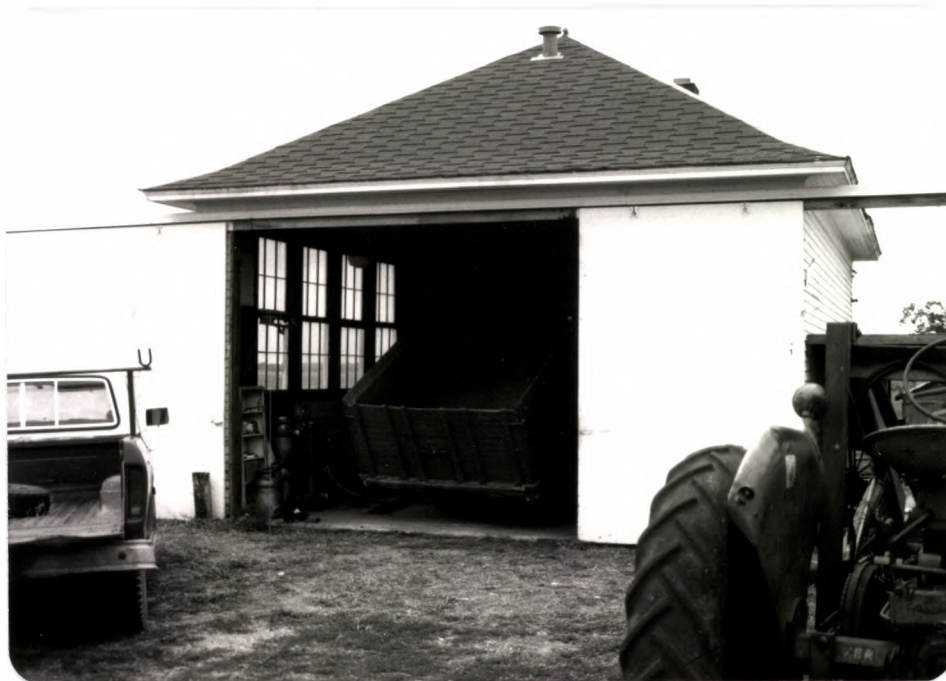
Roll# 8 Frame# 9

Feature 3 is a tall, one story, wood frame former school house with a hipped roof. The structure has clapboard exterior siding except on the east end where the almost the entire wall has been converted to sliding doors. The structure sits on a poured concrete slab foundation and floor, and has asphalt shingles on the roof. (Photo ID: 8:9 from the east, 8:10 from the southwest)

Feature #3 View from: east

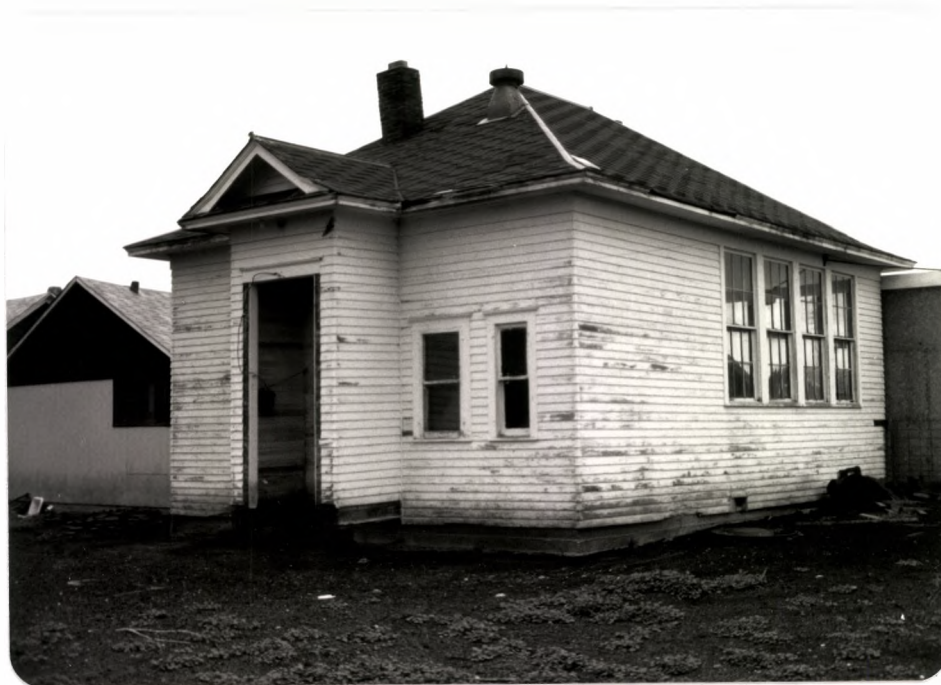
Roll# 8 Frame# 10

Feature #3 View from: southwest
