NDCRS ARCHITECTURAL SITE FORM
PAGE 2—Feature Data

Field Code V.W.-1.1.4.5.-12 Site Name SCHOOL NO. 1
Field Code _____ Site Name _____

9. Cover (% of visible ground) 35% - 55%.
10. Man-hours spent on site 2 hours.
11. Project Title McLean-Sheridan Rural Water Pipeline Project.
P.I. David D. Kuehn.

12. Report Title McLean-Sheridan Rural Water Pipeline Cultural Resource
Survey Report Author Jacqueline Foster
13. Other Published References None.
14. Description of Collections Observed None.

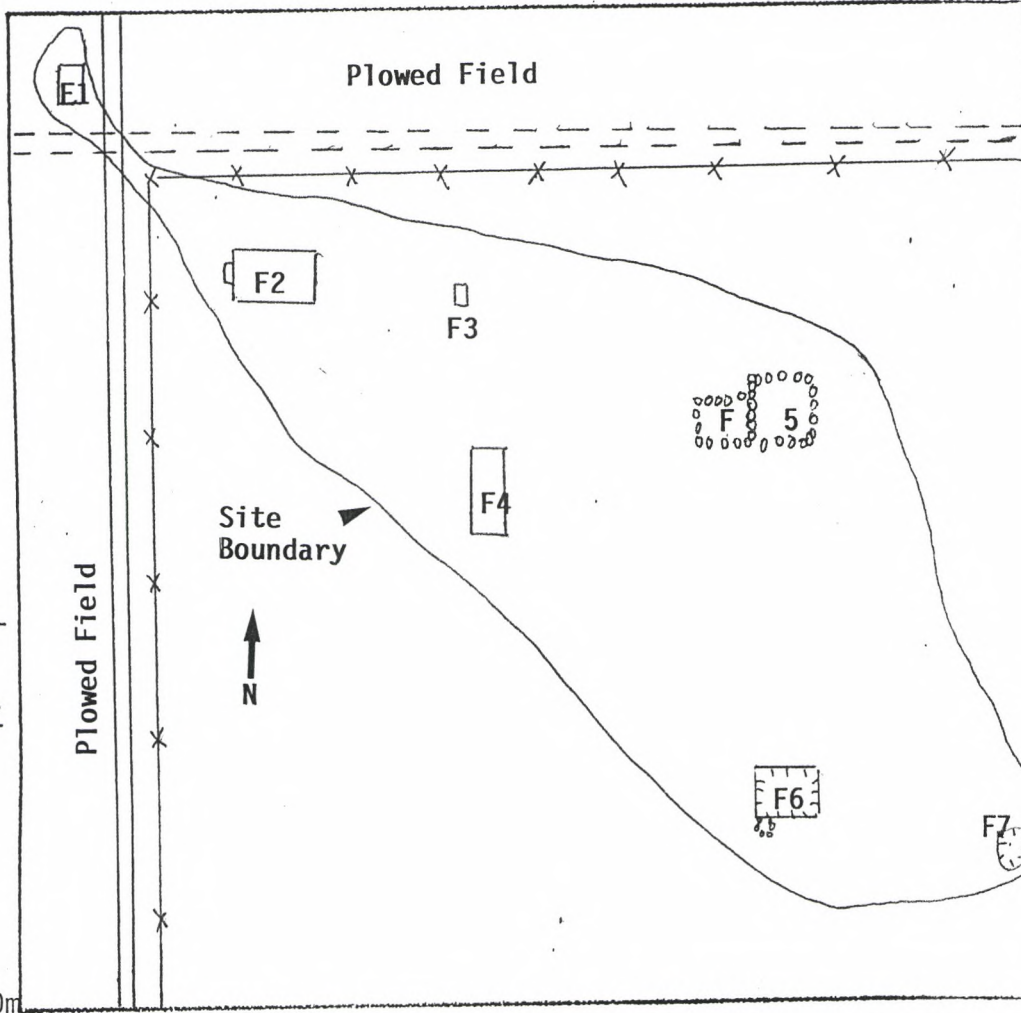
SKETCH MAP

2. Description of Site This site is a school house and the foundations of five other features. A storage shed has also been included in the site although it probably isn't directly associated with the school and the other features. The site is located on a low ridge with marshy land all around. Little cultural material was observed. For details of Features 1 and 2 see the Architectural code sheets and page 2's. Feature 3: A small concrete foundation 2.5m north-south by 1.2m east-west. Believed to be a privy. Feature 4: A concrete foundation 8.5m north-south by 3.7m east-west. Feature 5: A fieldstone rectangular foundation with an iron stake. The foundation appears to be divided into two areas. Feature 5 measures 12m east-west by 6.4m north-south. Feature 6: A 1.2m deep depression measuring 6.4m east-west by 5.5m north-south. A 1.5m² rectangle of fieldstone lies on Feature 6 south-west side. Feature 7: Another possible privy, a depression measuring 1m² and 1m deep.

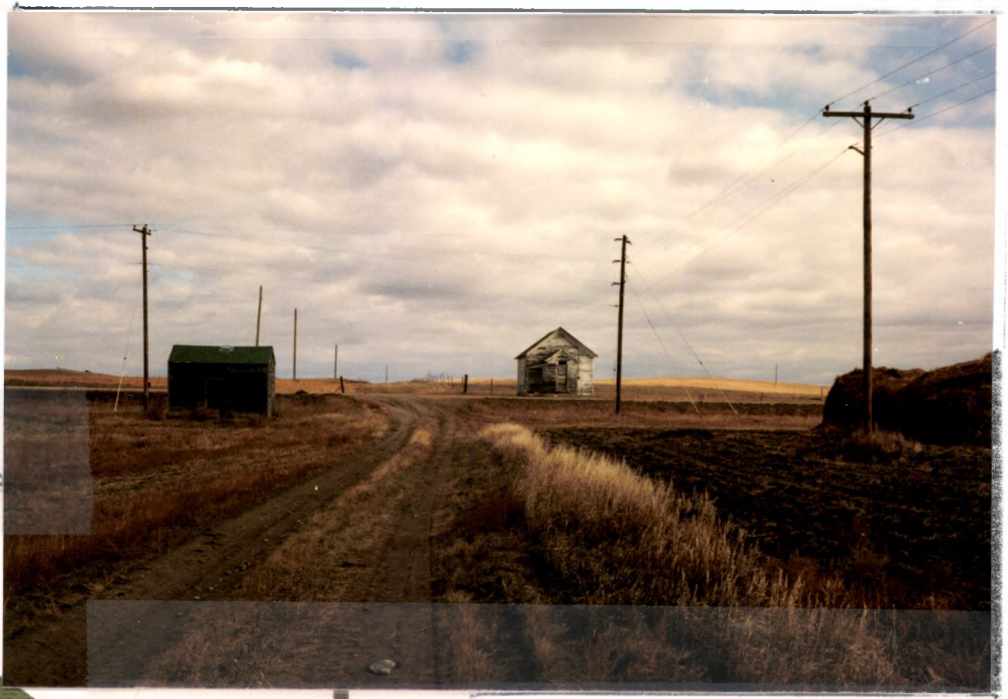
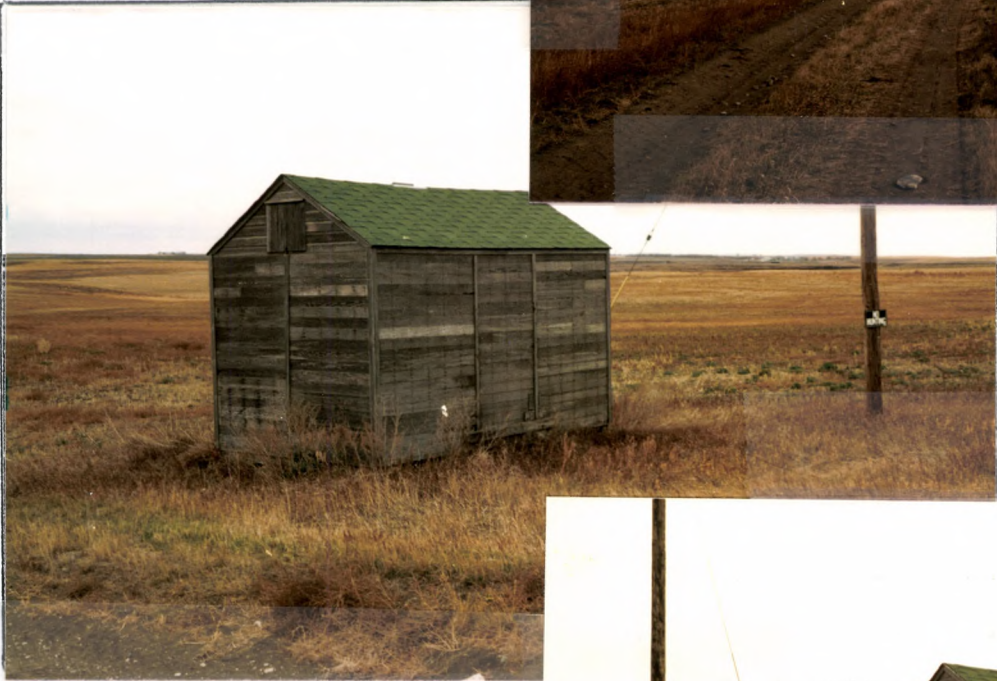
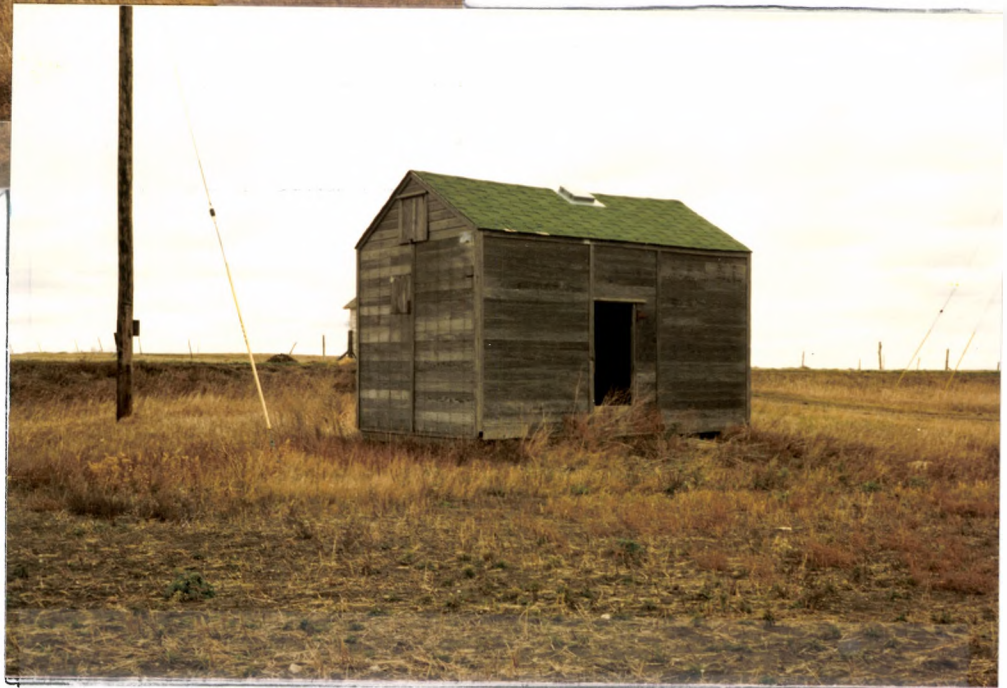
Appendix 2. Photographic coverage of site UW#1145-12. Legal: NW $\frac{1}{4}$ NW $\frac{1}{4}$ NW $\frac{1}{4}$, Section 26, SE $\frac{1}{4}$ SE $\frac{1}{4}$ SE $\frac{1}{4}$, Section 22, T146N, R76W, Sheridan County, ND. Top photo taken of site overview facing east, middle photo taken of Feature 1 facing northwest, bottom photo taken of Feature 1 facing southeast. Field Date: October 13, 1988.

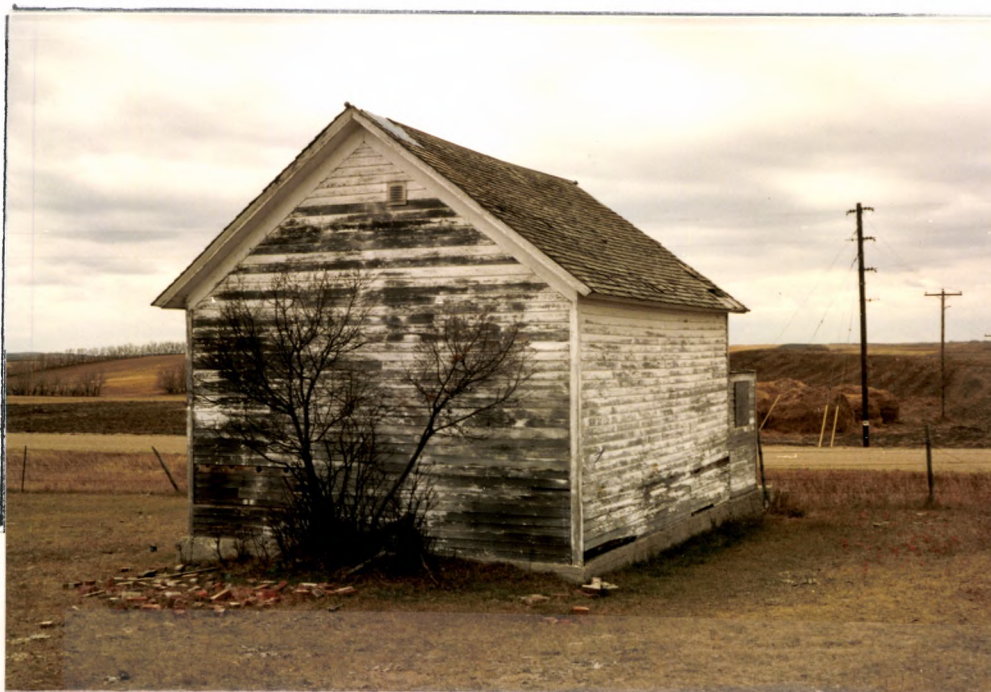
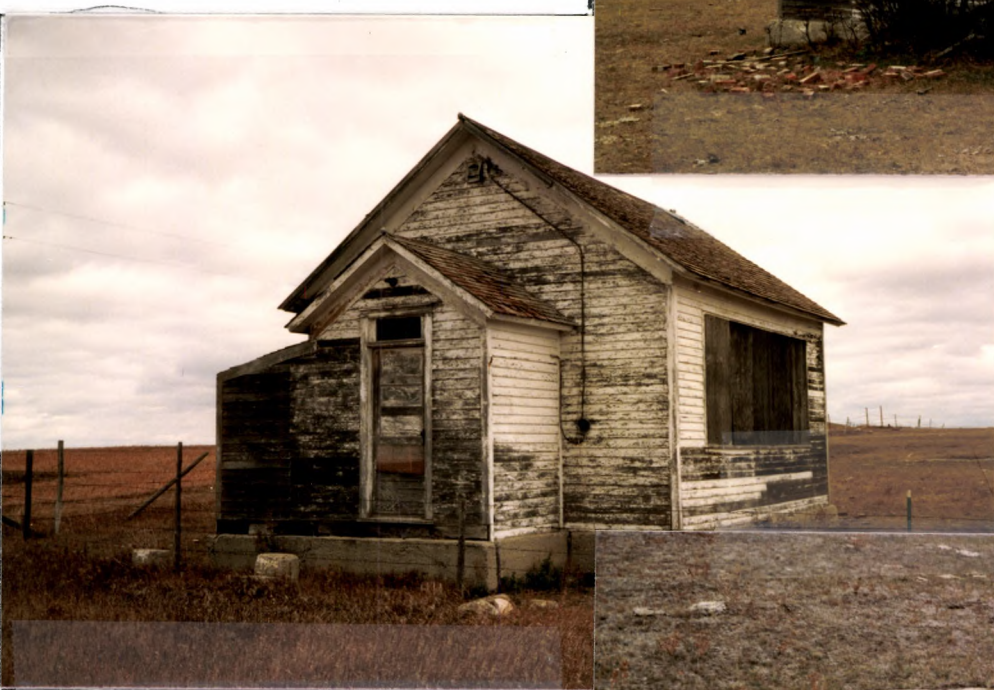
FEATURE DESCRIPTION & STATEMENT OF INTEGRITY This feature is a small school-house designated Lamont Township School Number 1. The school has horizontal board walls over a wooden frame. At the wall corners, thin vertical strips of wood cover the board ends. The exterior walls are painted white. The roof is gabled with wooden shingles. The porch is of a similar construction. The door is locked and the windows boarded so the interior could not be examined. Adjacent to the entryway is a small coat room which based on the foundation was part of the original construction. The school measures 8.5 m east-west by 5 meters north-south.

15. Owner-Address of Collections Observed N/A.
16. Statement of Integrity The majority of this site is lacking integrity. Five of the seven features have had the structures removed. Of the remainder, Feature 1 is a recent shed which is probably not associated with the site, and Feature 2 is in questionable condition. From the exterior Feature 2 appears to be in fair shape but the interior has not been examined.

Appendix 2a. Photographic coverage of site UW#1145-12. Legal: NW $\frac{1}{4}$ NW $\frac{1}{4}$ NW $\frac{1}{4}$, Section 26, SE $\frac{1}{4}$ SE $\frac{1}{4}$ SE $\frac{1}{4}$, Section 22, T146N, R76W, Sheridan County, ND. Photo taken of Feature 2 facing southwest, middle photo taken of Feature 2 facing northeast, bottom photo taken of Feature 3 facing south. Field Date: October 13, 1988.
