NDCRS ARCHITECTURAL SITE FORM PAGE 1

Field Code Buchmann #1 Site Name Buchmann #1
Map Quad McClusky Site Name Goodrich School

Project Title & Supervisor:
Country Schoolhouse Project

This feature is a one room, wood framed prairie school hou. It has been move to a farm for storage/garage/shop use. The building sits on a concrete foundation and the east end has been changed to accomodate an overhead garage door and a small walk in door. The bulding measures 32 feet 4 inches east to west and 22 feet 4 inches north to south. The name of this school is Goodrich school and it is believed to have been in the town of Goodrich. There are no school records prior to 1912 for Sheridan County as it was part of McClean County. It is believed to have been built in 1912.

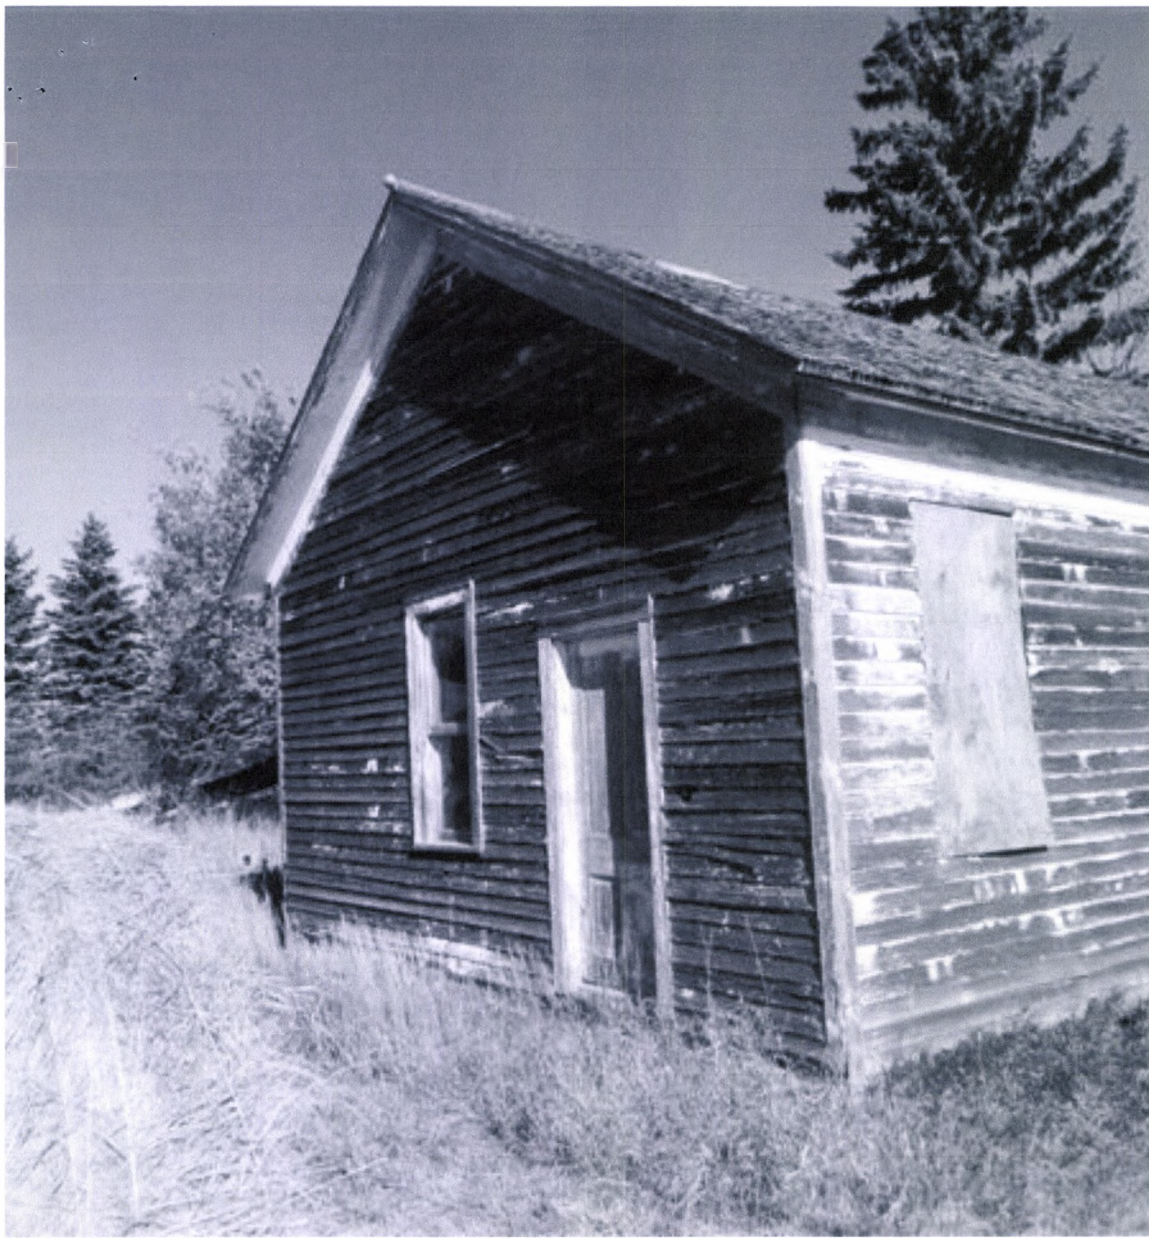
West Side

There are windows on both the north and south sides, three on each side for the main body of the school and then another full lenght one on the west side of what I suspect is the entry area and a small opening to the north, also in the area of the entry. The smaller opening might have been access for fuel. The windows in the main body of the school have intact glass and most are covered with hinged shutters. Most of the exterior is in need of paint. On the west side there is an entry door. The door is wood and sports an old looking metal door knob.
