NDCRS ARCHITECTURAL SITE FORM PAGE 1

Field Code Hellman Township School Site Name Hellman Township School #3

Project Title & Supervisor:
Country Schoolhouse Project

NDCRS ARCHITECTURAL SITE FORM
PAGE 3—Feature Data

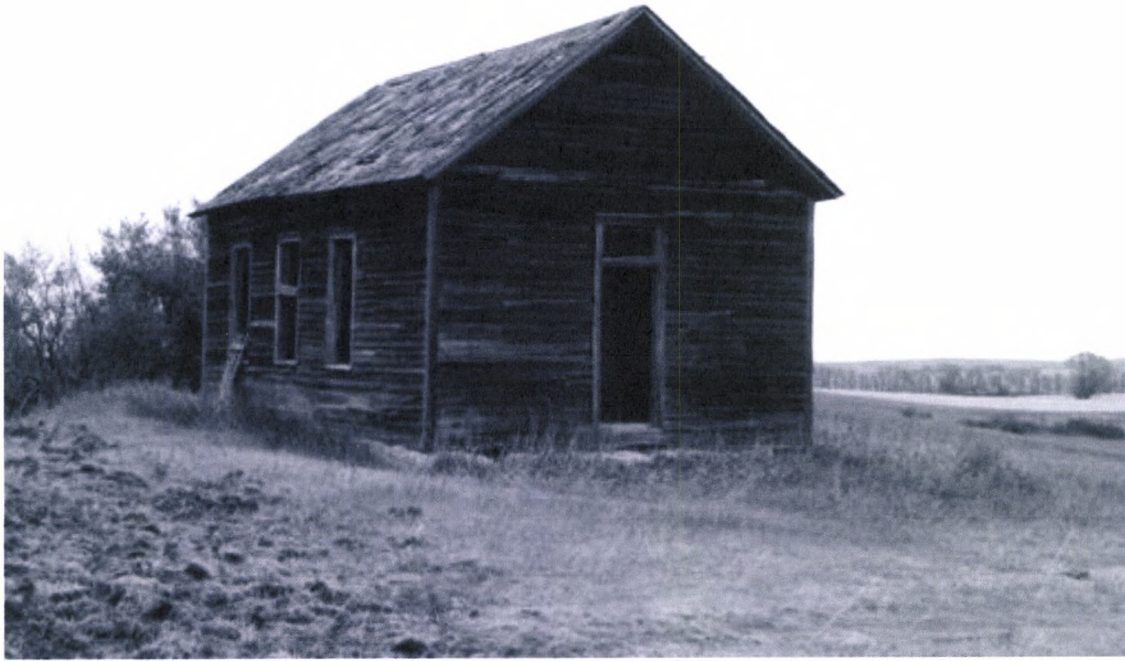
South Side
Hellman Township School 10/7/2012 Tracy Stein/Kathy Wilner SH
West Side

The outside walls are mostly covered with 6 inch lap siding with the same at the corners to trim and finish. On the north side wider boards can be seen filling in some of the wall, perhaps for repair. There is no paint left on the building. The school had six windows with three on the west and three on the east side. All the glass is gone and most of the framing as well. At one window there are remnants of a shutter that has fallen off the building. The door opening faces south and the door itself is gone. A transom opening is above the door.
