NDCRS ARCHITECTURAL SITE FORM
PAGE 2—Feature Data

This site is schoolhouse and privy, ⁿLincoln School #1.

NDCRS ARCHEOLOGICAL AND HISTORICAL SITE FORM
SKETCH MAP

FIELD CODE: CRM-LT-15

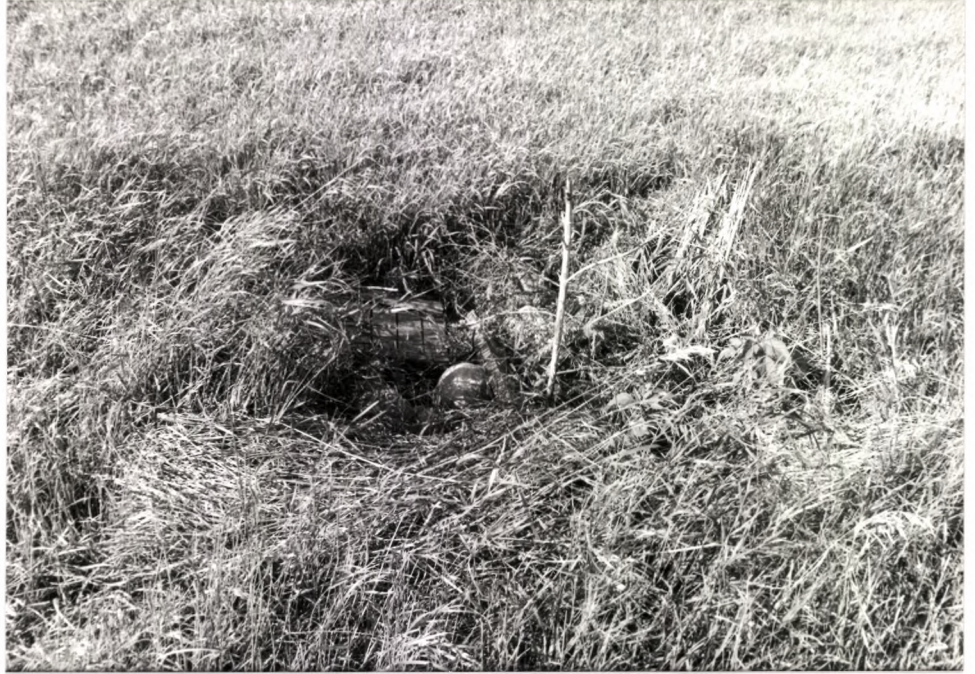
5:13 FEATURE 3, PRIVY
HOLE, FROM SOUTH

FEATURE 3: A rectangular outhouse depression to the north of Feature 1. This feature may be the location that the outhouse was recently moved from, as evidenced by relatively recent trash in the hole including used toilet paper. The depression now has fieldstone in it and some cut lumber. It has apparently been partially filled with earth. (photo 6:13 from S)

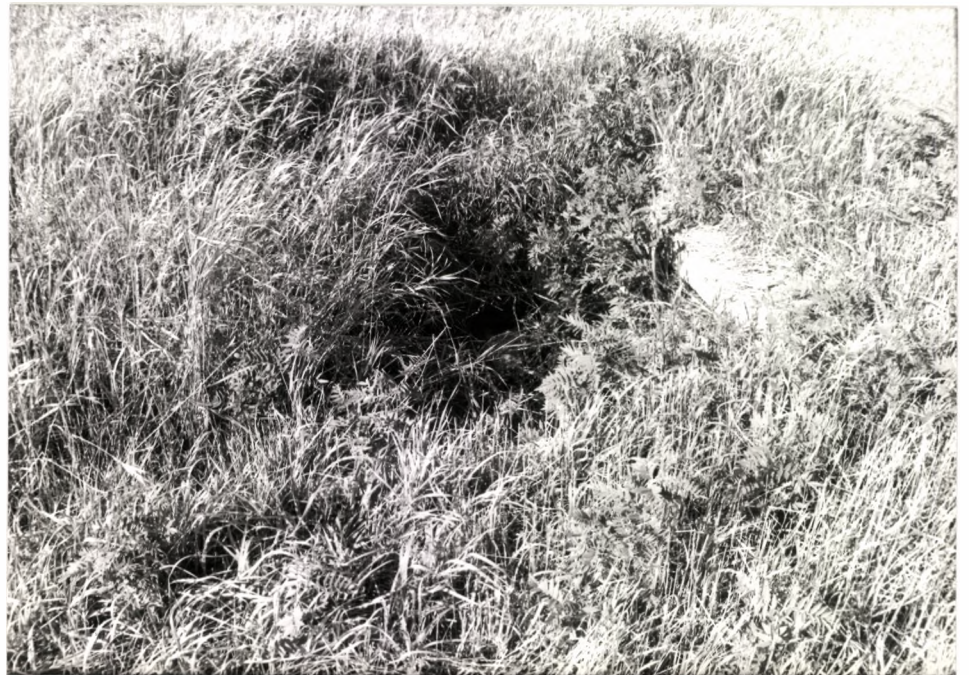
6:14 FEATURE 4, PRIVY
HOLE FROM SOUTH

FEATURE 4: A second apparent outhouse depression or possibly a well, which has a poured concrete foundation around it. It is roughly the same dimensions as the other outhouse depression. It now has some cut lumber and fieldstone pushed into it. (photo 6:14 from S)

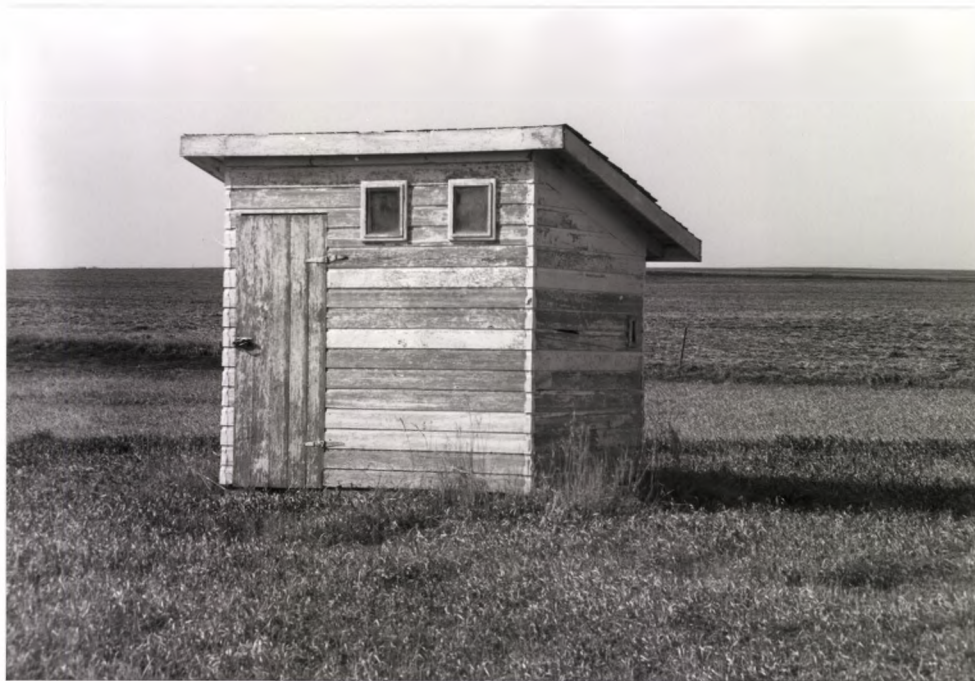
A:2 Feature 2 from NE

FEATURE 2: A shed-roofed wood-frame outhouse, apparently a two- or three-holer. The structure has fitted horizontal lap siding and wood shingles on the roof.

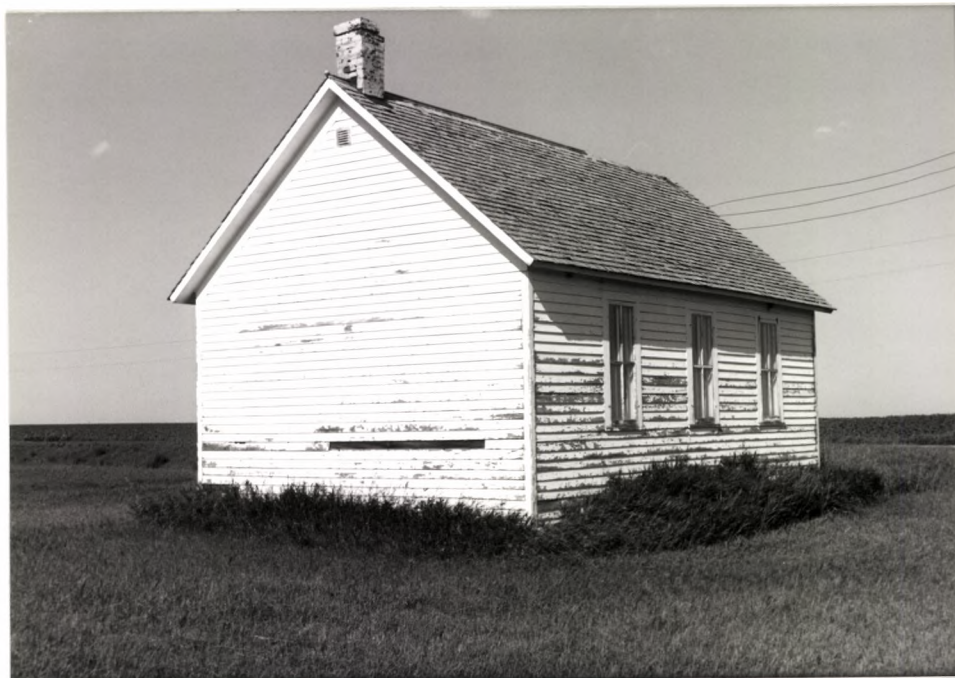
6:11 SCHOOLHOUSE FROM THE SW

FEATURE 1: A 1-story wood-frame gabled schoolhouse with gabled wood-frame entry addition on the east end. The structure has clapboard siding on exterior walls and cornerboards. It has wood shingles on the roof, poured concrete foundation. No basement is evident. The structure has been electrified. Three 2/2 double hung windows are on each of the north and south sides; these windows are covered with 4-pane storm windows. The entry addition also has a 2/2 double hung window on each side and has a five horizontal pattern door at center of east end. The building is in a fair degree of maintenance and may still be used as a township meeting hall, voting place. (photo 6:11 from SW, 6:12 from NE)
