NDCRS ARCHITECTURAL SITE FORM PAGE 1

Field Code Rainy School		SITS# 32	SL

The feature is a one room prairie school, cannot see the foundation. I did not get close to this school. The hip roof of the school and the half hip of the entry have wood shakes with much of the planking showing. Metal capping is here and there at the peak and the hips. There is a tall red brick chimney, with stucco or cement covering some of it, that is held up by cables attached the roof on the north slope. On the south slope and onto the entry roof there is a large bell tower. The base of the tower is finished with wood shakes up to the housing that has four corner posts supporting the roof. All sides of the bell tower are open. The pyramidal roof has wood shade and is topped with a flagpole. Soffits are closed.

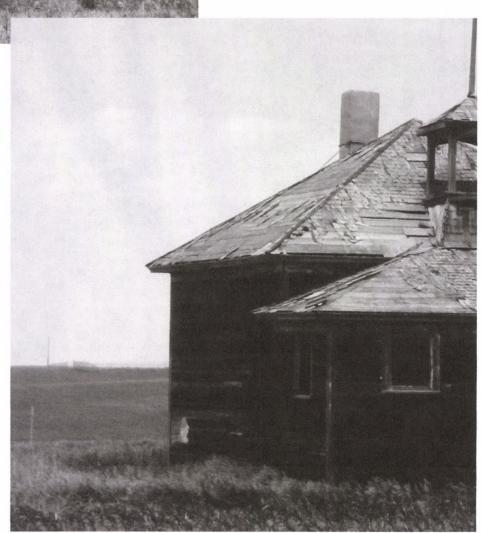
West Side

There is a wide trim board under the soffits on all sides of the school and entry. The remainder of the siding appears to be 6 inch wood lap with 6 inch corner trim, no paint. There are several double hung window openings, very little framing and no glass. On the north wall are two sets of two windows, the east side has a bank of four, a single window is on the west side of the entry. The entry has a door opening, door is gone, and two smaller window openings. The walls and ceiling (seen from the road) are lather and plaster with much falling in. Conduit on the east side of the entry would suggest electricity.
